YOUR Inspection Report

Toronto, ON M4M 2X9

Wednesday, May 22, 2024

RE: Report No. 2818, v.3

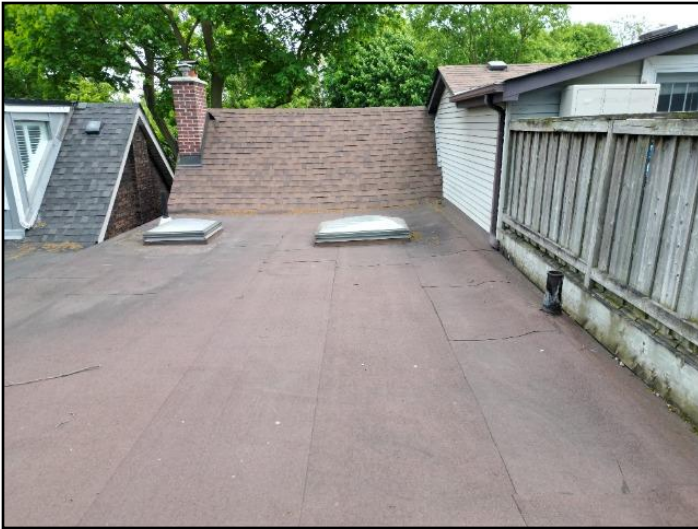
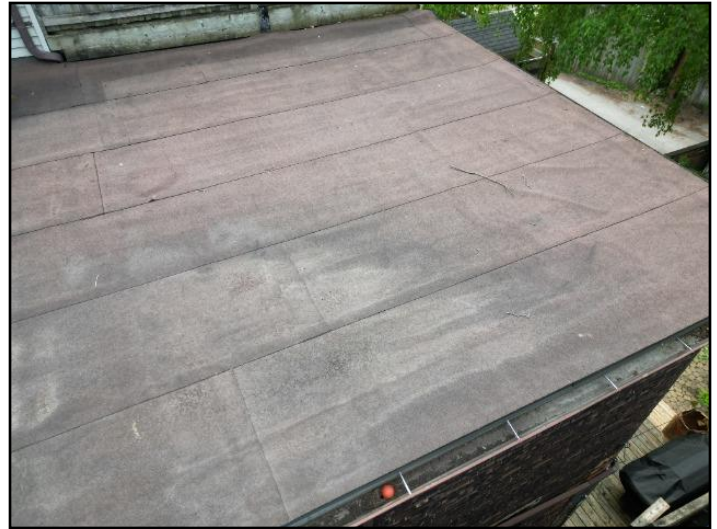
FLAT ROOFING \ Modified bitumen

1. Condition: • Blisters

Noted unknown hump that extends the full length of the flat roof near party wall.

Recommended immediate service and full replacement in less than 2 years.

Task: Replace

Time: Less than 2 years

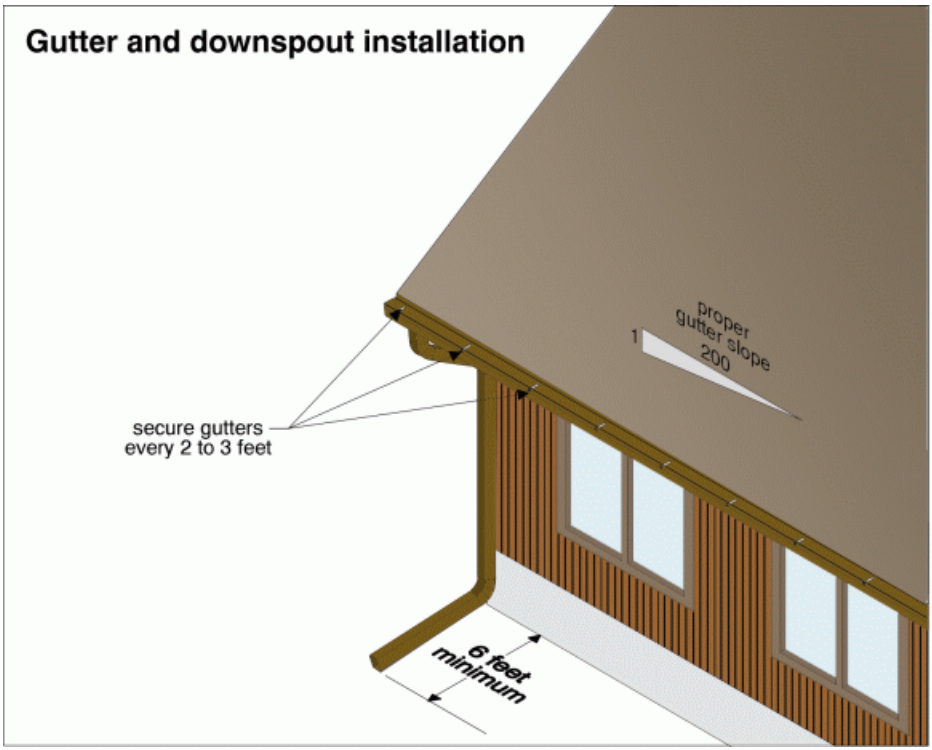
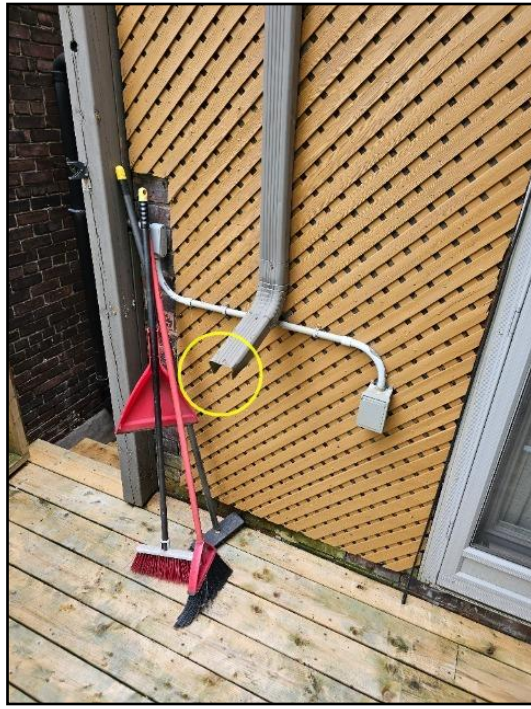
2. Condition: • Should discharge 6 feet from building

Time: As soon as feasible

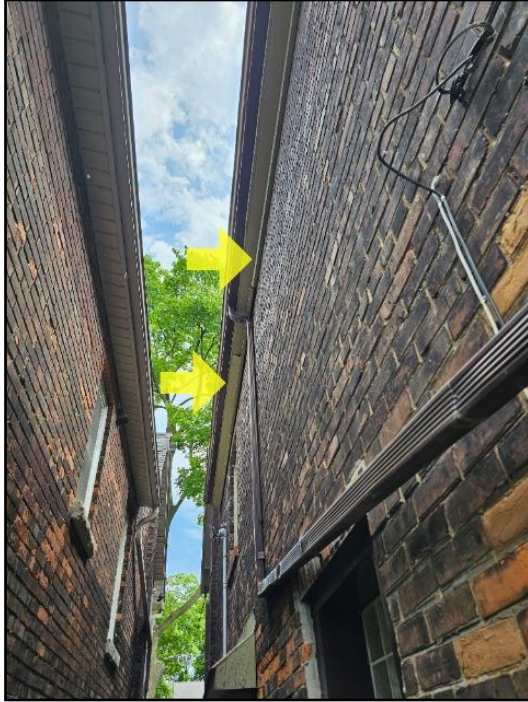
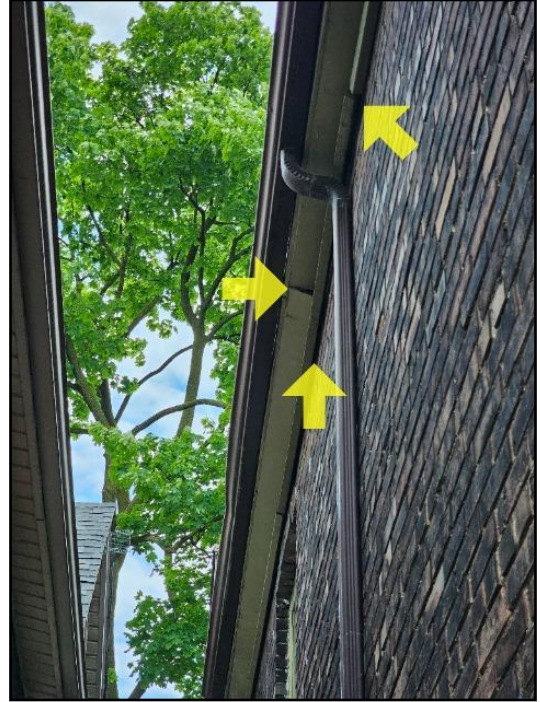
WALLS \ Soffits (underside of eaves) and fascia (front edge of eaves)

3. Condition: • Loose or missing pieces
Soffit trim is loose.

Task: Repair

Time: Less than 1 year

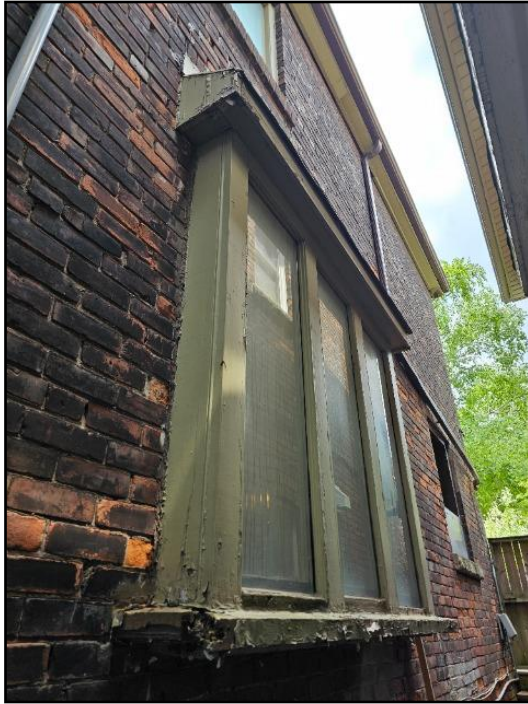
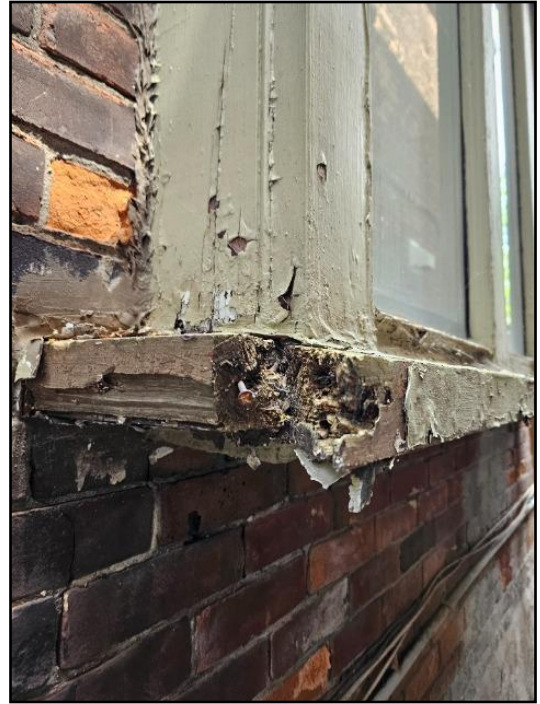
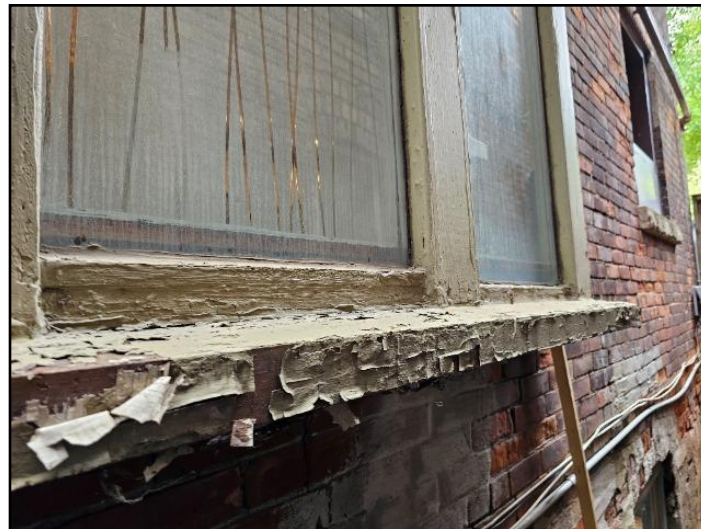
EXTERIOR GLASS/WINDOWS \ Exterior trim

4. Condition: • Rot

Task: Repair or replace

Time: Less than 1 year

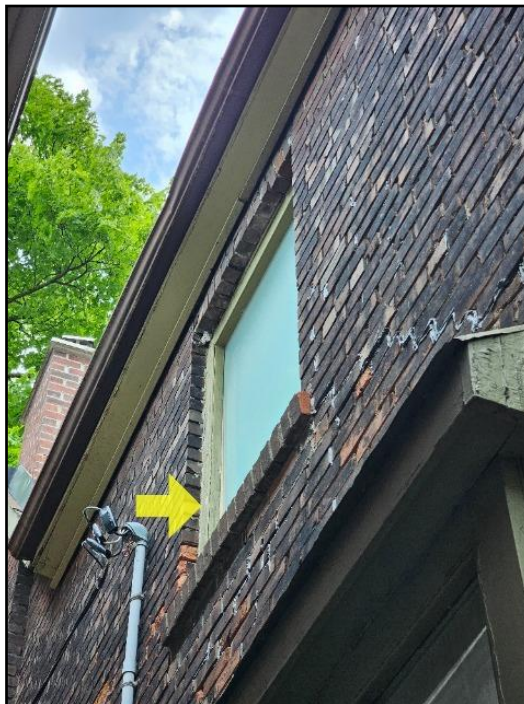
5. Condition: • Paint or stain needed

Paint around frames of windows is chipping away exposing raw wood. Paint or stain necessary to prevent future rot.

Task: Repair

Time: Regular maintenance

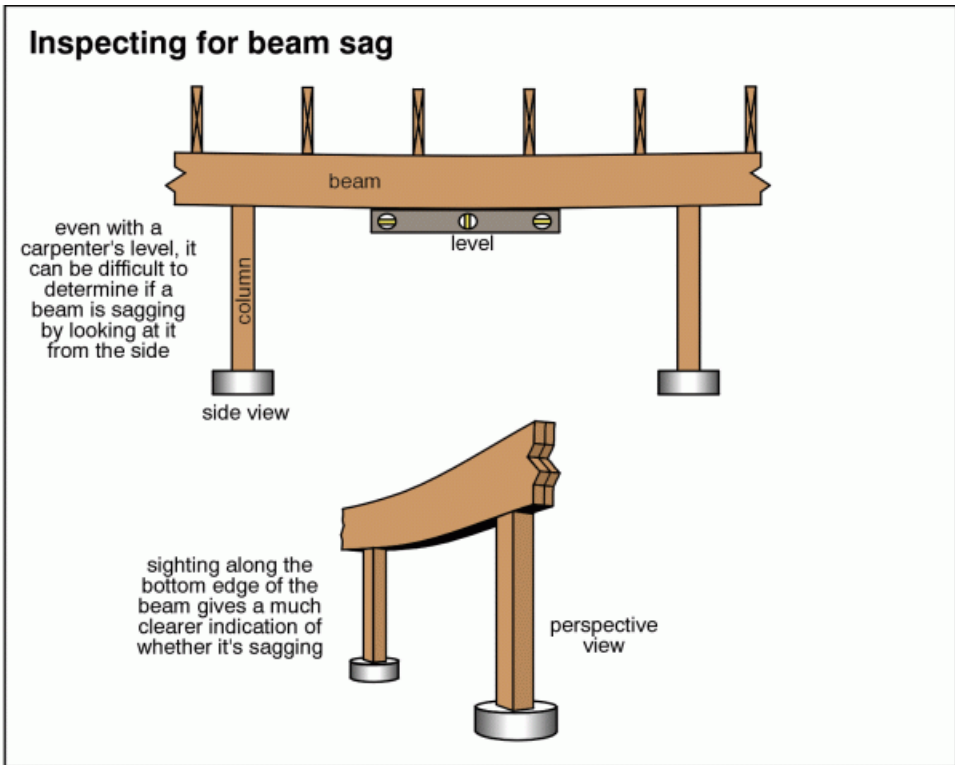
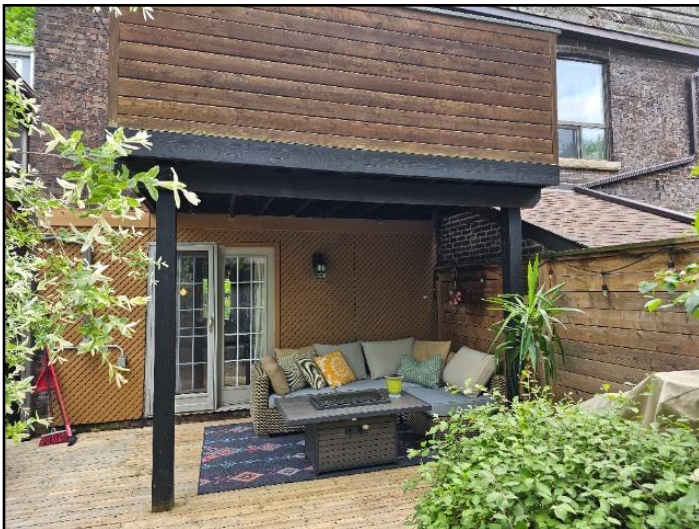
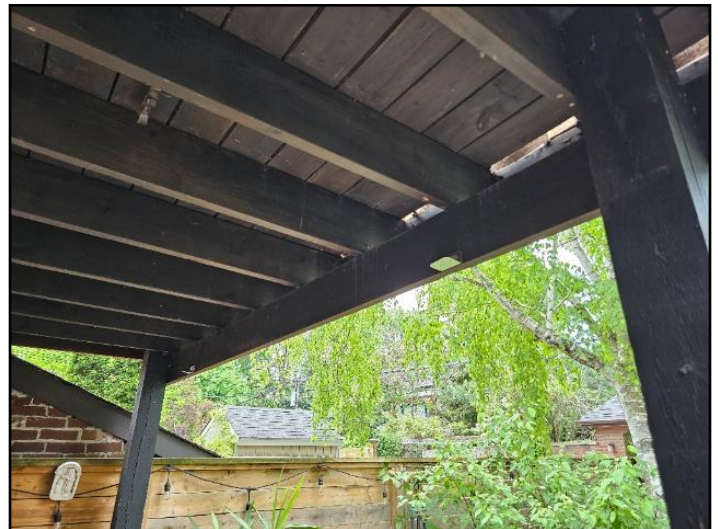
PORCHES, DECKS, STAIRS, PATIOS AND BALCONIES \ Beams

6. Condition: • Sag

Recommended repair/reinforcement by a qualified framing contractor.

Time: Before use

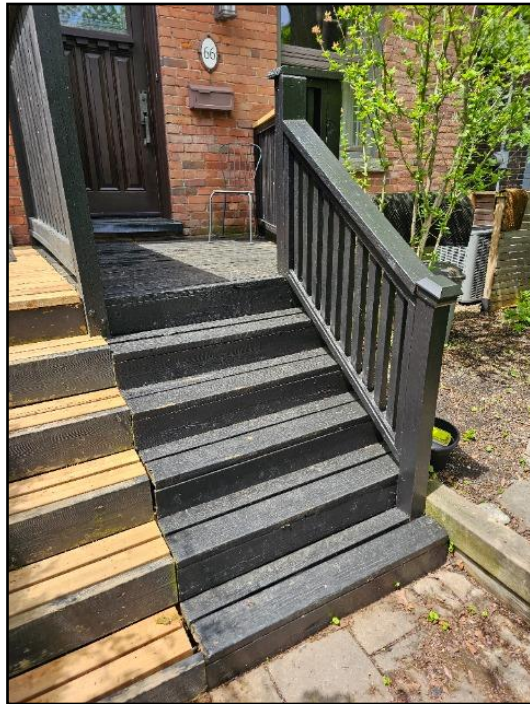
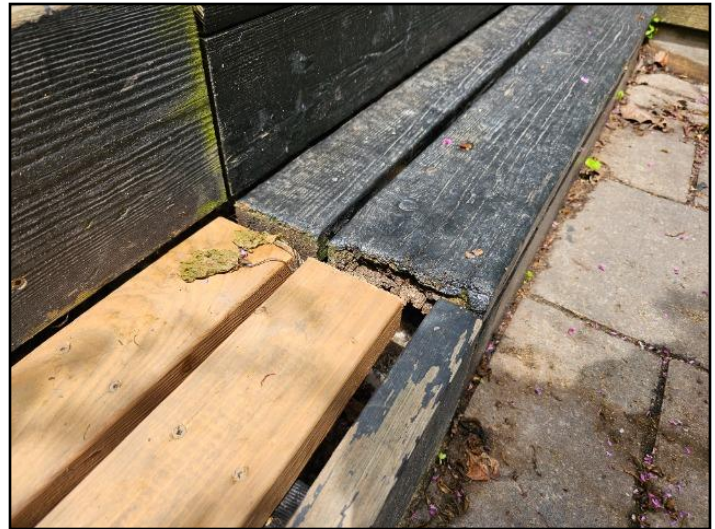
PORCHES, DECKS, STAIRS, PATIOS AND BALCONIES \ Floors

7. Condition: • Rot

No performance issues noted with front porch structure.

Task: Replace

Time: Less than 1 year

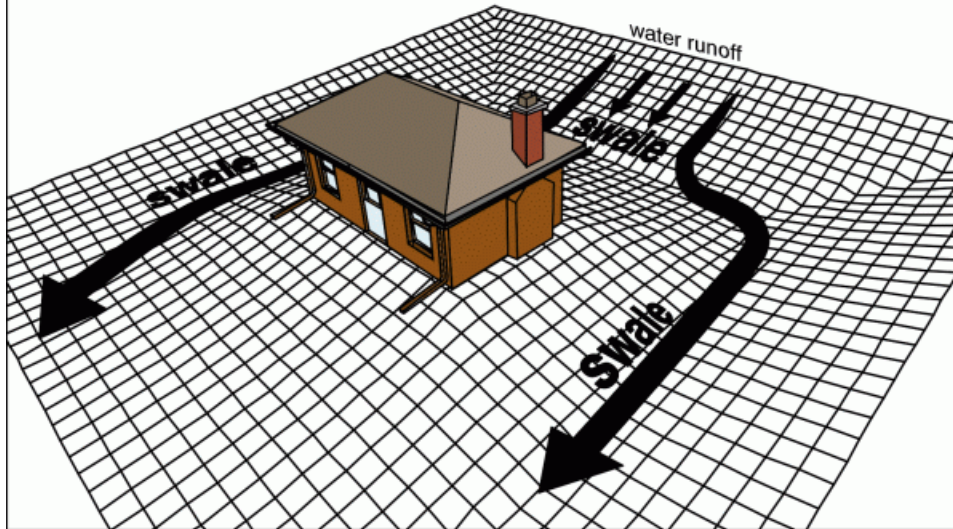
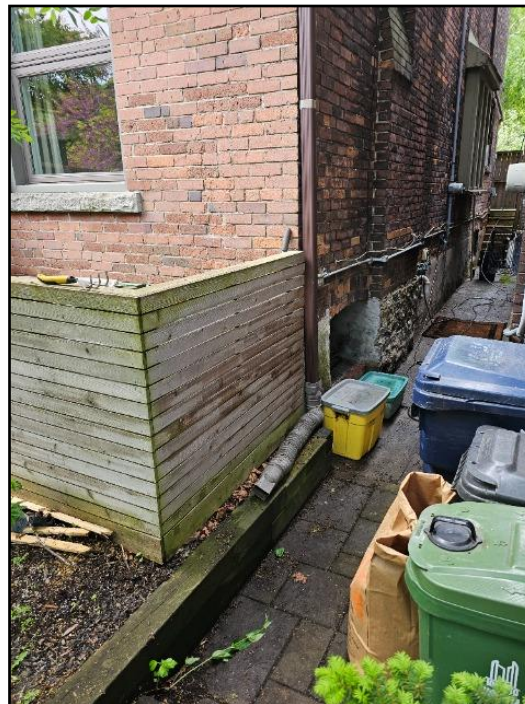
LANDSCAPING \ Lot grading

8. Condition: • No swale

The right side of the home (exterior) grading was lower than the front and backyard. A concrete walkway is present which has a good slope to divert water away from the foundation but water has nowhere to go afterwards. It is imperative the eavestrough system is properly managed to minimize the water that can go between the homes.

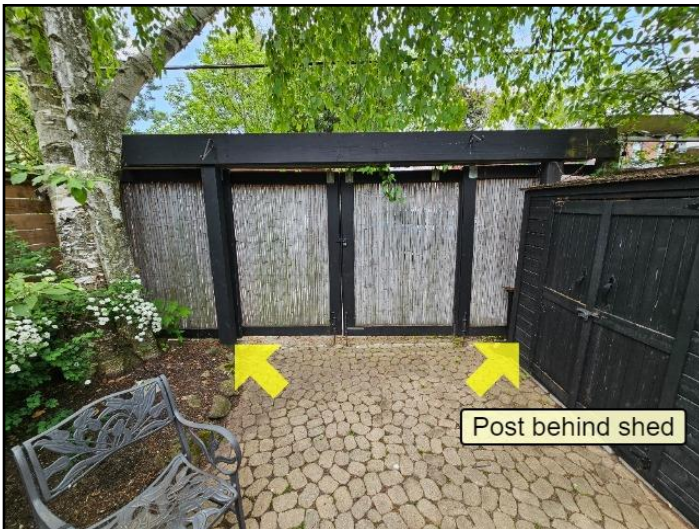
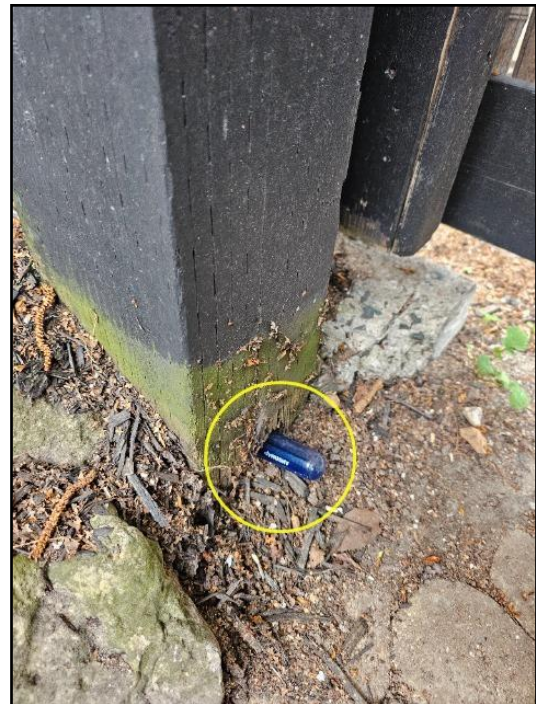
LANDSCAPING \ Fence

9. Condition: • Rot

Task: Replace

Time: Less than 1 year

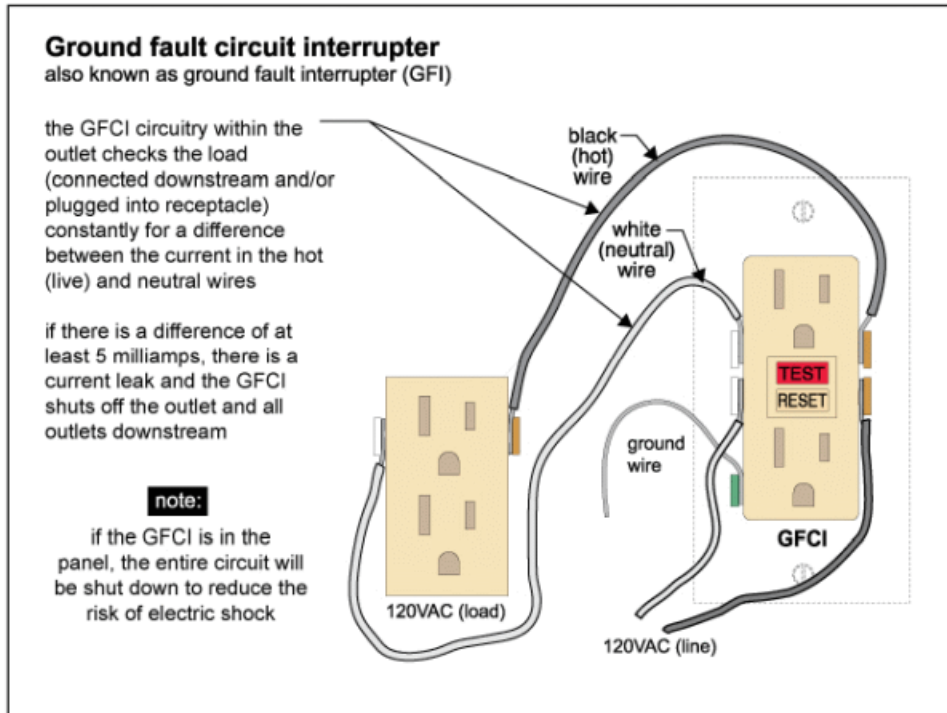
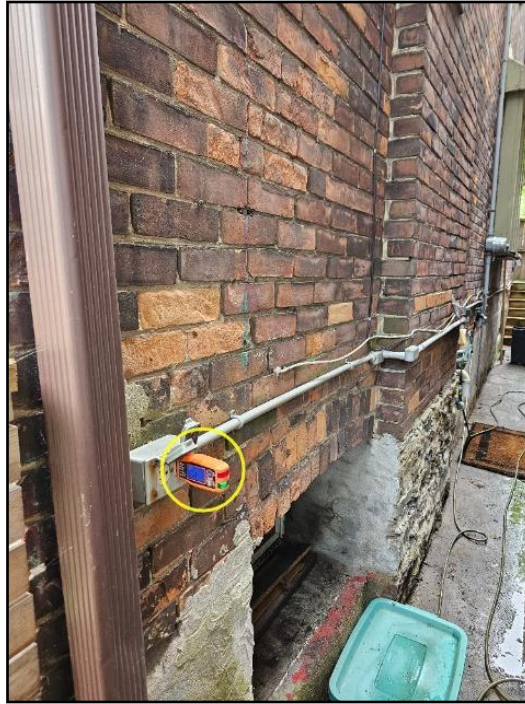
12. Condition: • GFCI/GFI needed (Ground Fault Circuit Interrupter)

GFCI receptacles recommended for any receptacle that is within 5 feet of a water source or on the exterior.

Task: Replace

Time: Before use

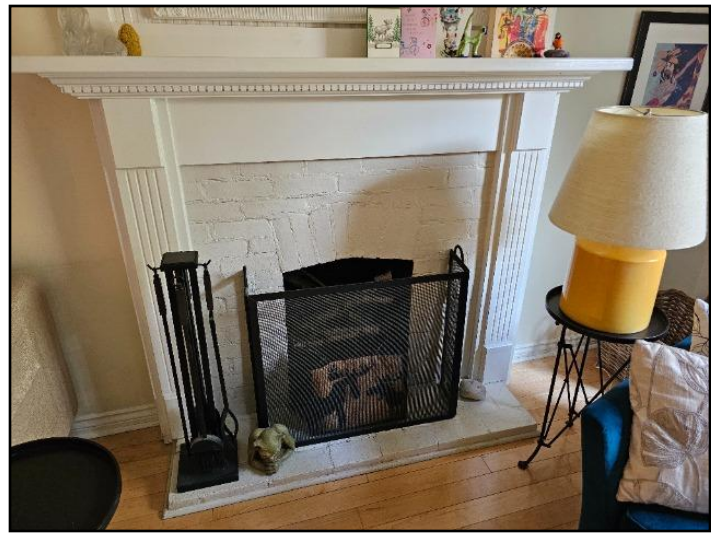
13. Condition: • Inspect chimney, and sweep, if needed before using
Fireplace should be inspected to receive a WETT certification prior to any use.

Task: Further evaluation

Time: Before use

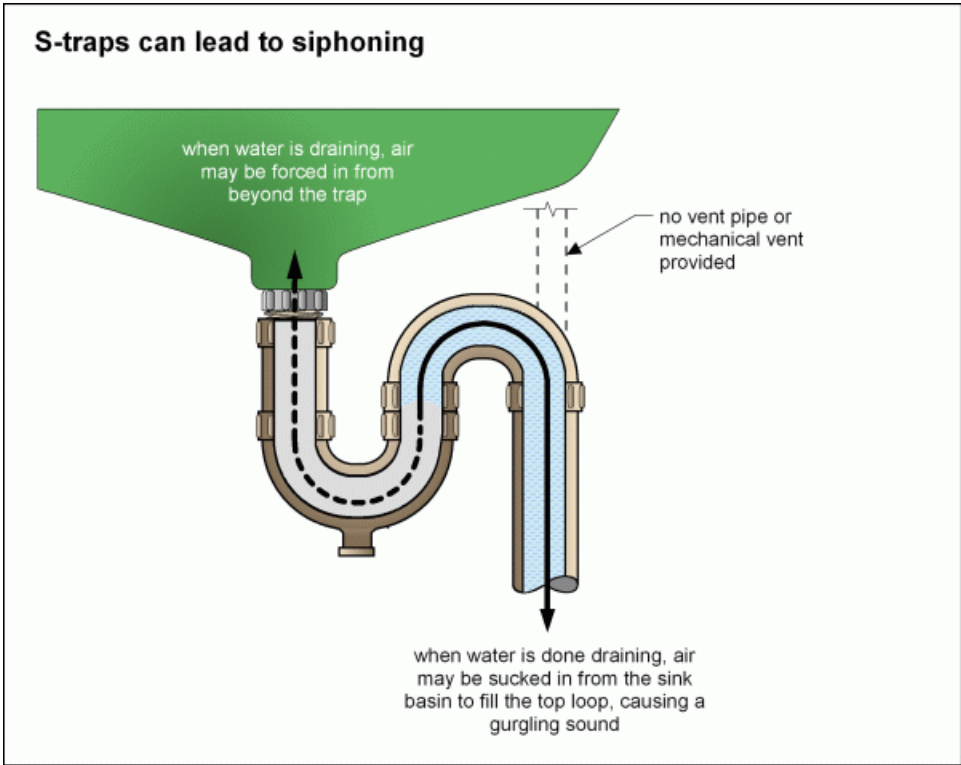
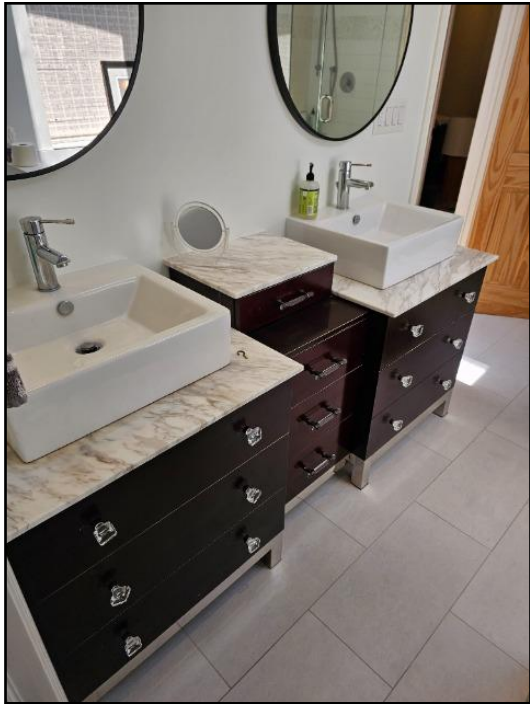
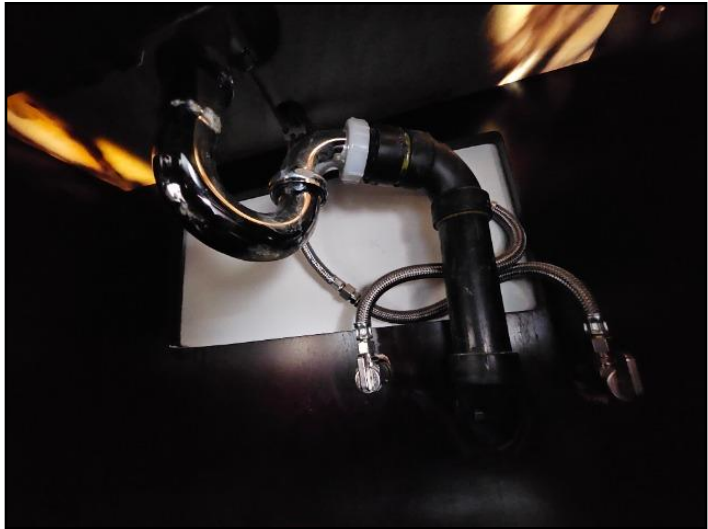
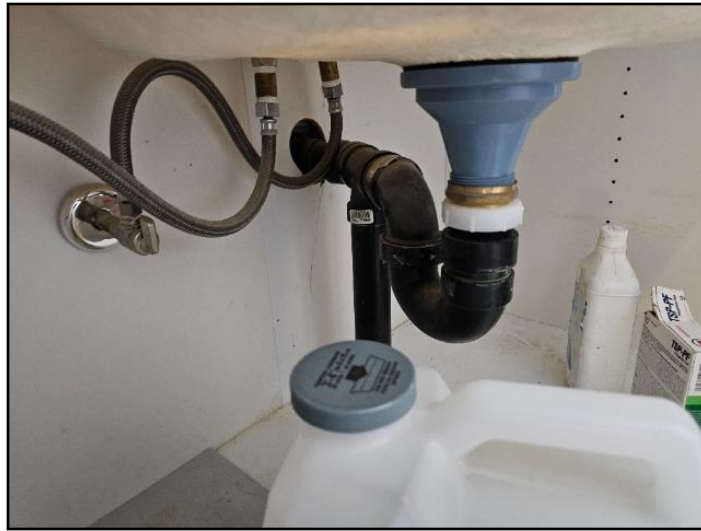
16. Condition: • Nonstandard shape or material

Task: Repair

Time: When necessary

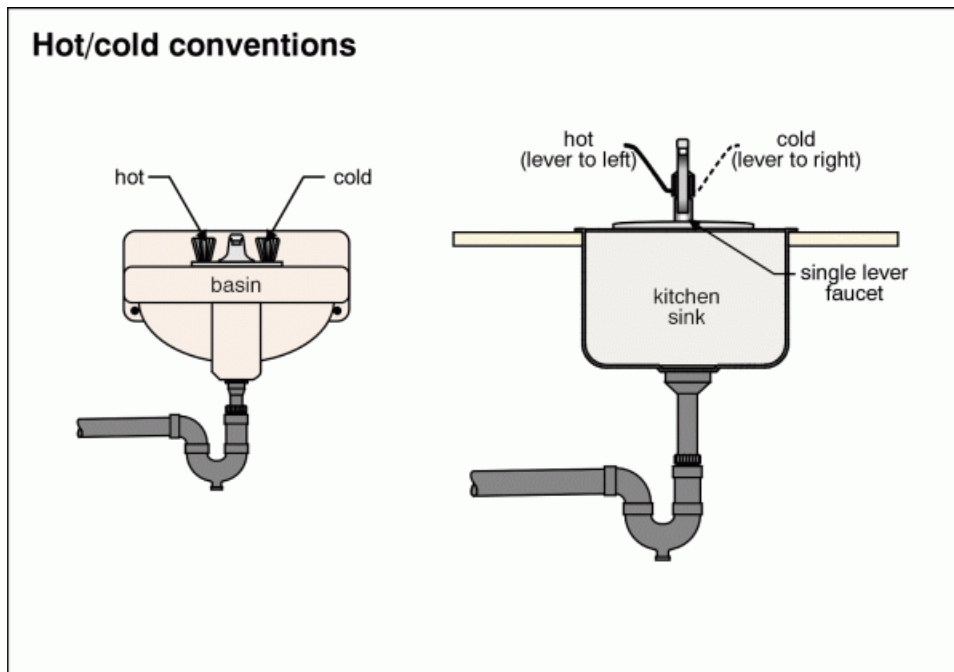
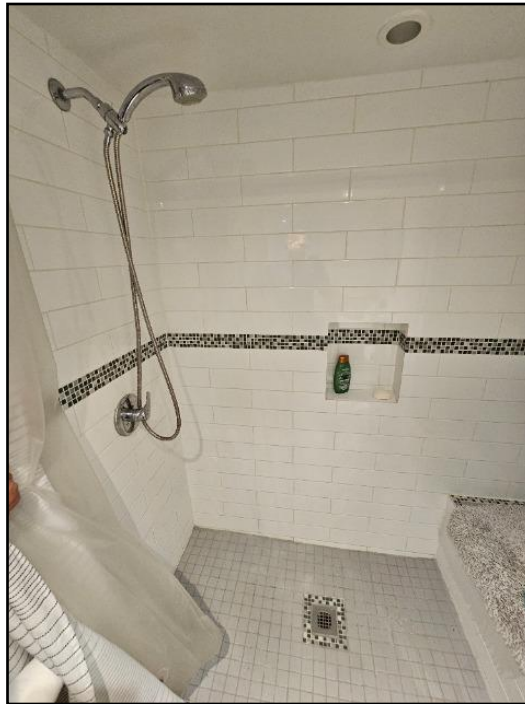
FIXTURES AND FAUCETS \ Faucet

17. Condition: • Hot and cold reversed

Task: Repair

Time: When necessary

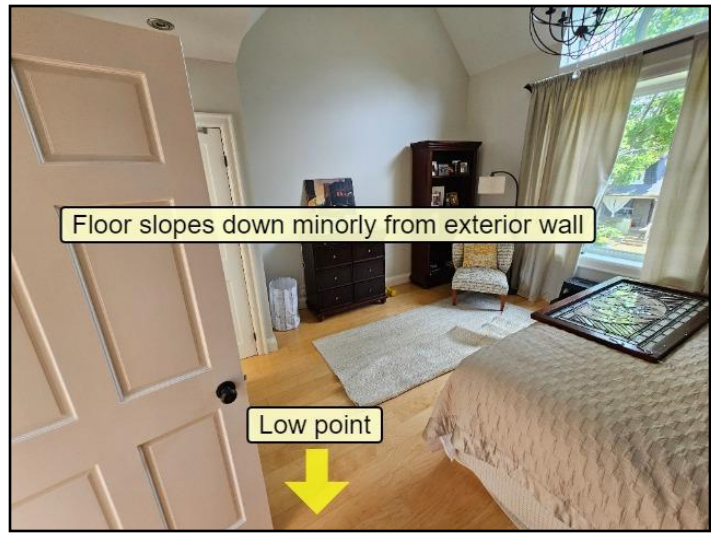
18. Condition: • Floor slope/sag is typical in a home of this era. Typically this is not a major issue unless the sloping worsens in a short period of time.

Minor sloping was noted in the master bedroom.

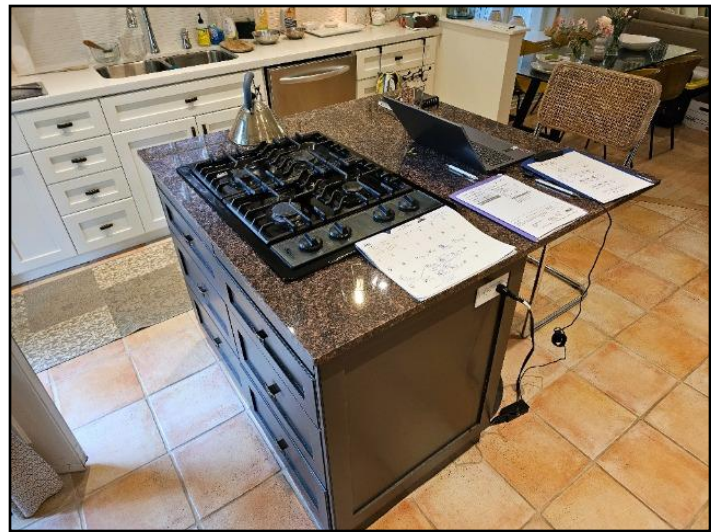
EXHAUST FANS \ Kitchen range exhaust system (range hood)

19. Condition: • Missing

Task: Provide

Time: Before use of cooktop

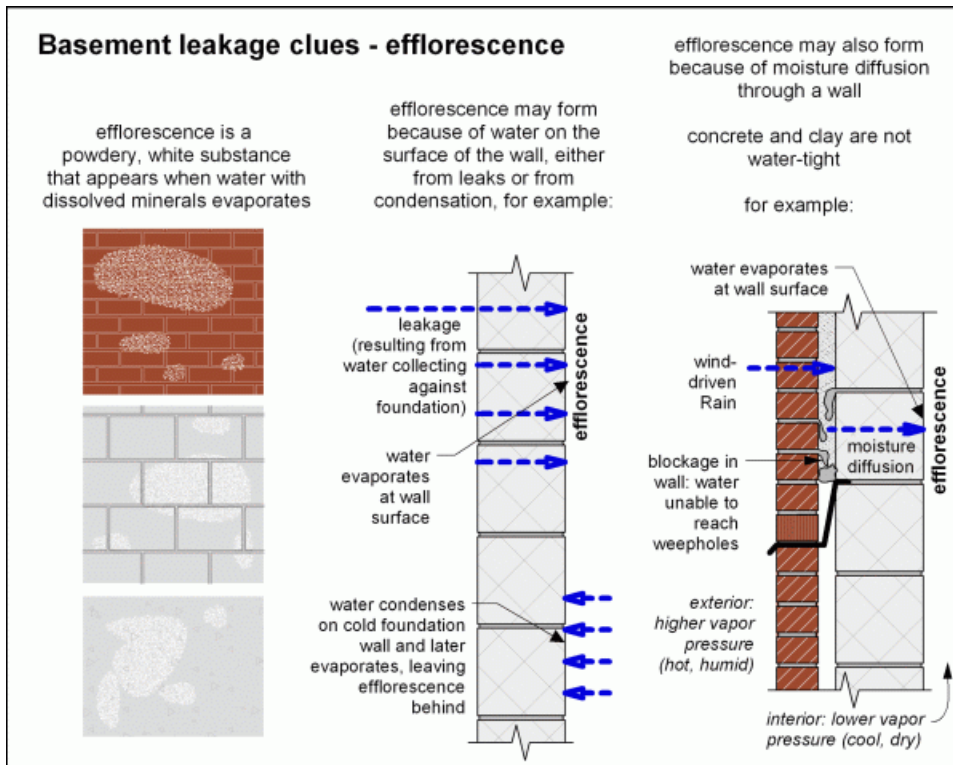
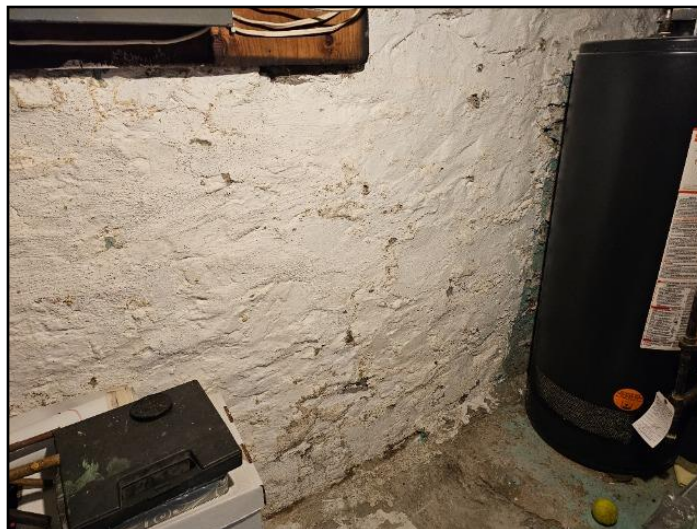
BASEMENT \ Wet basement - evidence

20. Condition: • Efflorescence

Efflorescence was noted on the accessible walls of the basement. Refer to exterior section for recommendations to drastically improve water management from the exterior.

We should not have trees, planters or any plants next to the foundation as watering them will greatly increase the chance of water penetration.

Grading must be sloped in such a way around the home that it diverts water away from the foundation. If leakage continues after these fixes a qualified waterproofing company is recommended for repair.

Task: Improve

Time: Ongoing

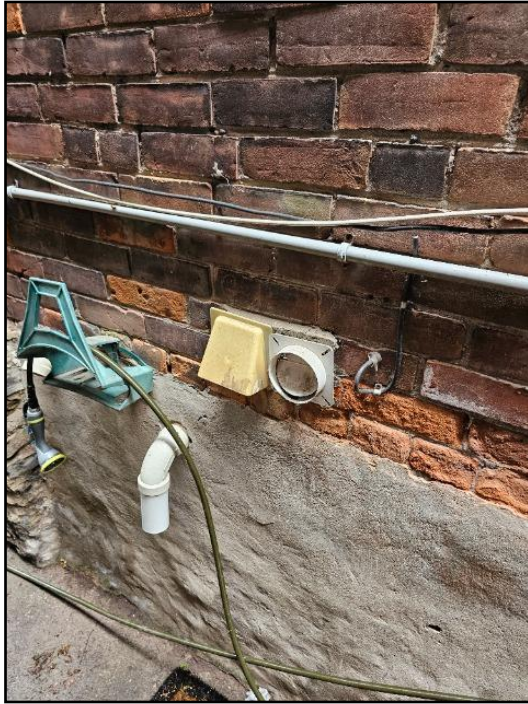
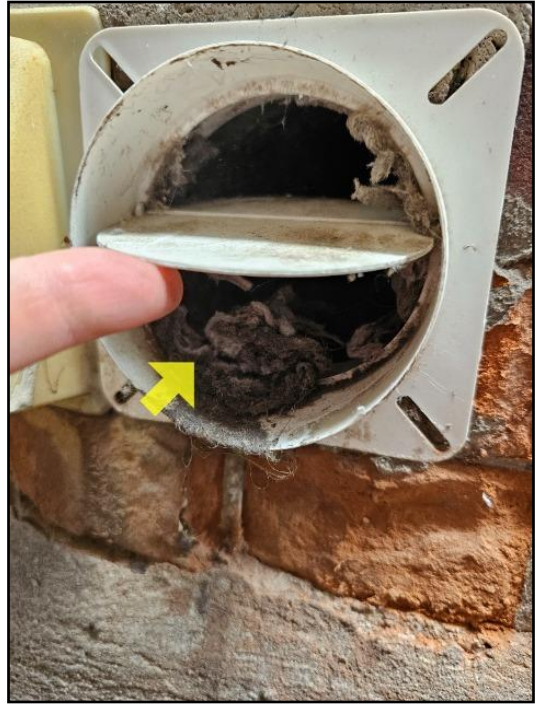
22. Condition: • Dryer vent is clogged

Time: Regular maintenance
