Your Inspection Report

123 Yonge Street
Toronto, ON

PREPARED BY:
Boris Vorobyov

RE: Report No. 1015, v.2
123 Yonge Street
Toronto, ON

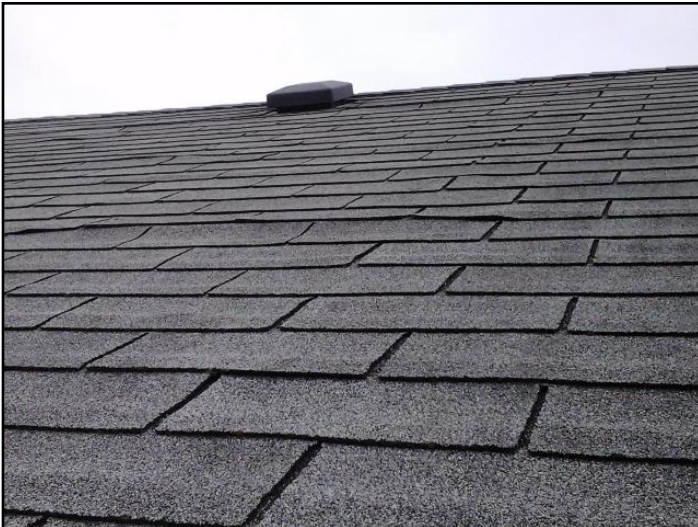
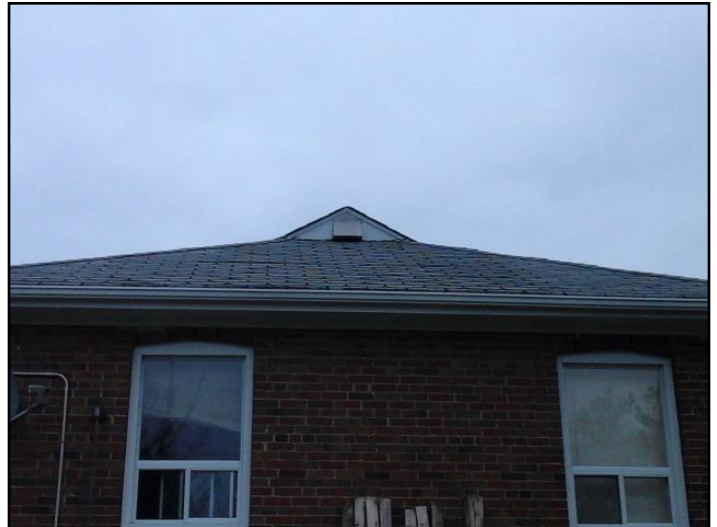
1. Condition: • [Cupping, curling, clawing](#)

Implication(s): Chance of water damage to contents, finishes and/or structure

Location: Throughout

Cupping, curling, clawing

Task: Repair or replace

Time: Less than 4 years

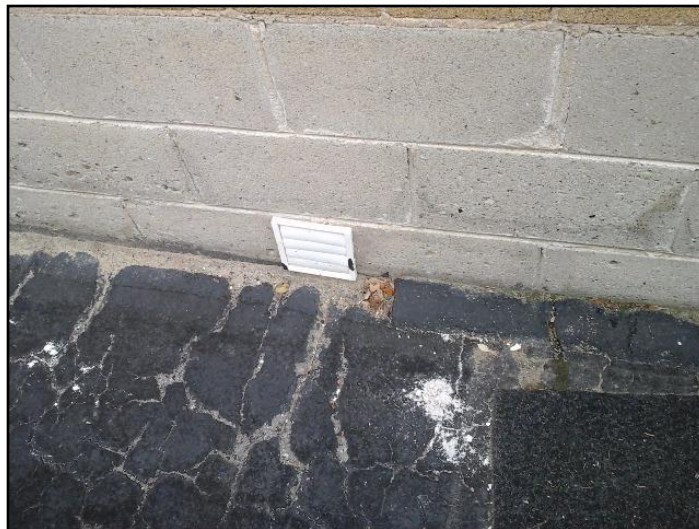
2. • Vent grill to low to the ground. Can get blocked by snow accumulation.

Location: West Exterior Wall

Task: Further evaluation

Time: Less than 1 year

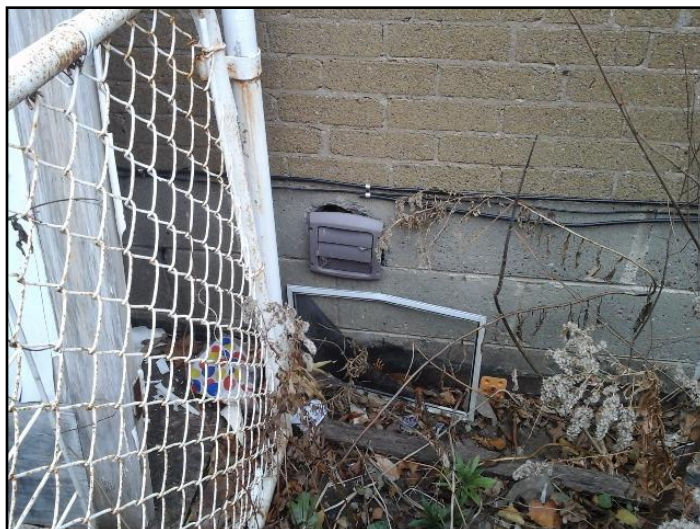
3. **Condition:** • Vent not sealed around. Water penetration is possible.

Location: East

Task: Repair

Time: Immediate

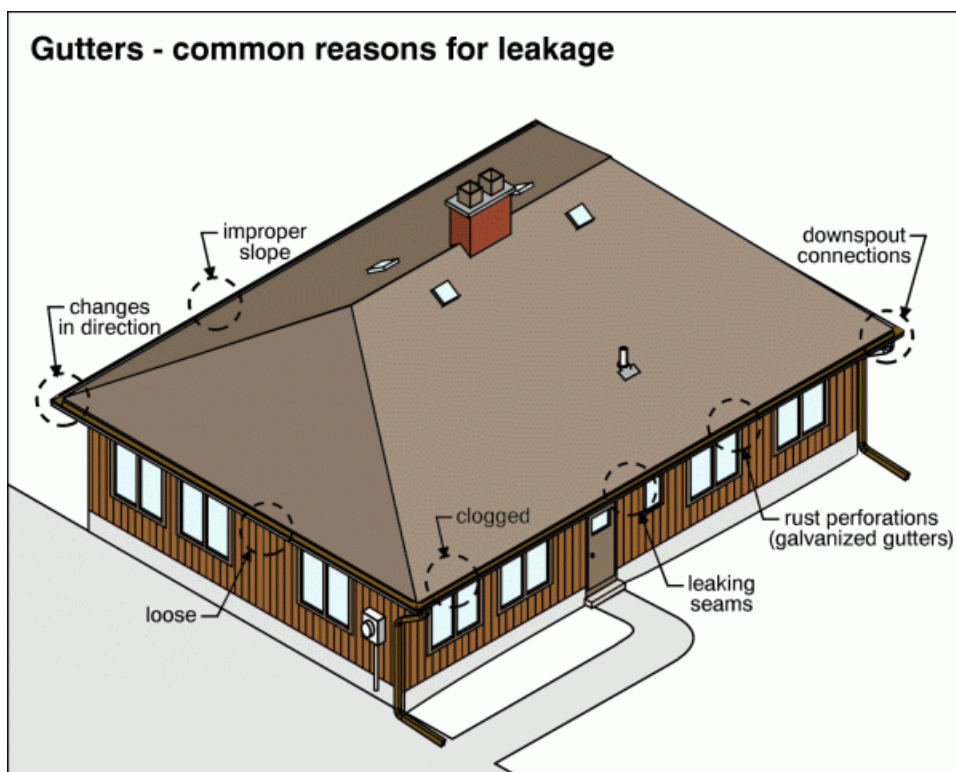
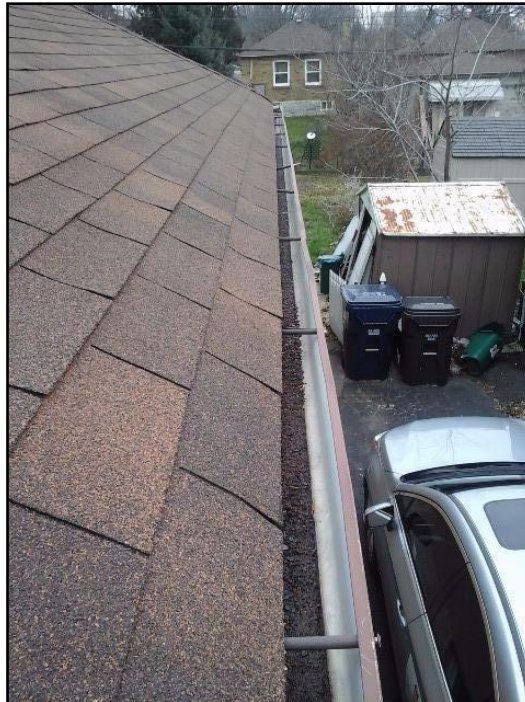
4. Condition: • [Clogged](#)

Implication(s): Chance of water damage to contents, finishes and/or structure

Location: Throughout

Clogged

Task: Clean

Time: Less than 1 year

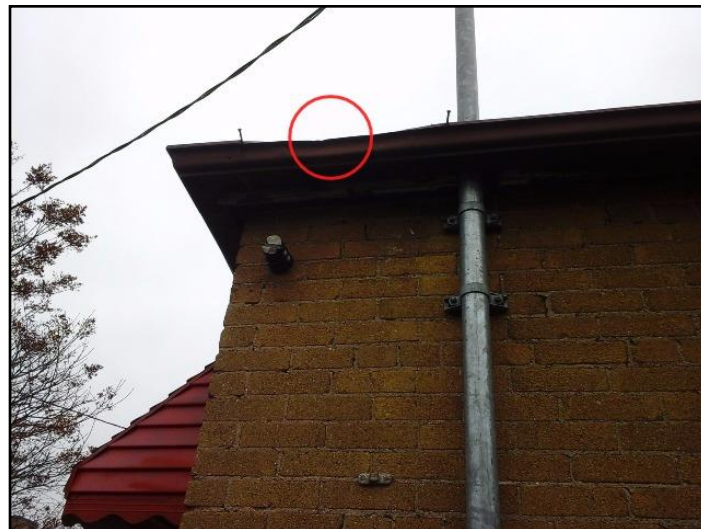
5. Condition: • [Loose or damaged](#)

Implication(s): Chance of water damage to contents, finishes and/or structure

Location: West Exterior

Loose or damaged

Task: Repair or replace

Time: Less than 1 year

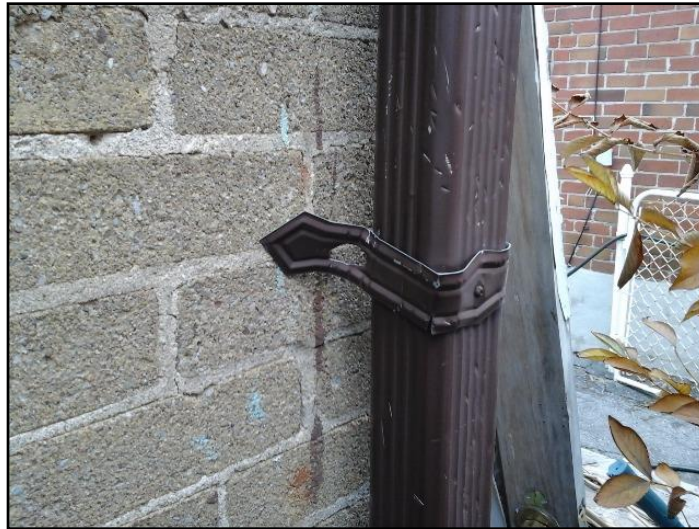
6. Condition: • [Not well secured](#)

Implication(s): Leakage

Location: South

Not well secured

Task: Repair

Time: Less than 1 year

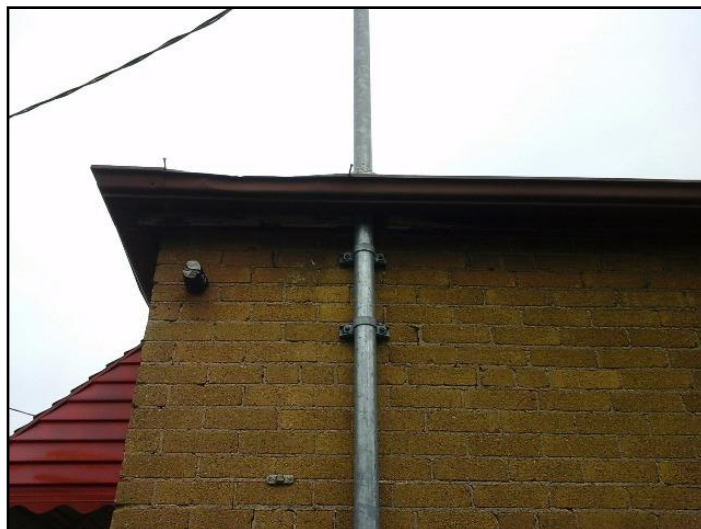
7. Condition: • [Paint or stain - deteriorated / missing](#)

Implication(s): Chance of water damage to contents, finishes and/or structure | Shortened life expectancy of material

Location: Throughout

Paint or stain needed

Task: Repair

Time: Less than 2 years

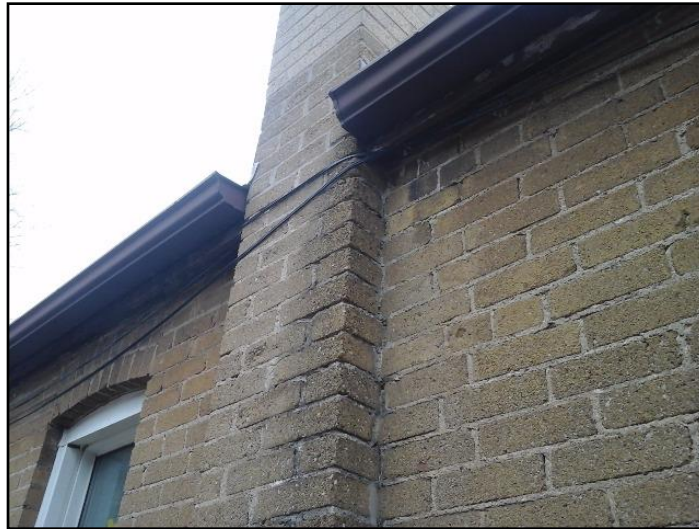
8. Condition: • [Mortar deterioration](#)

Water spilling over causing mortar deterioration.

Implication(s): Chance of water entering building | Weakened structure | Chance of structural movement

Location: East

Mortar deterioration

Task: Repair or replace

Time: Immediate

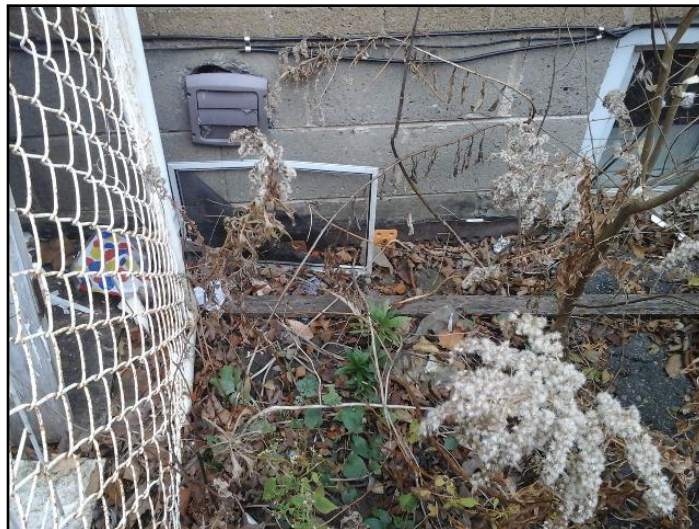
9. Condition: • [Improper slope or drainage](#)

Implication(s): Chance of water damage to contents, finishes and/or structure

Location: East

Improper slope

Task: Repair or replace

Time: Immediate

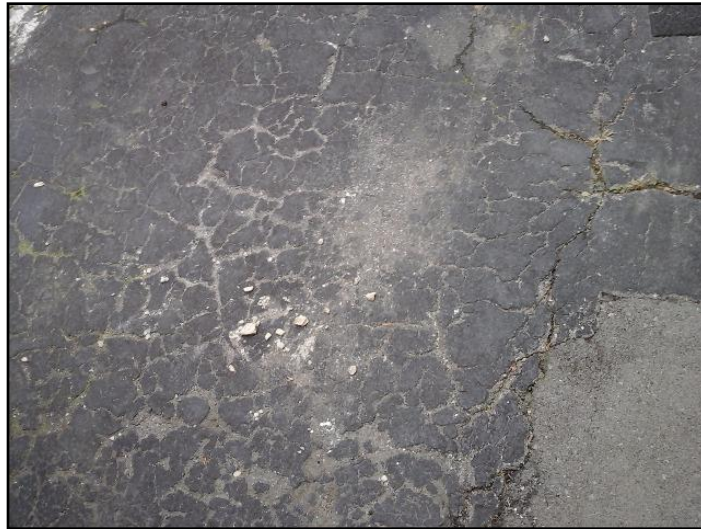
10. Condition: • [Cracked or damaged surfaces](#)

Implication(s): Trip or fall hazard

Location: West

Cracked or damaged surfaces

Task: Repair or replace

Time: Less than 5 years

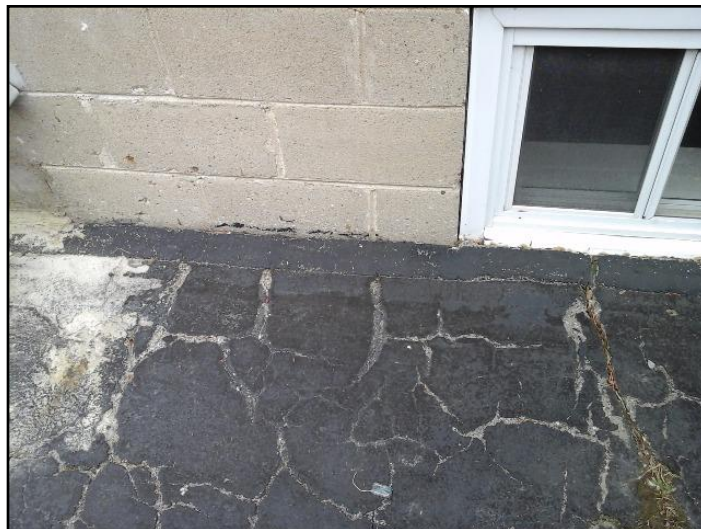
11. Condition: • [Unsealed gap at building](#)

Implication(s): Chance of water damage to contents, finishes and/or structure

Location: West

Unsealed gap at building

Task: Provide

Time: Less than 1 year

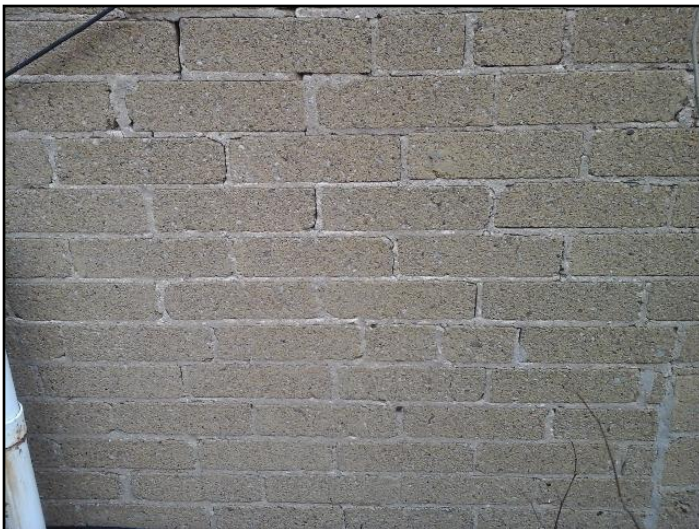
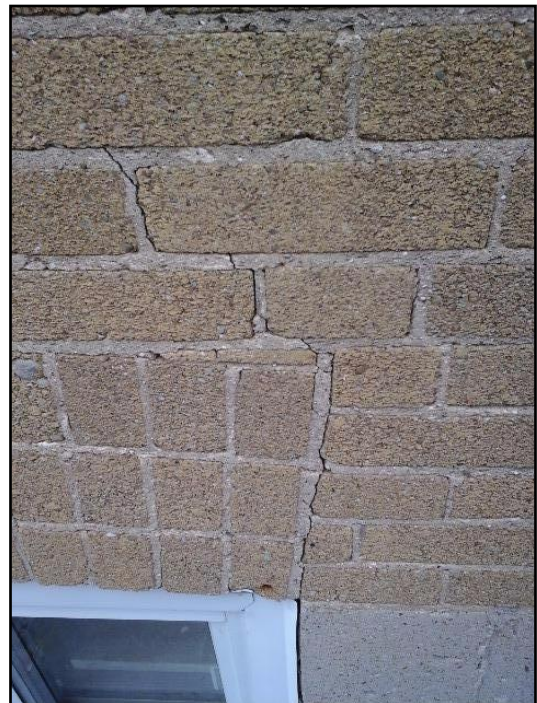
12. Condition: • Typical minor cracks

Implication(s): Chance of water entering building

Location: Throughout

Typical minor cracks

Task: Repair or replace Further evaluation

Time: Less than 1 year

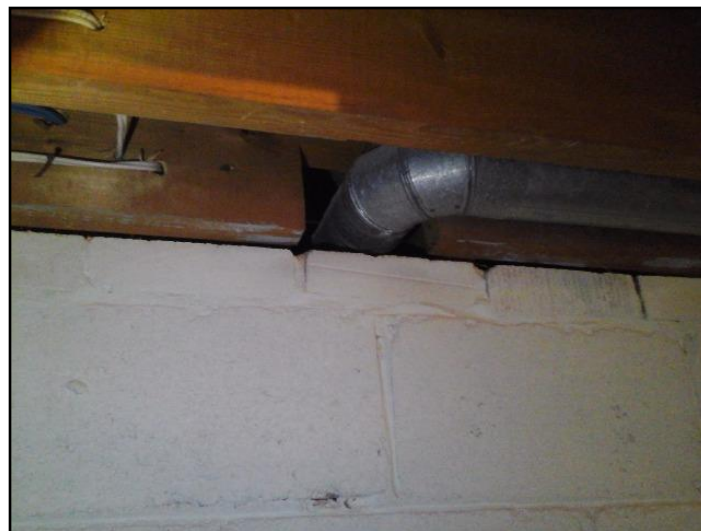
13. Condition: • [Notches or holes](#)

Implication(s): Weakened structure | Chance of structural movement

Location: Basement

Notches or holes

Task: Repair or replace Further evaluation

Time: Immediate

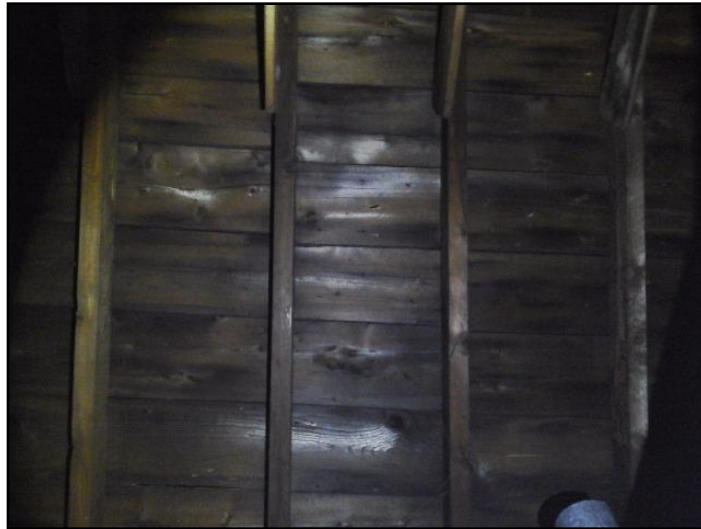
14. Condition: • [Mold](#)

Implication(s): Weakened structure | Chance of structural movement

Location: Throughout Attic

Mold

Task: Repair or replace Further evaluation

Time: Less than 1 year

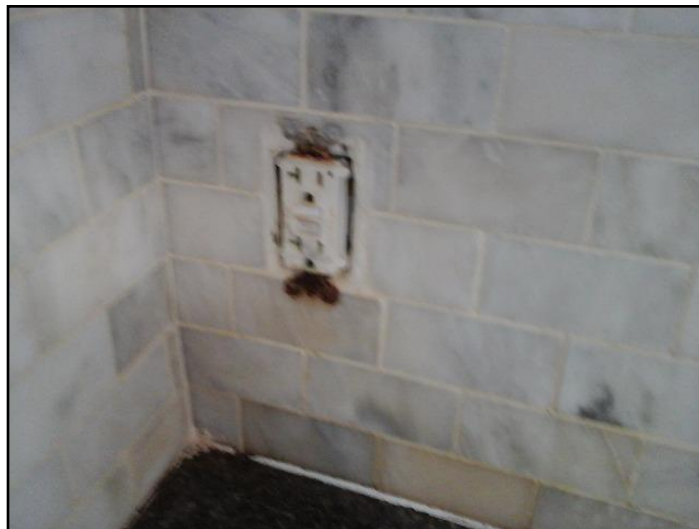
15. Condition: • [Inoperative](#)

Implication(s): Equipment inoperative

Location: First Floor Kitchen

Inoperative

Task: Replace

Time: Immediate

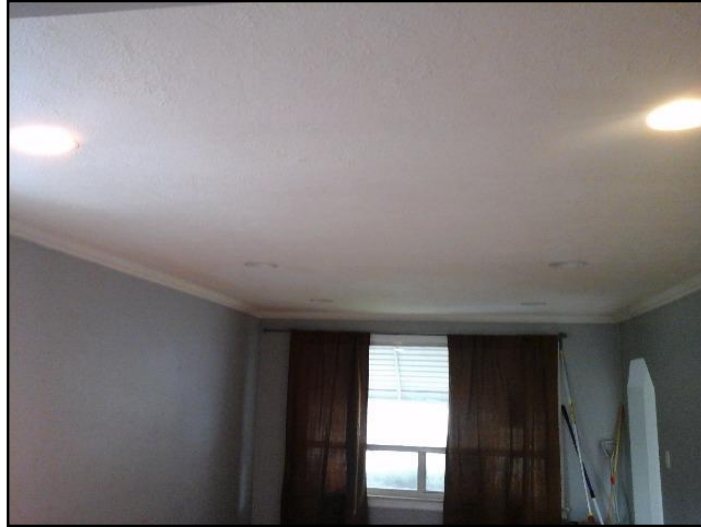
16. Condition: • [Inoperative](#)

Implication(s): Inadequate lighting

Location: First Floor Living Room

Inoperative

Task: Further evaluation

Time: Immediate

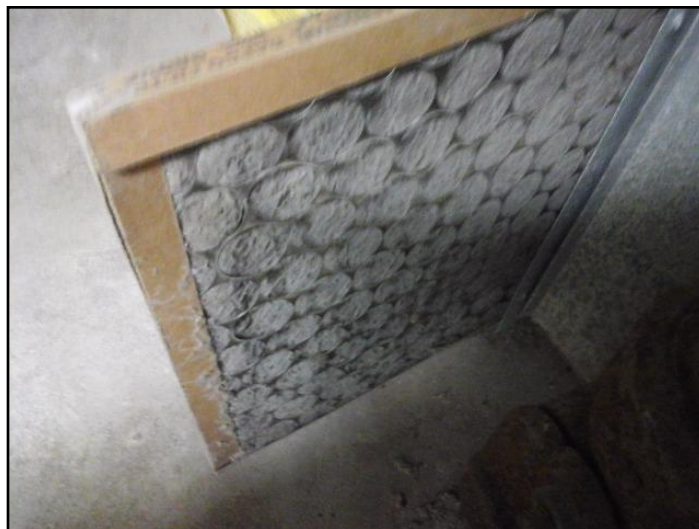
17. Condition: • [Dirty](#)

Dirty

Task: Replace

Time: Immediate

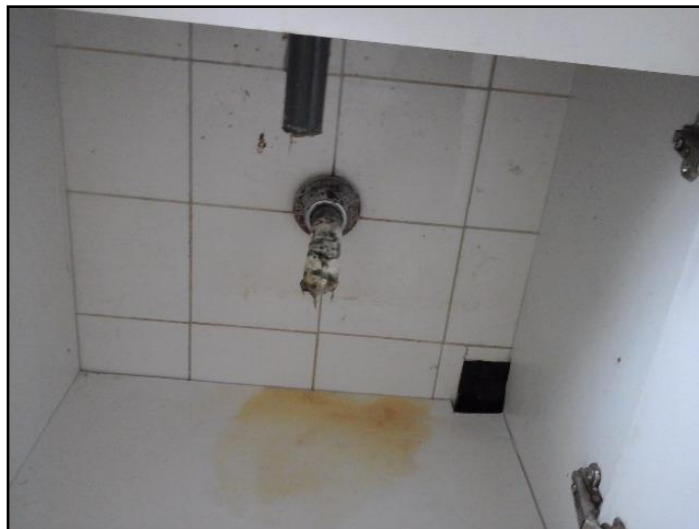
19. Condition: • "P" Trap completely missing.

Task: Provide

Time: Immediate

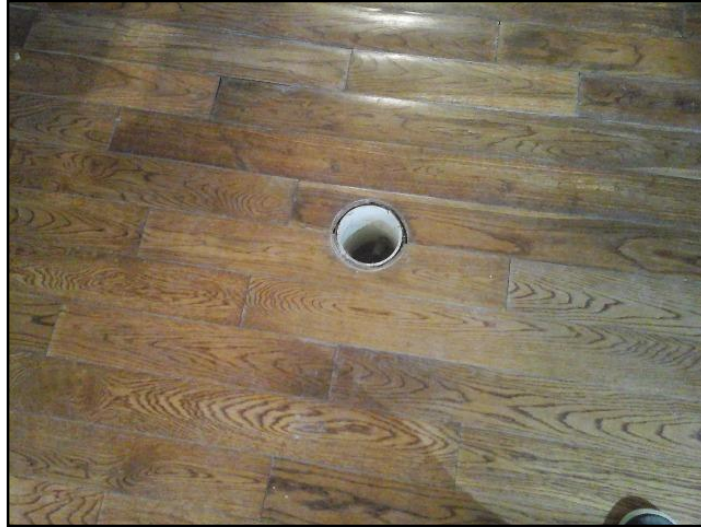
20. Condition: • [Grate missing, rusted or obstructed](#)

Implication(s): Chance of water damage to contents, finishes and/or structure | Trip or fall hazard

Grate missing, rusted or obstructed

Task: Provide

Time: Immediate

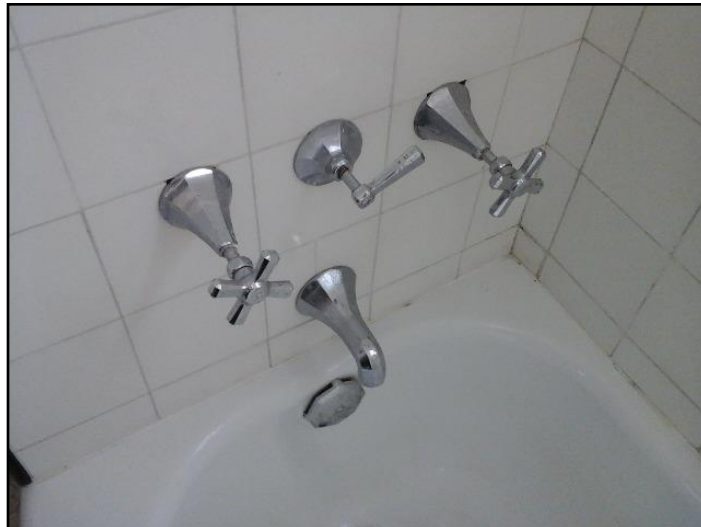
21. Condition: • [Stiff or inoperative](#)

Stiff or inoperative

Task: Repair or replace

Time: Immediate

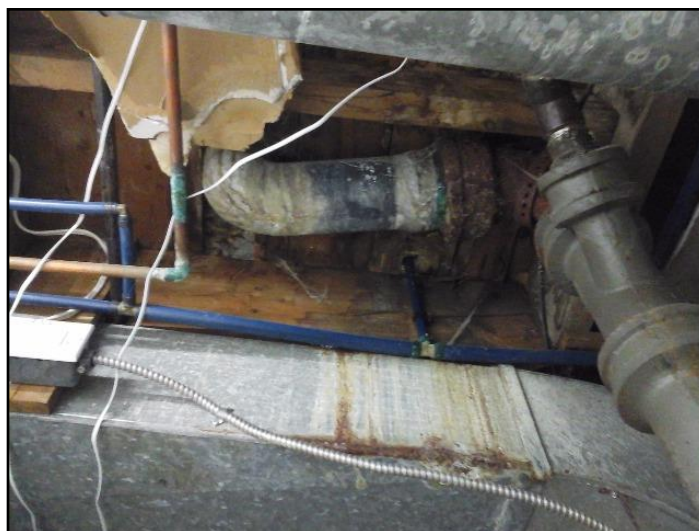
22. Condition: • [Water damage](#)

Leaks from first floor toilet. Staining on piping and rust on ducts.

Water damage

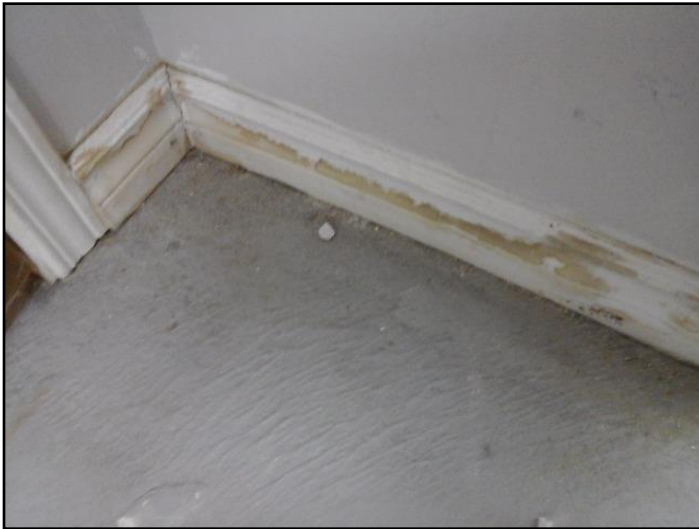
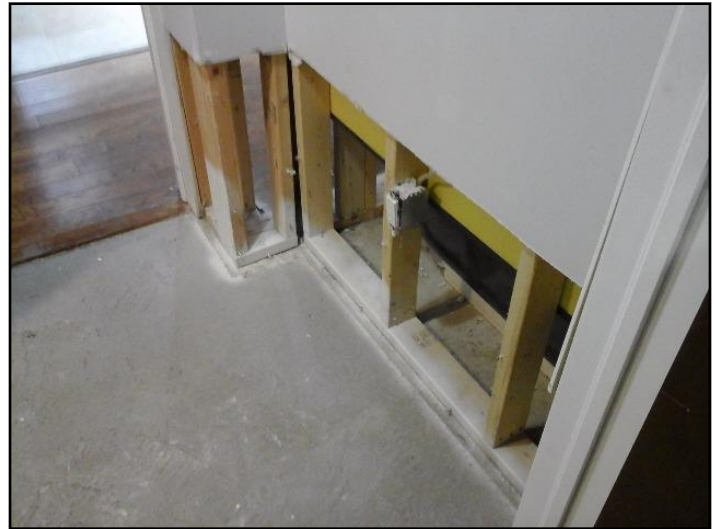
23. Condition: • Bottom 2 feet of drywall missing in basement. Likely indicating flood. Water damage on basement baseboards.

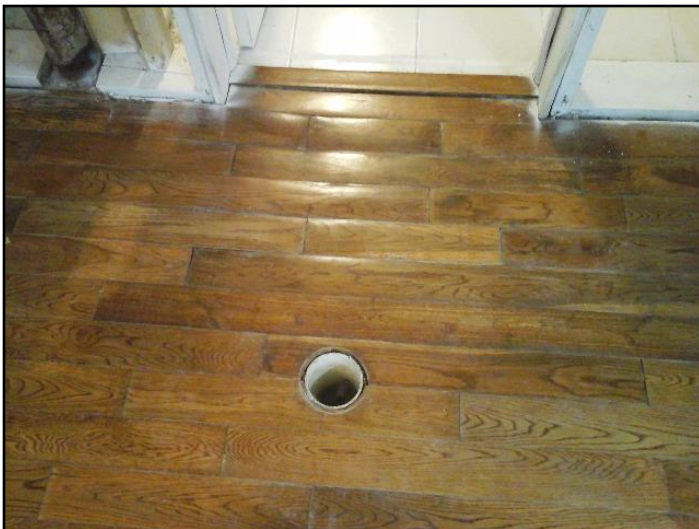
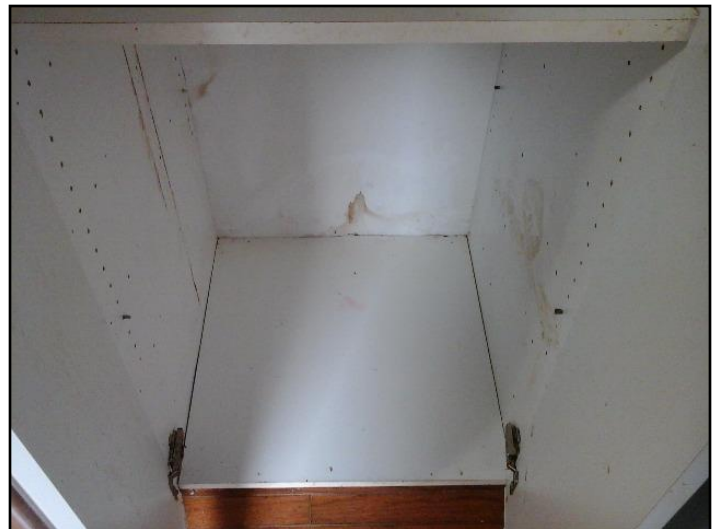
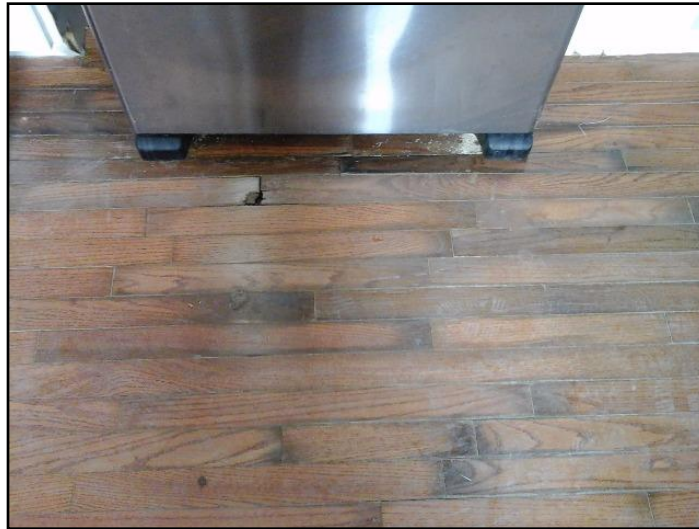
24. Condition: • [Warped](#)

Floor warped from water damage in first floor and basement kitchen

Implication(s): Trip or fall hazard

Warped

Task: Repair or replace

Time: Less than 1 year

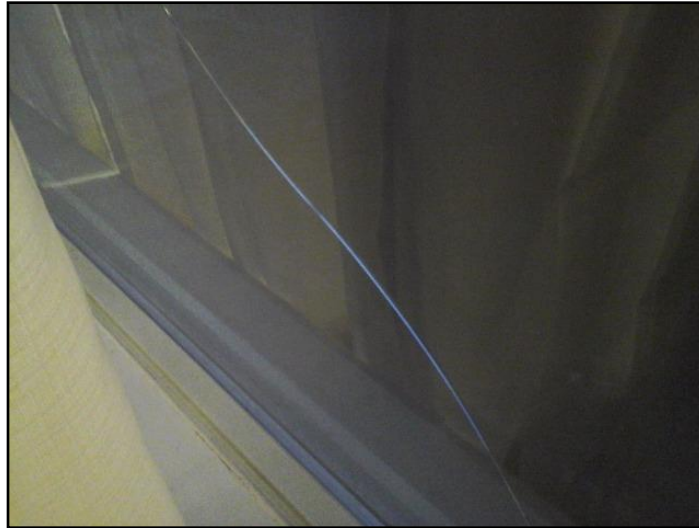
25. Condition: • [Cracked](#)

Cracked

Task: Replace

Time: Immediate

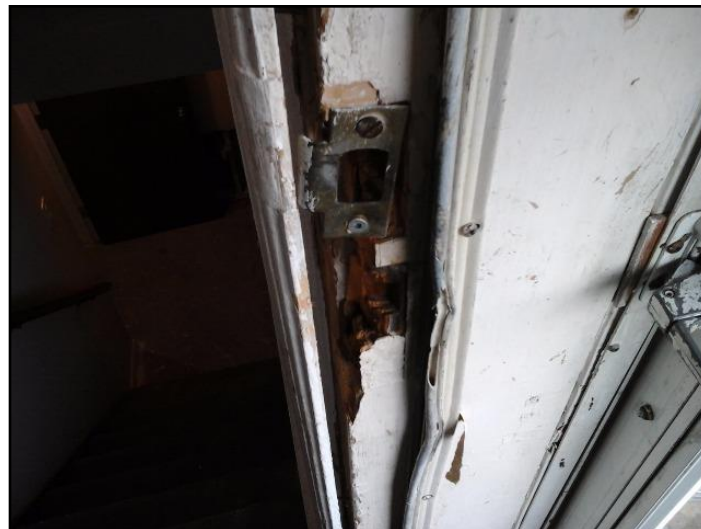
26. Condition: • [Rot](#)

Implication(s): Chance of damage to structure | Material deterioration

Rot

Task: Replace

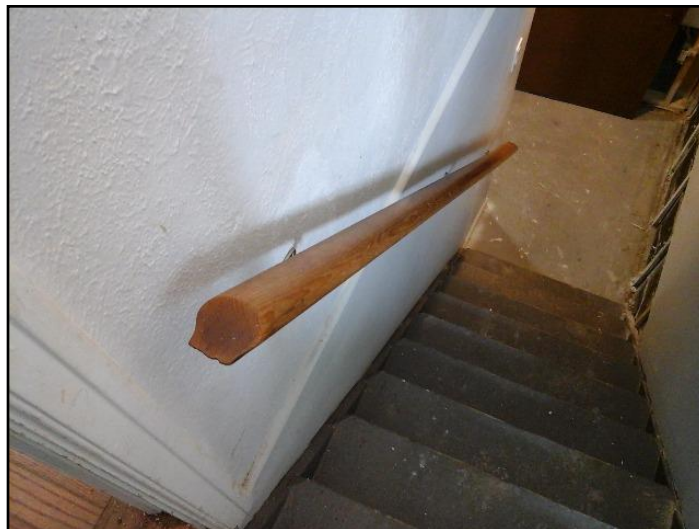
27. Condition: • [Loose](#)

Implication(s): Fall hazard

Loose

Task: Repair

Time: Immediate
