YOUR Inspection Report

INSPECTION DATE:

Wednesday, August 7, 2019

Boris Vorobyov

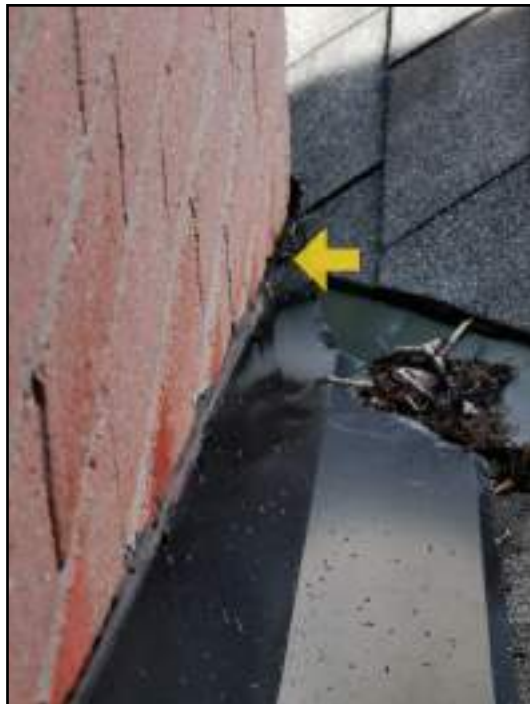
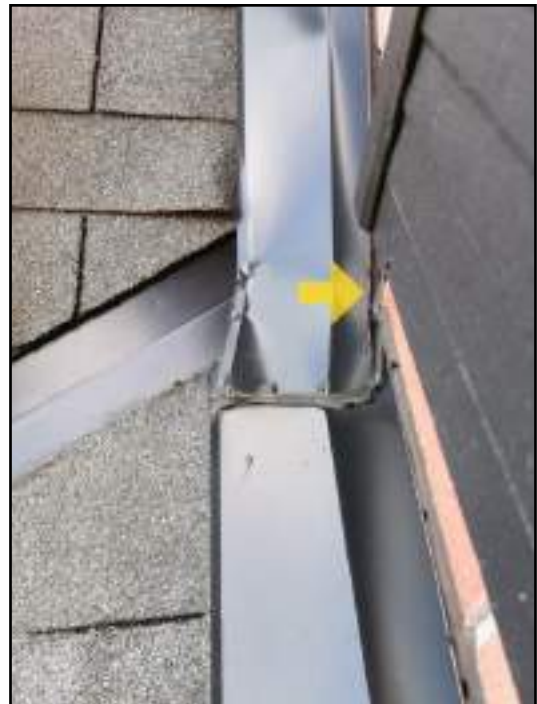
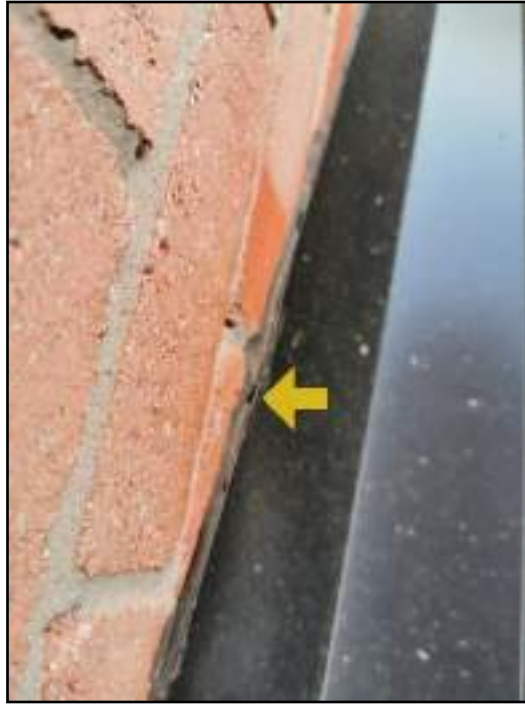
2. Condition: • Replace old and cracked caulking.

Flashing that was installed was done very poorly, at the very least caulking is to be added between wall connection. Flashings throughout home should be replaced when re-shingling.

Replace old and cracked caulking.

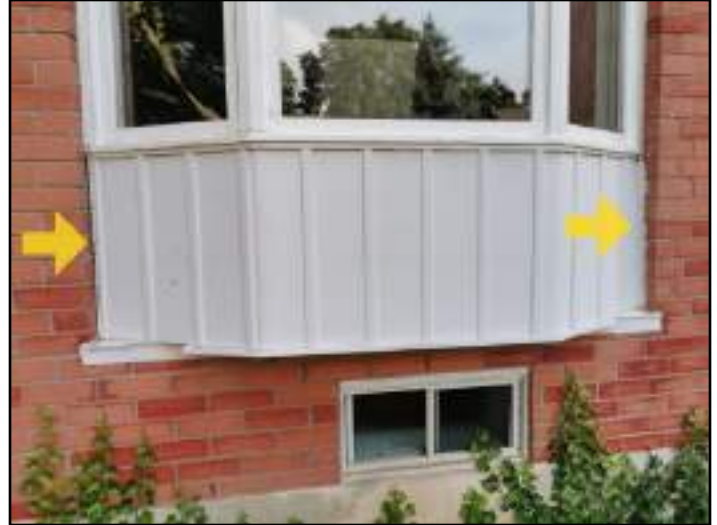
6. Condition: • Caulking missing or ineffective

Replace caulking where it is cracked and brittle and provide where it is missing.

Caulking missing or ineffective

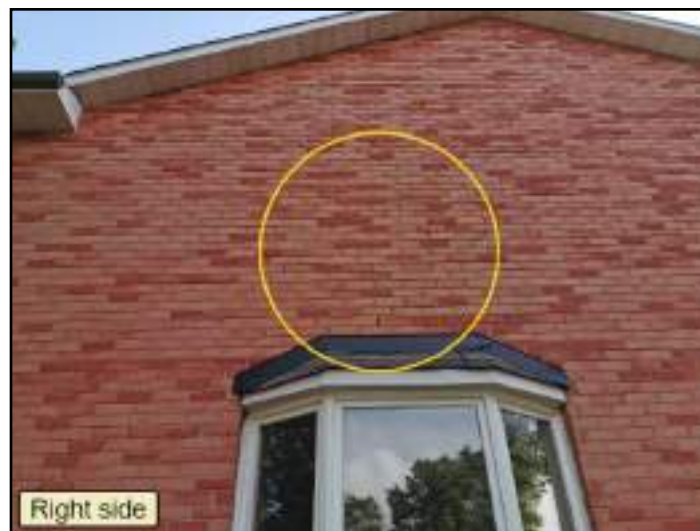
Front Porch

7. Condition: • [Cracked](#)

Step cracking on bricks in various areas around home. Typically cracks are caused due to minor settlement of home. Since the bricks are not structural but are brick veneer it is not as necessary but still recommended to repair by tuck pointing.

Cracked

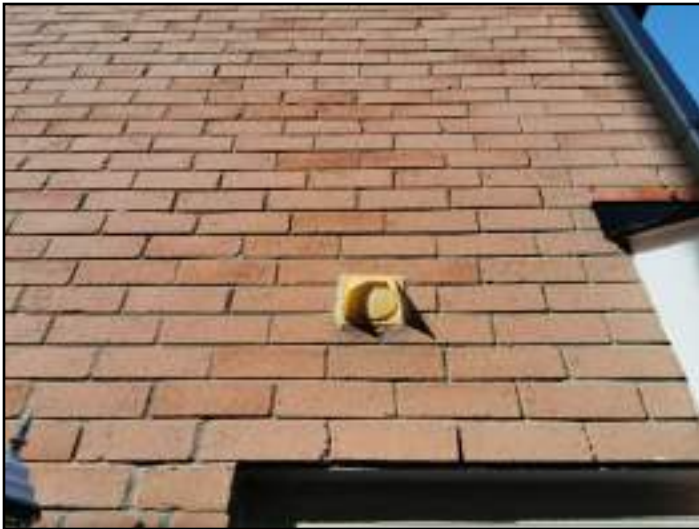
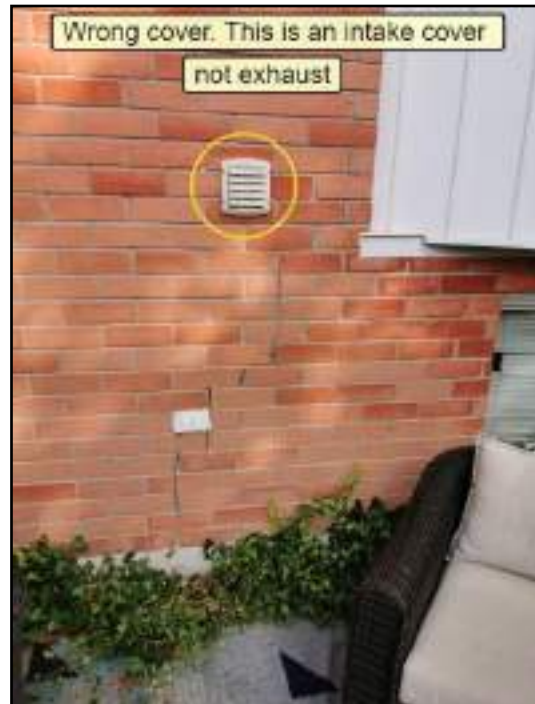
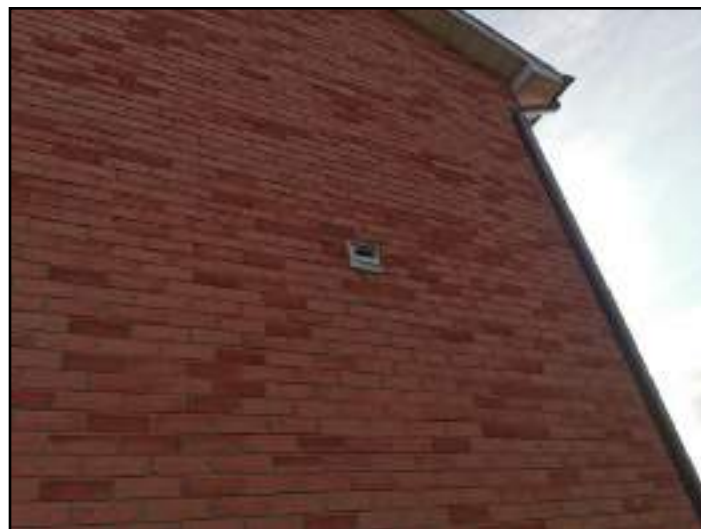
8. Condition: • Cover damaged

Cover damaged

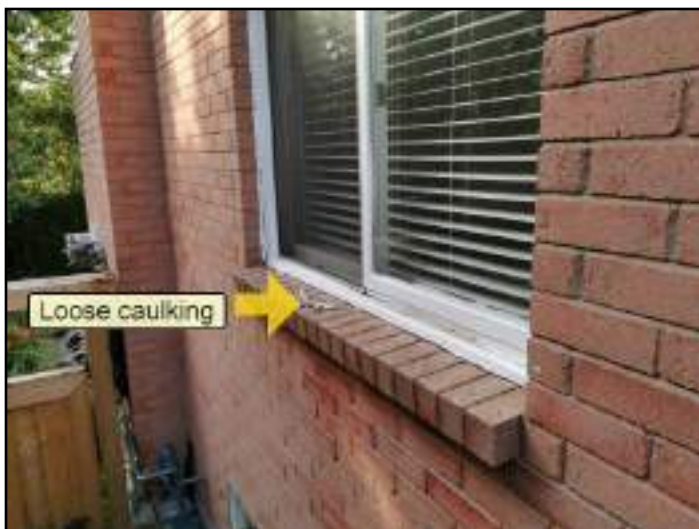
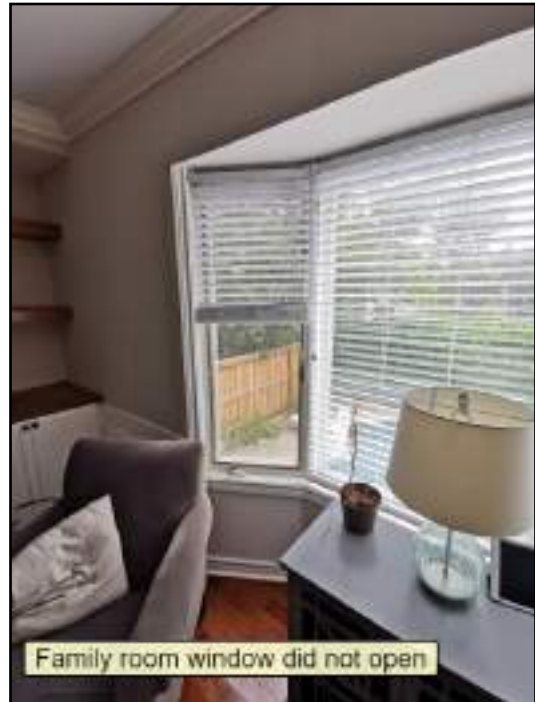
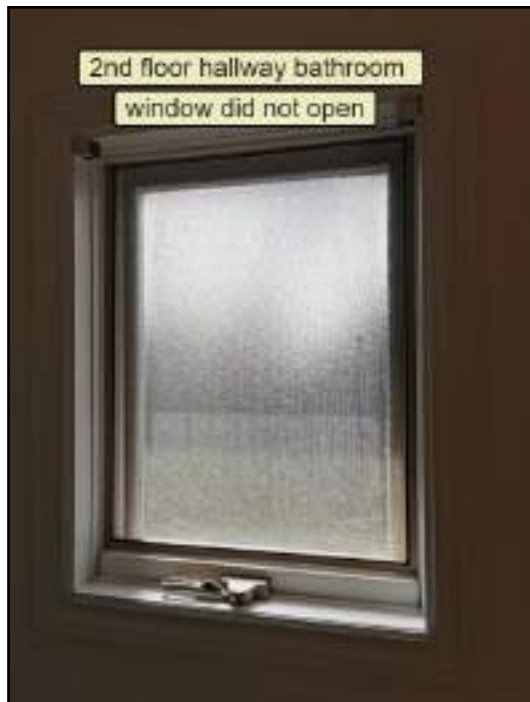
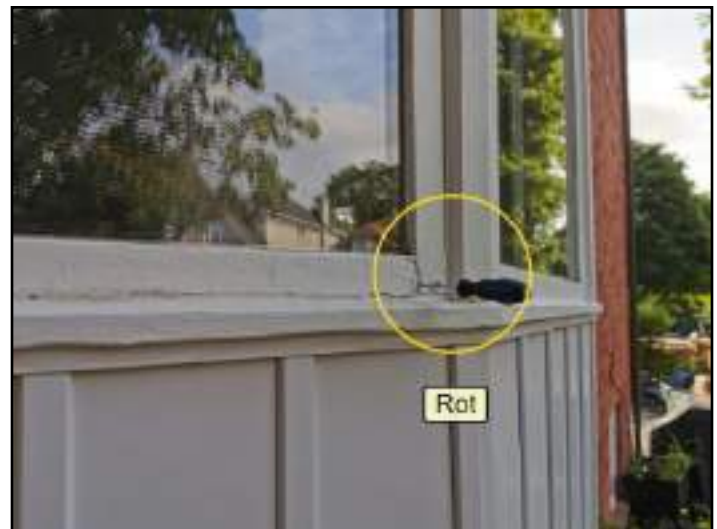
10. Condition: • Rot

Several windows that were original where in poor condition.

It is highly likely that many windows will not be able to be repair and will need to be replaced.

Rot

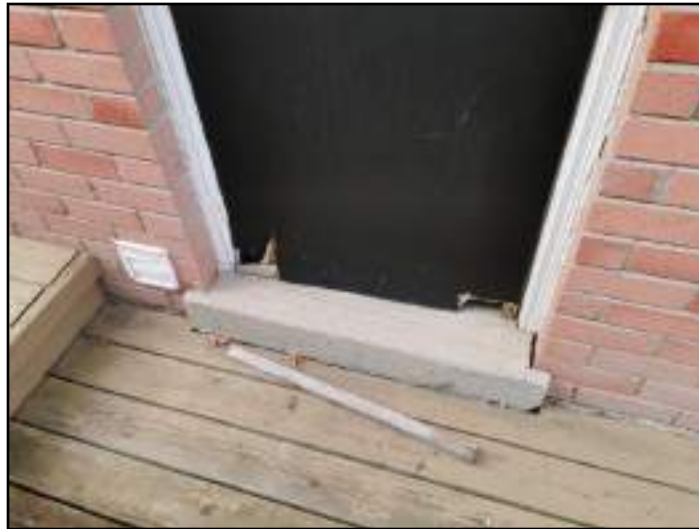
11. Condition: • [Damage](#)

Damage

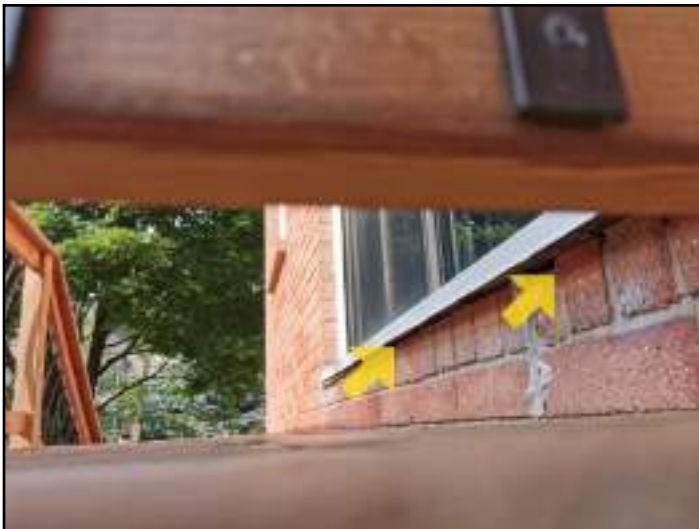
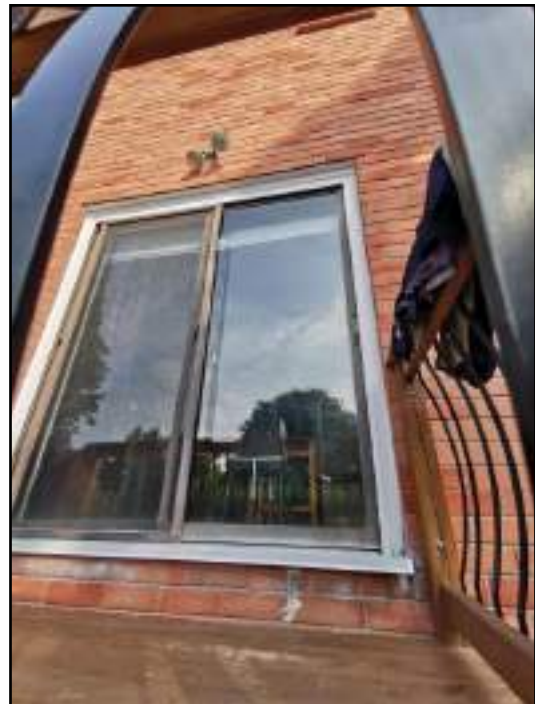
12. Condition: • [Caulking missing, deteriorated or loose](#)

Caulking missing, deteriorated or loose

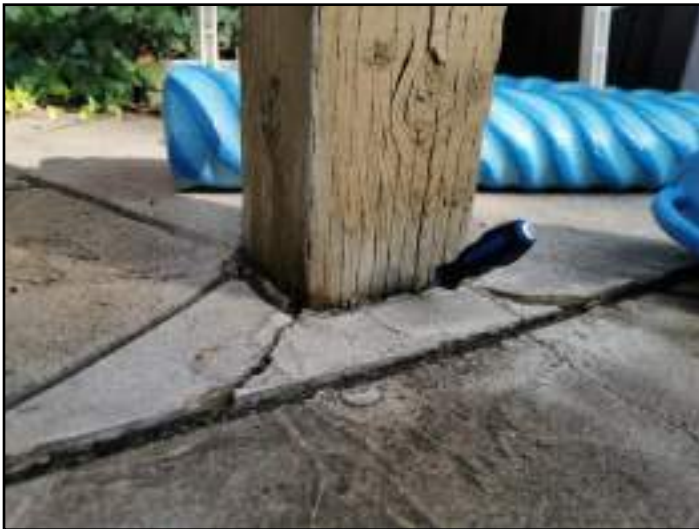
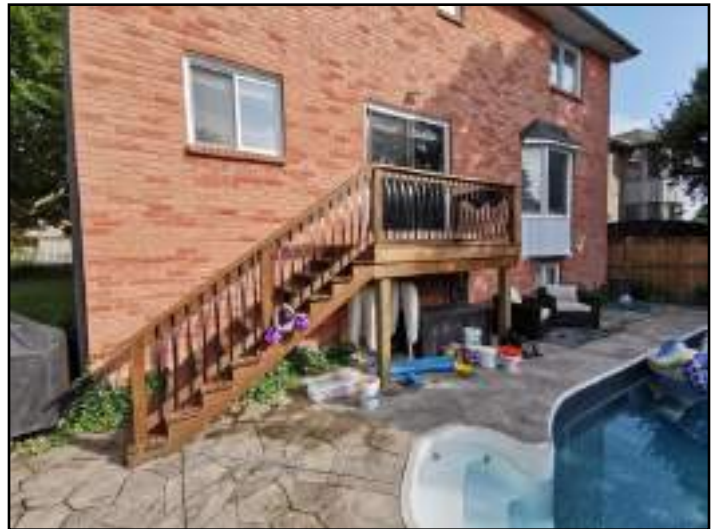
PORCHES, DECKS, STAIRS, PATIOS AND BALCONIES \ General**13. Condition:** • [Wood/soil contact](#)

Wooden deck structure mounted in ground as opposed to concrete footing. This post is starting to rot and will have to be replaced.

Wood/soil contact

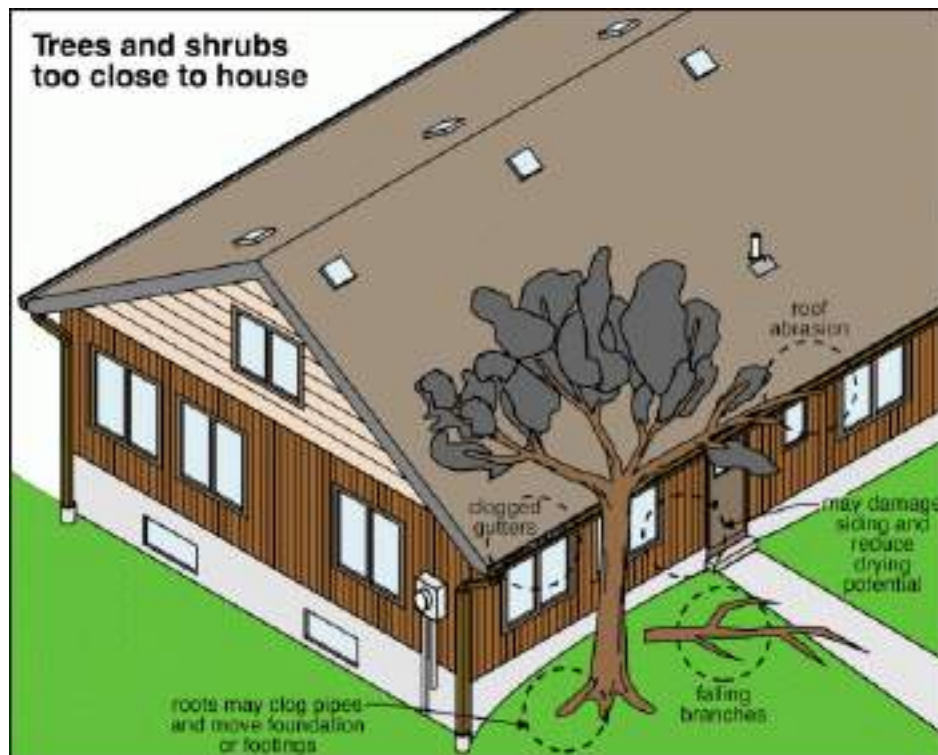
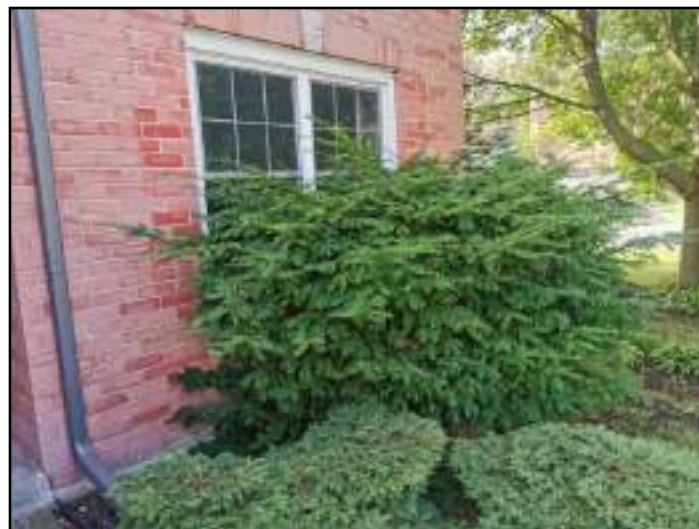
15. Condition: • [Trees or shrubs too close to building](#)

Trees or shrubs too close to building

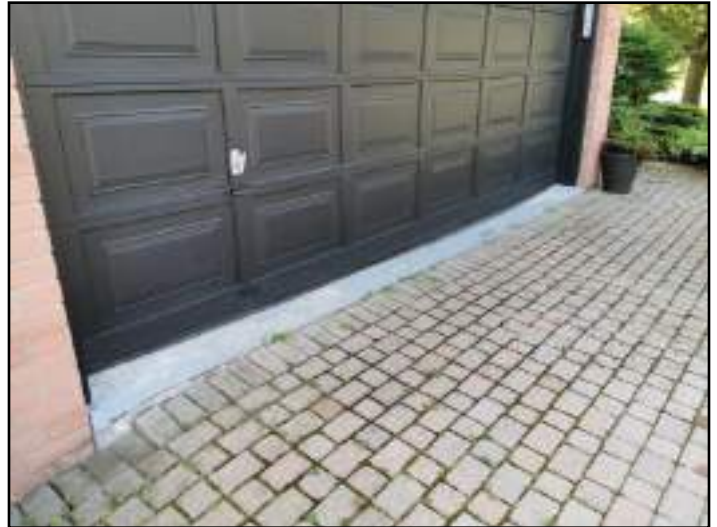
GARAGE \ Floor**18. Condition:** • [Improper slope](#)

Noted garage slab is settled towards middle and there has been an extension added to garage door to have it seal against floor. No corrective action needed.

Improper slope

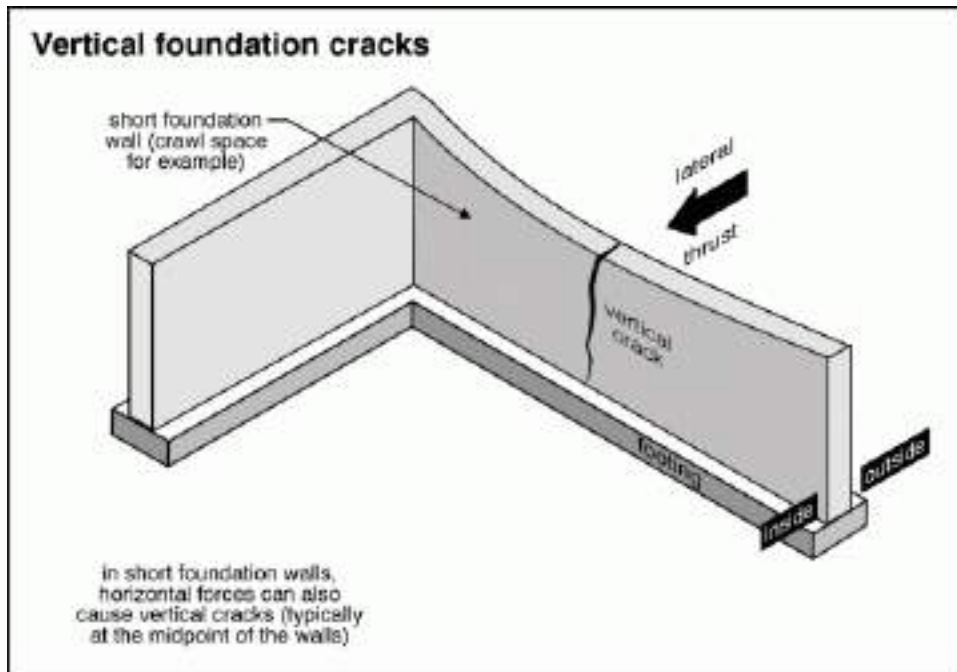
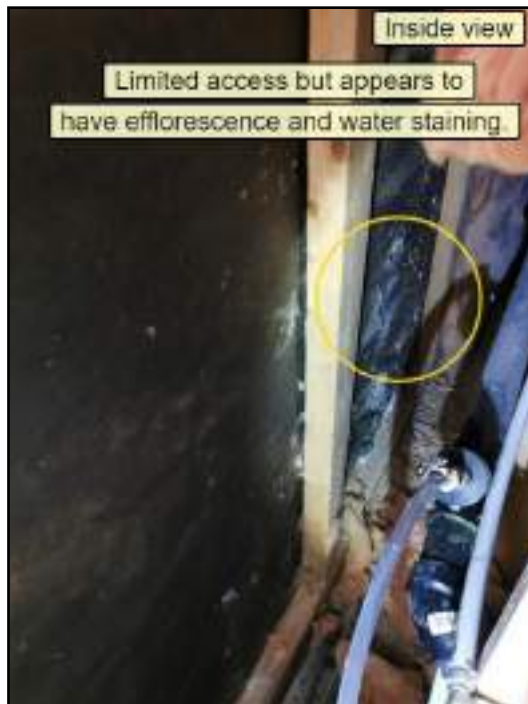
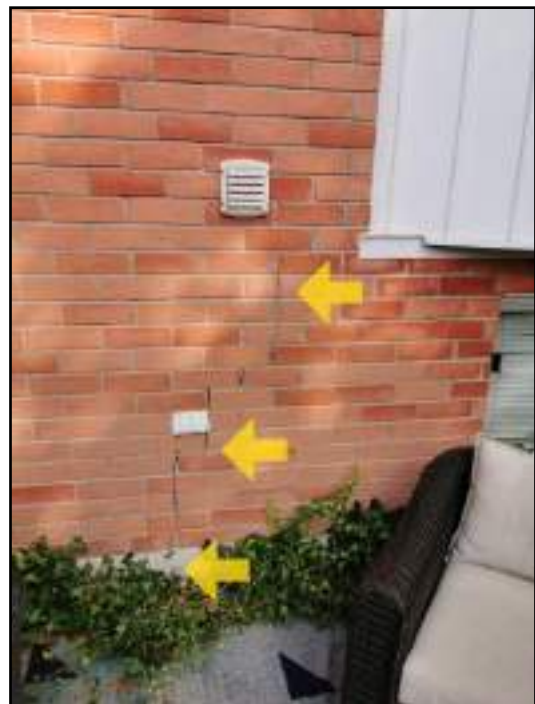
20. Condition: • [Cracked](#)

Cracked

Repair by licensed contractor or basement water proofing company recommended.

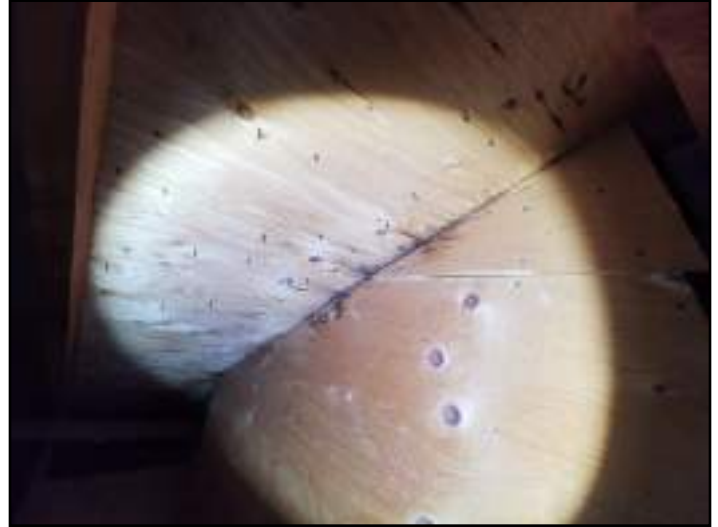
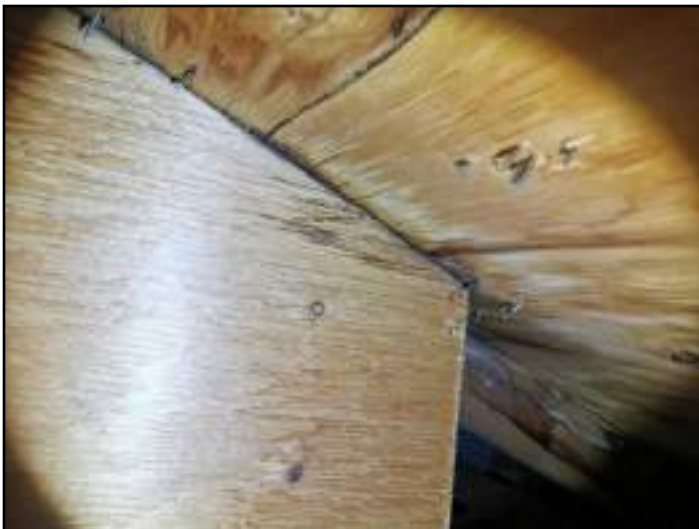
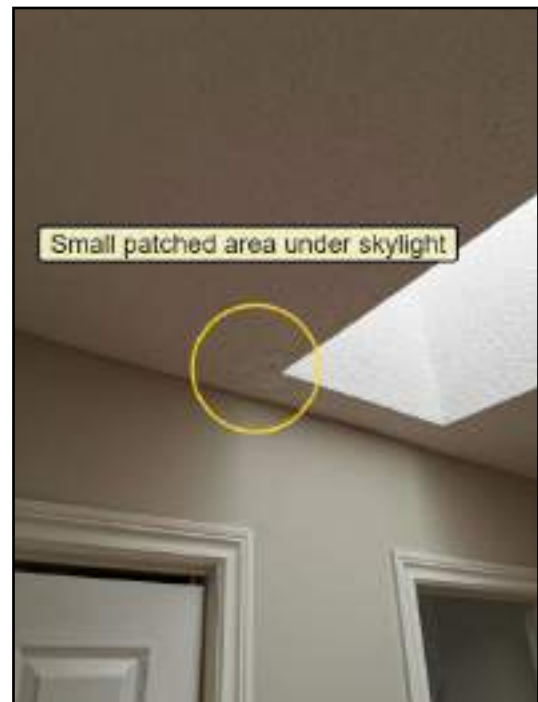
21. Condition: • [Water stains](#)

Small area where there was some water staining around skylight. Area was dry at time of inspection. Likely it is a minor problem, recommended to replace or re-seal skylight when re-shingling and monitor until then.

Water stains

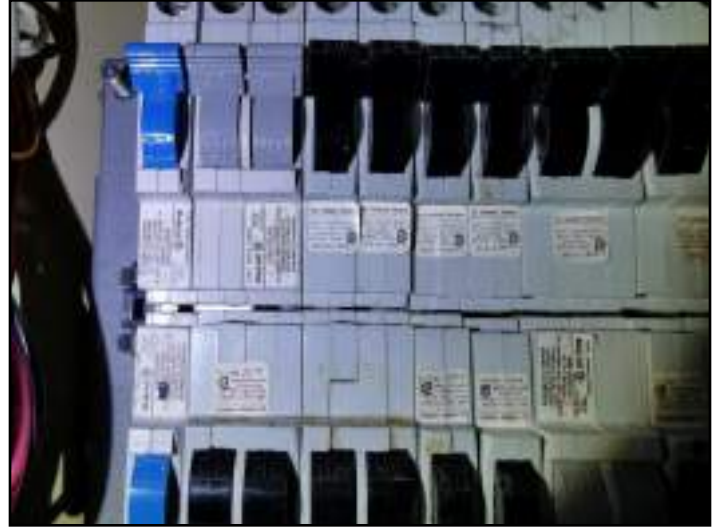
22. Condition: • [FPE \(Federal Pioneer Electric\) - Stablok breakers should be evaluated by Licensed electrician as there](#) are breakers that have been recalled and must be replaced.

FPE (Federal Pioneer Electric) - Stablok...

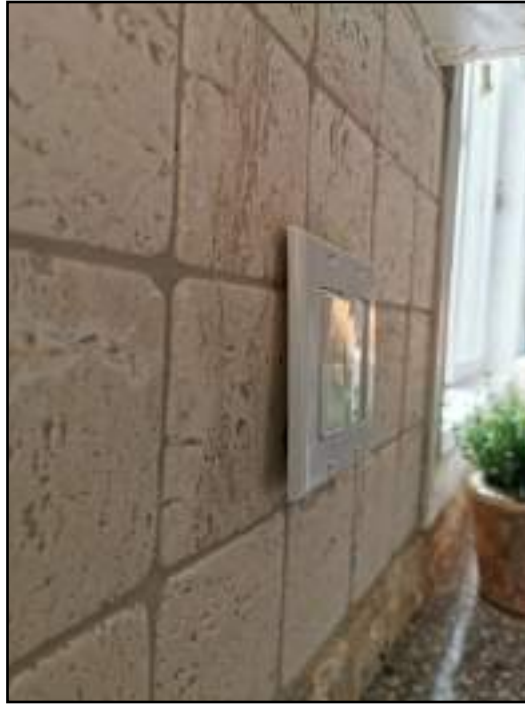
25. Condition: • [Loose](#)

Loose

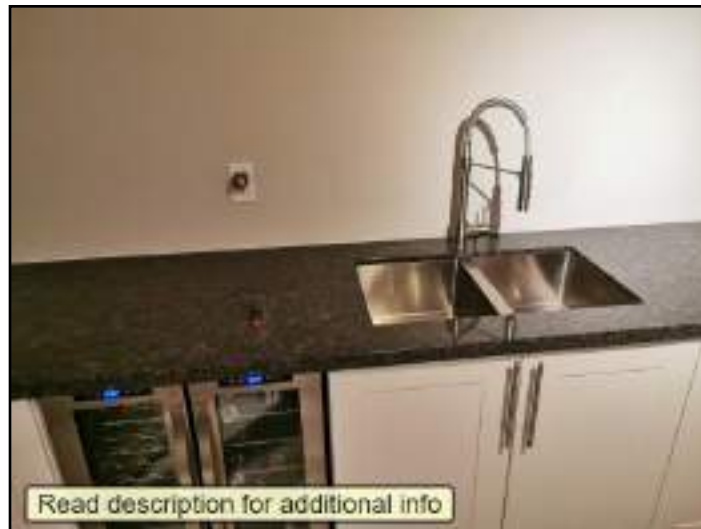
26. Condition: • [GFCI/GFI needed \(Ground Fault Circuit Interrupter\)](#)

Judging by finishes basement appears to be built after 2012. There were numerous electrical defects that should be evaluated by licensed electrician. Highly likely basement was not wired by a licensed electrician request permit from homeowners.

GFCI/GFI needed (Ground Fault Circuit...

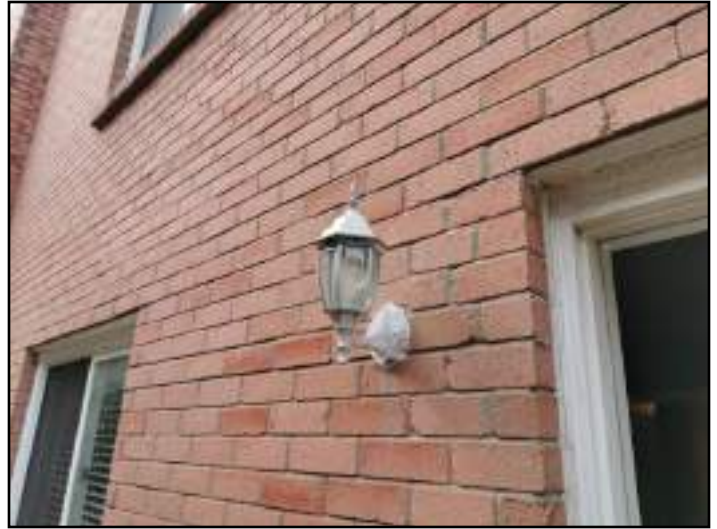
Back of home

DISTRIBUTION SYSTEM \ Lights**27. Condition:** • [Inoperative](#)

Several lights around the house are not working. Most likely burnt out bulbs. Request bulbs be changed to ensure fixture is functioning properly.

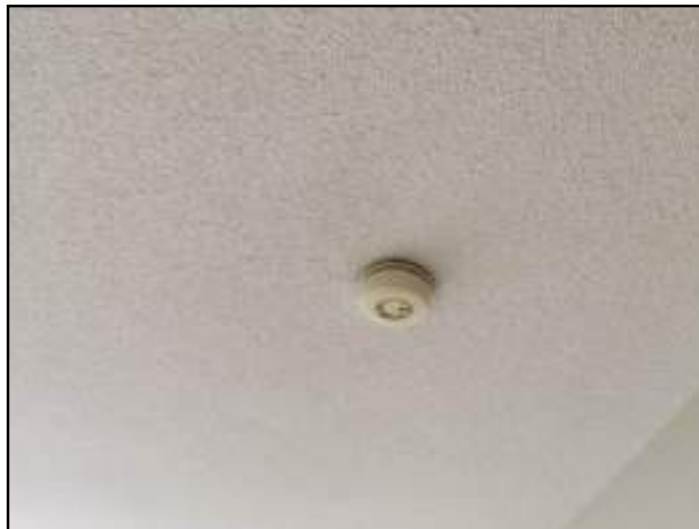
DISTRIBUTION SYSTEM \ Smoke alarms (detectors)**28. Condition:** • [Inoperative](#)**Implication(s):** Fire hazard**Location:** Basement First Floor Second Floor**Task:** Replace**Time:** Immediate

Inoperative

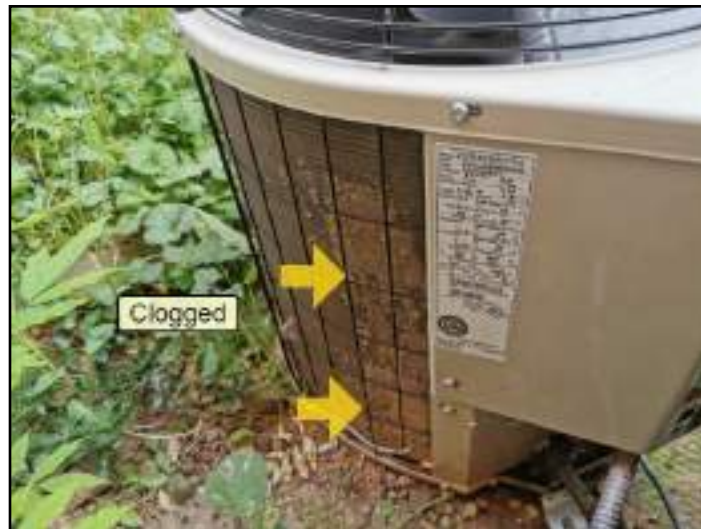
35. Condition: • Service air conditioner

Service air conditioner

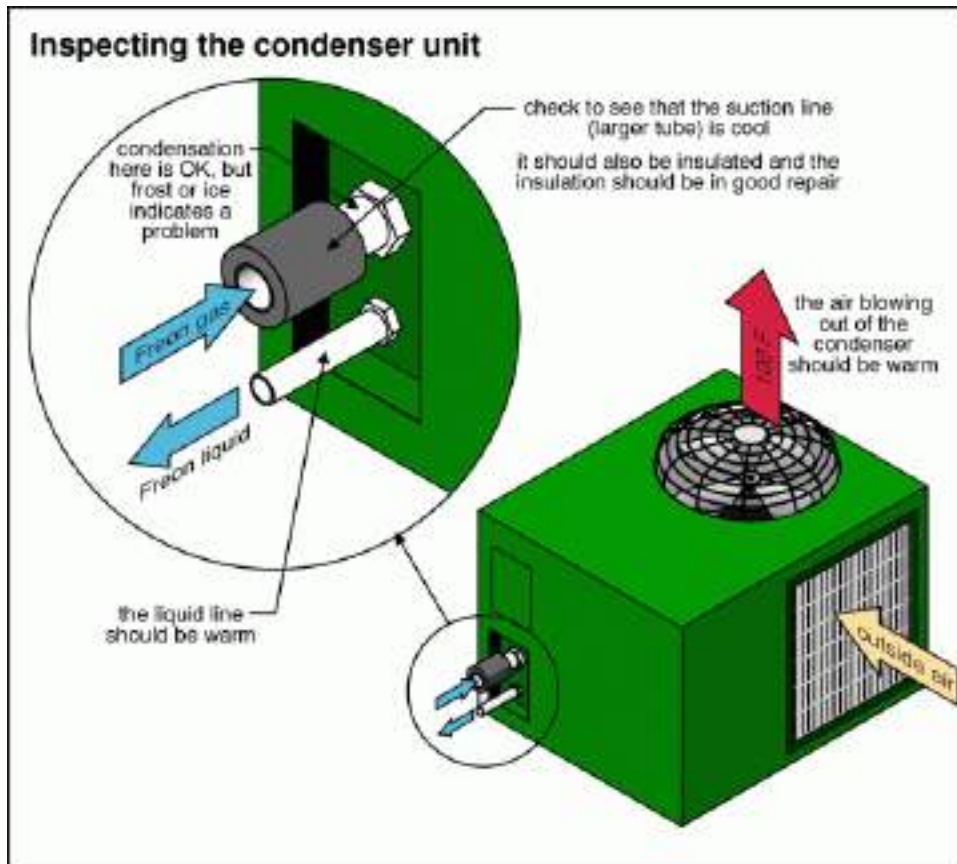
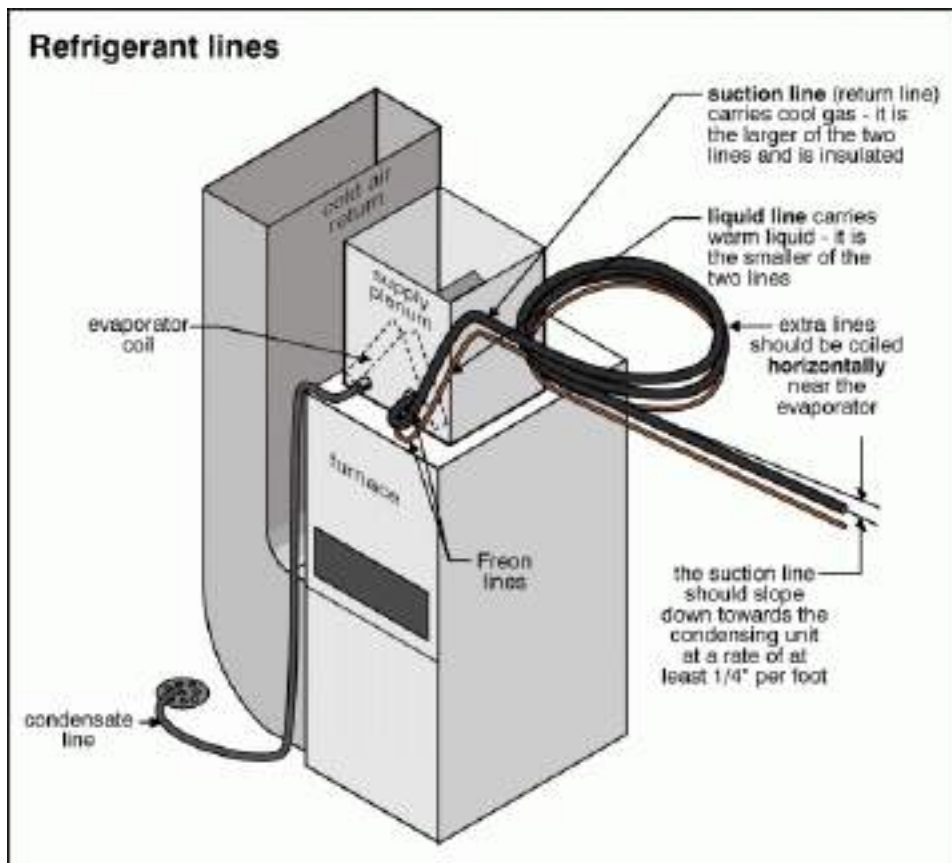
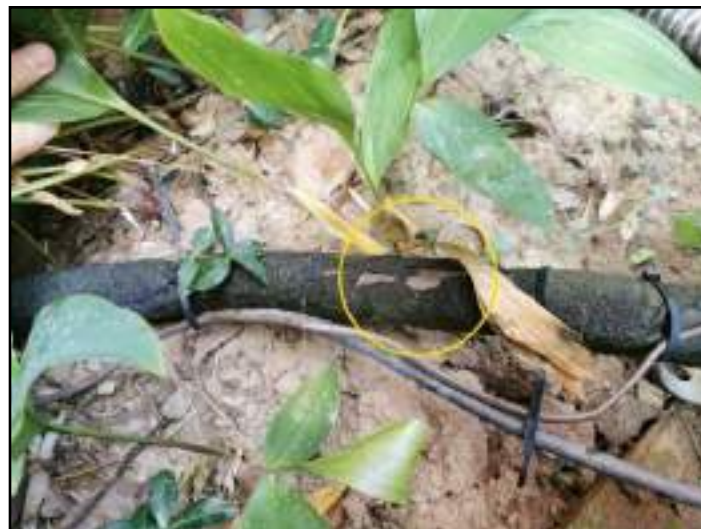
37. Condition: • [Insulation - missing](#)

Insulation around freon line wears away. This can be easily changed by homeowner.

Insulation - missing

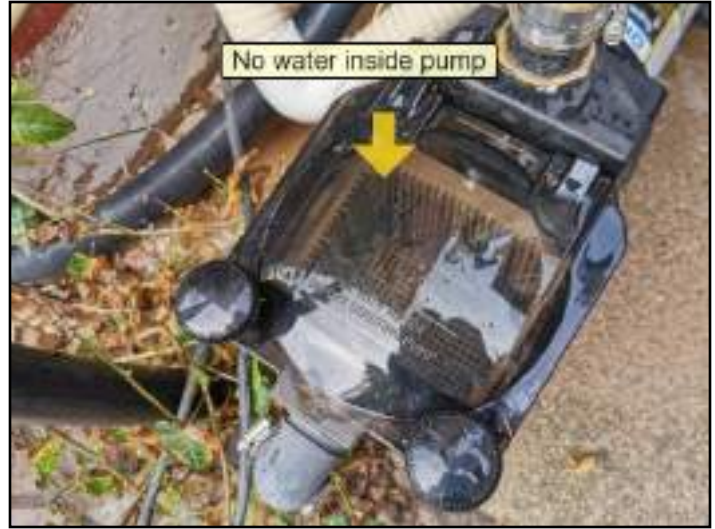
Pool

As a courtesy and at the request for buyer the pump and heater were turned on and appeared to be working. Inspection by pool company is still highly recommended.

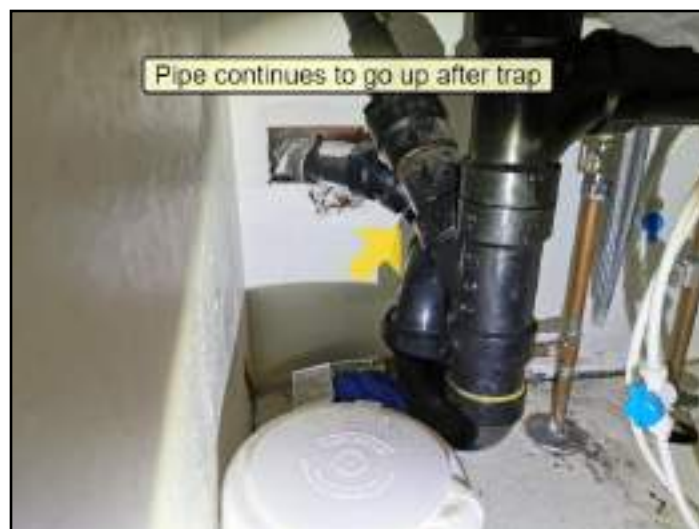
44. Condition: • [Poor manifolding of drain pipe](#)

Poor manifolding of drain pipe

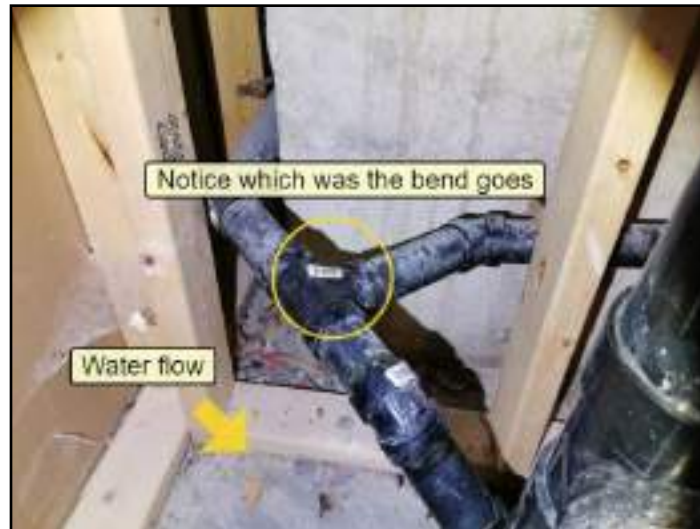
45. Condition: • [Poor manifolding of drain pipe](#)**Implication(s):** Sewage entering the building**Location:** Basement**Task:** Repair**Time:** Less than 1 year

Poor manifolding of drain pipe

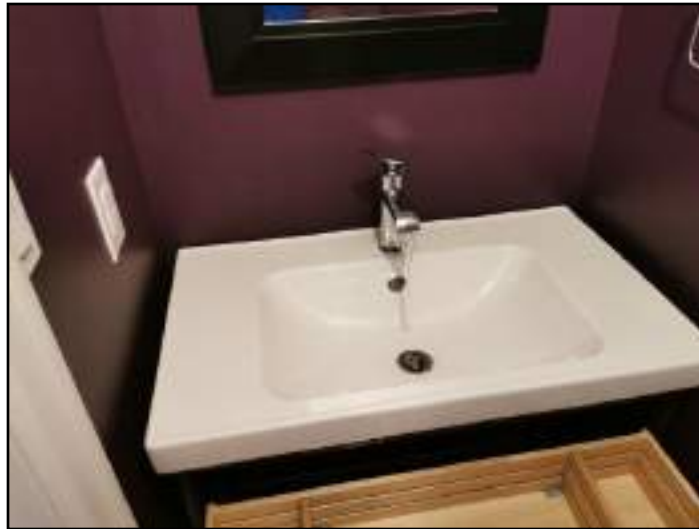
47. Condition: • [Loose](#)

Loose

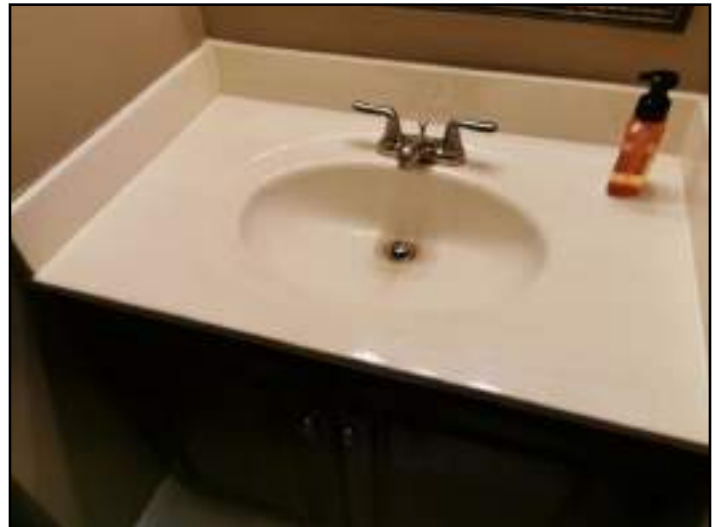
48. Condition: • [Surface defects](#)

Surface defects

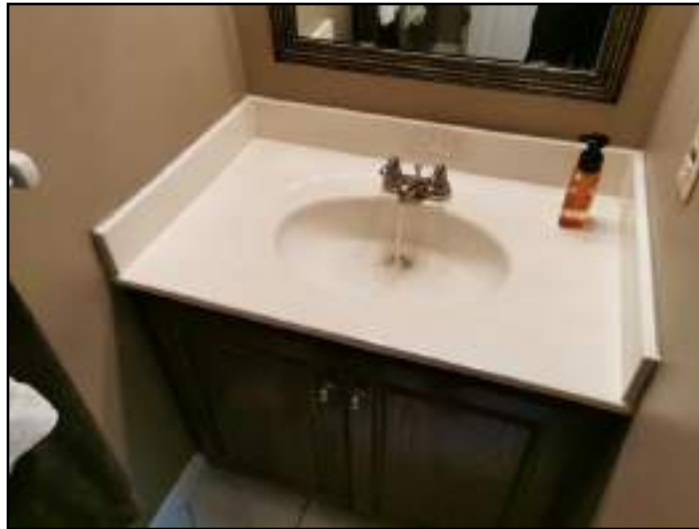
49. Condition: • [Slow drains](#)

Slow drains

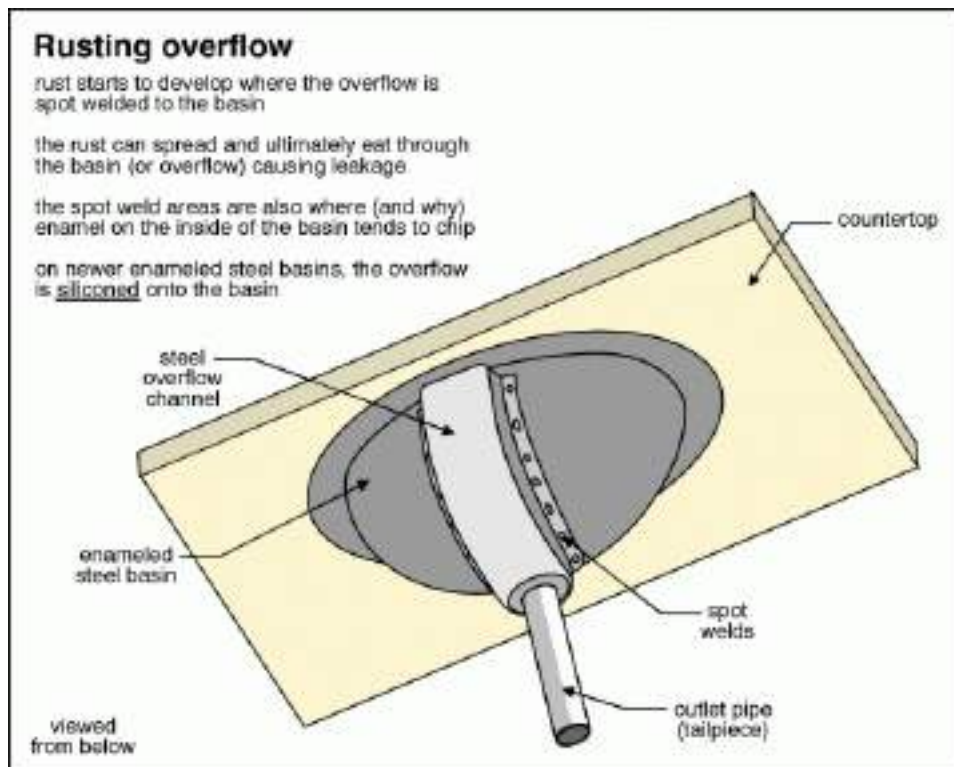
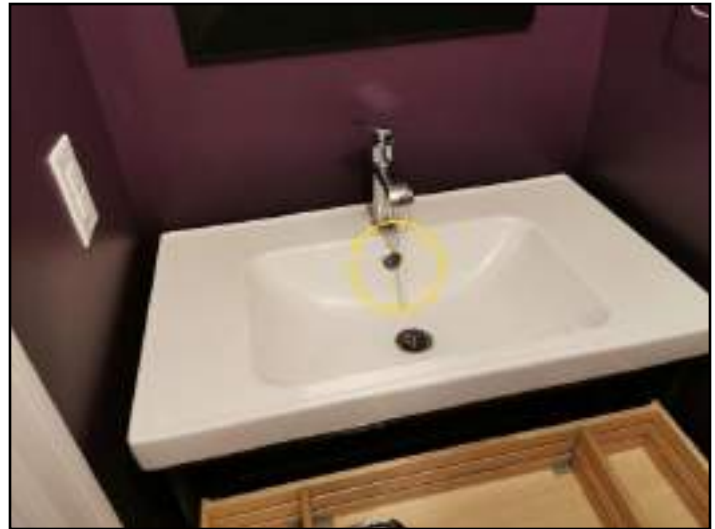
50. Condition: • [Overflows missing, leak, rust or inappropriate](#)

Overflows missing, leak, rust or...

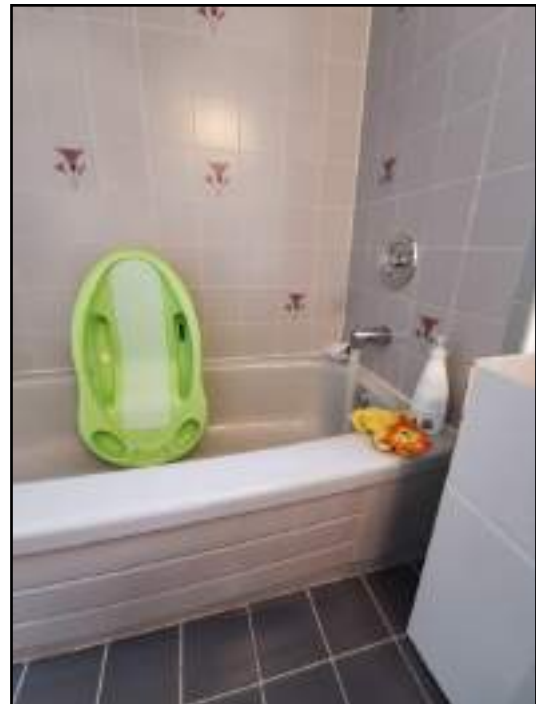
51. Condition: • [Caulking loose, missing or deteriorated](#)

Caulking loose, missing or deteriorated

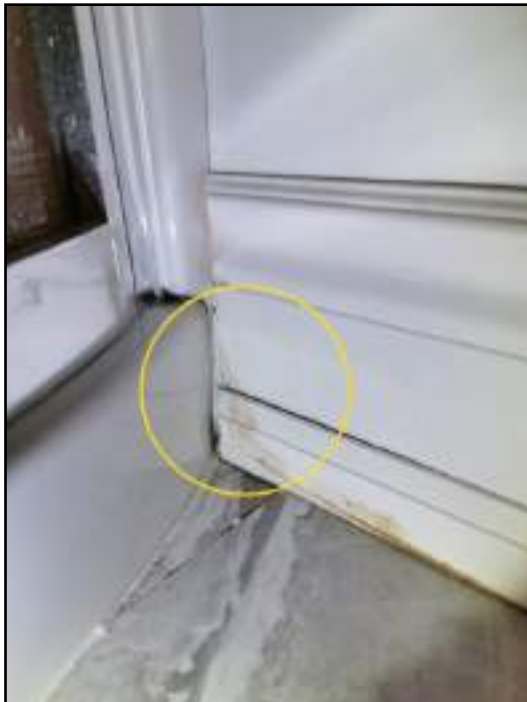
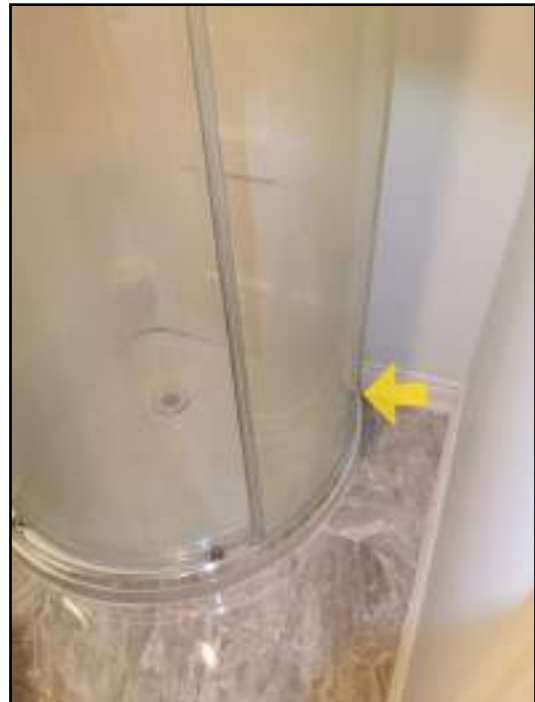
52. Condition: • [Leak](#)

Water leaked out where arrow was pointed in photo. Likely there is leakage because connection is poorly sealed with silicone and needs to be sealed better to achieve waterproofing.

Leak

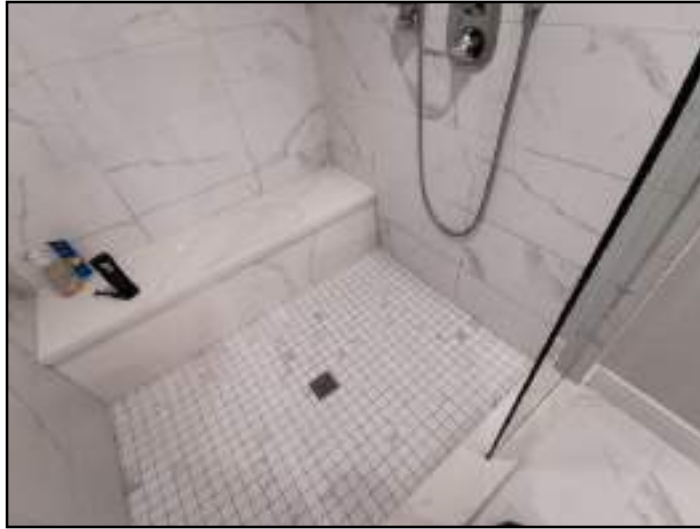
53. Condition: • [Caulking loose, missing or deteriorated](#)

Caulking loose, missing or deteriorated

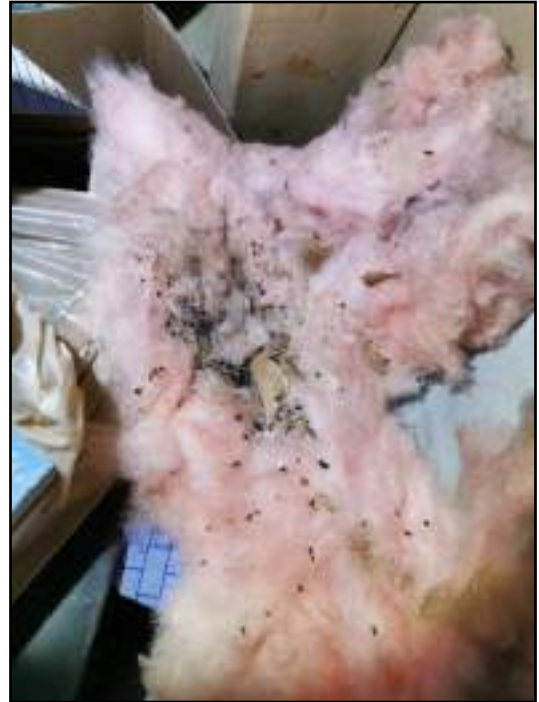
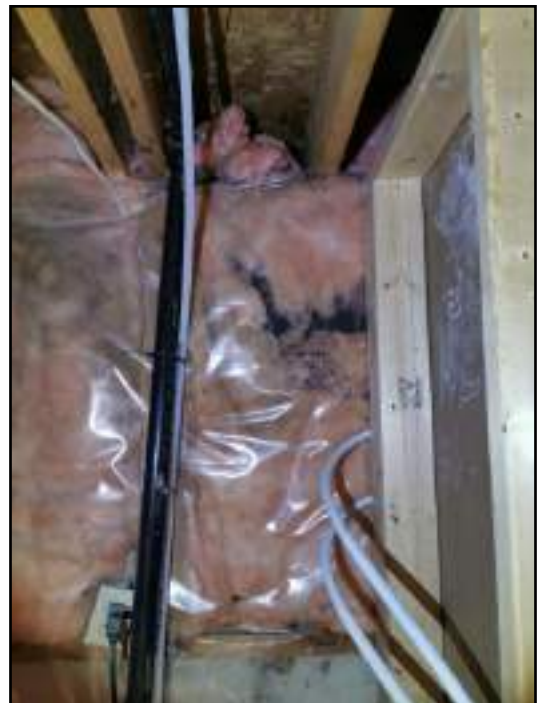
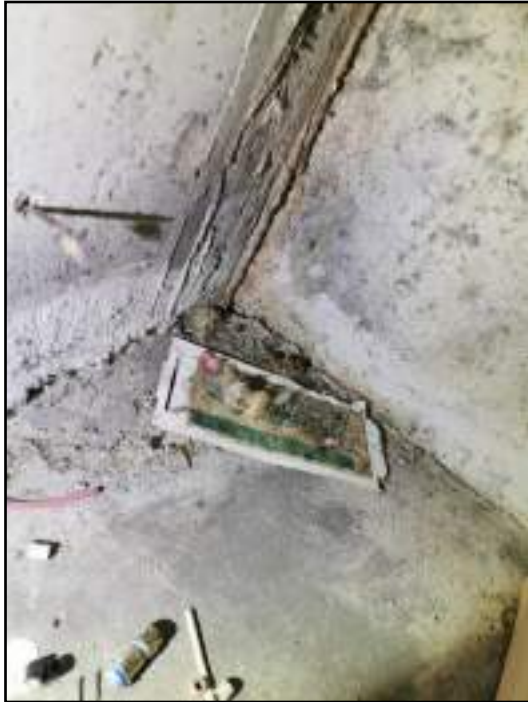
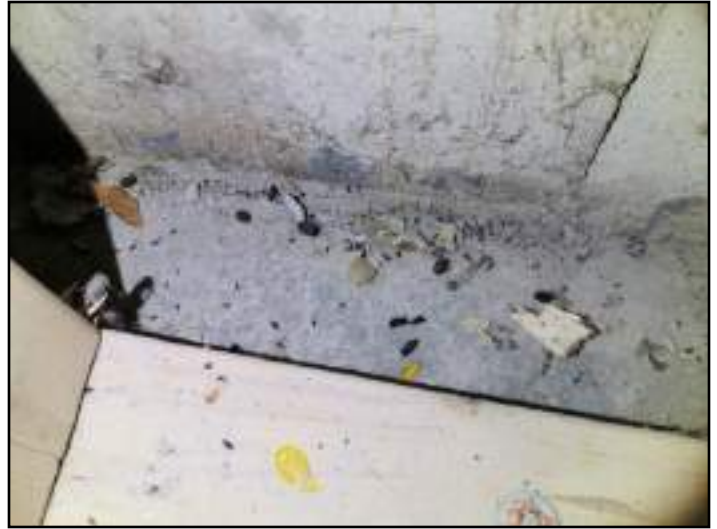
54. • Noted presence of mice due to droppings around the home. Further evaluation and inspection by rodent inspector recommended.

Noted presence of mice due to droppings...

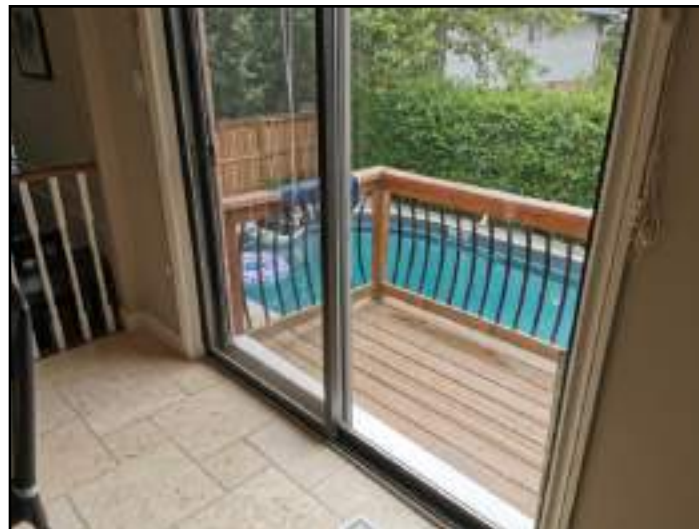
56. Condition: • [Broken](#)

Broken

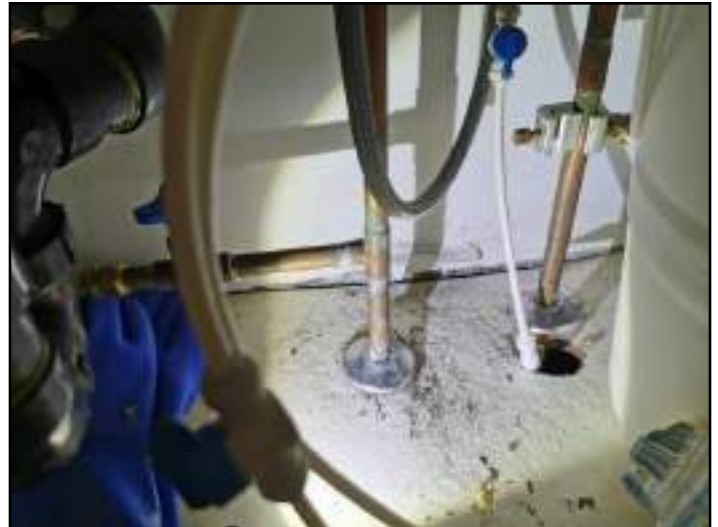
57. Condition: • [Water damage](#)

Water was leaking from faucet onto cabinet and causing damage to cabinet and wall behind it. Fungal growth noted.

Water damage
