YOUR Inspection Report

INSPECTION DATE:

Wednesday, August 7, 2019

Boris Vorobyov

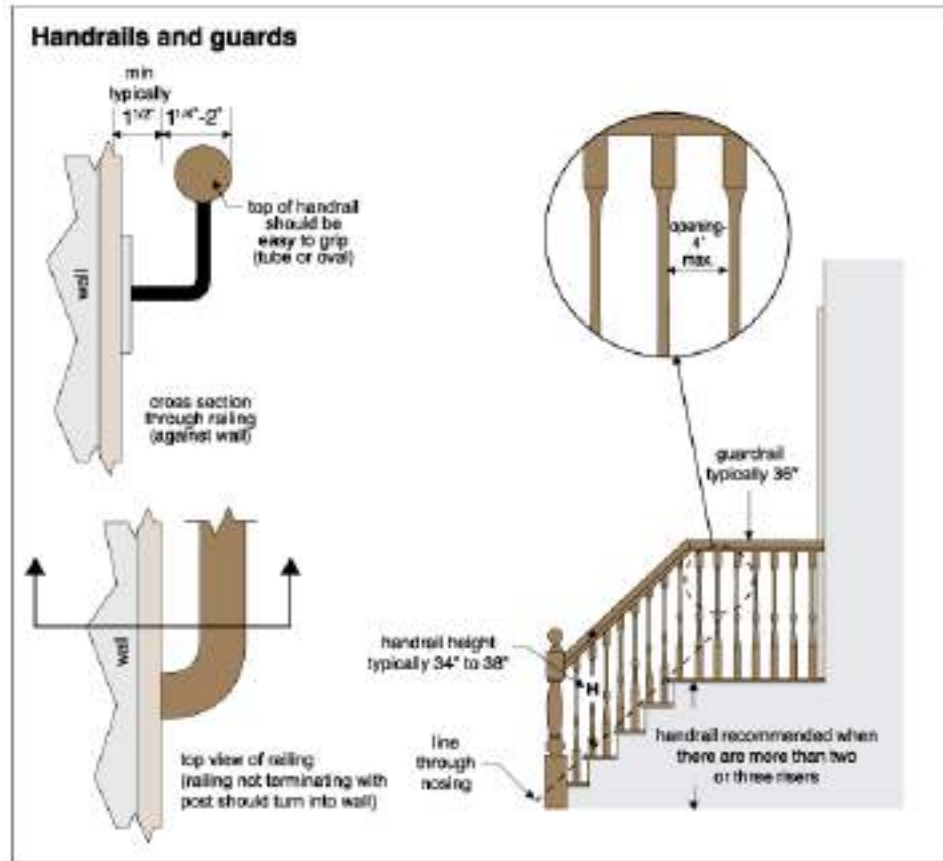
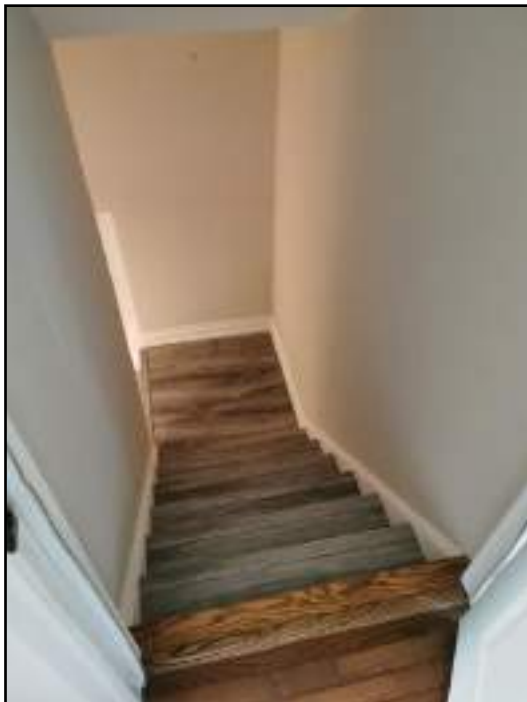
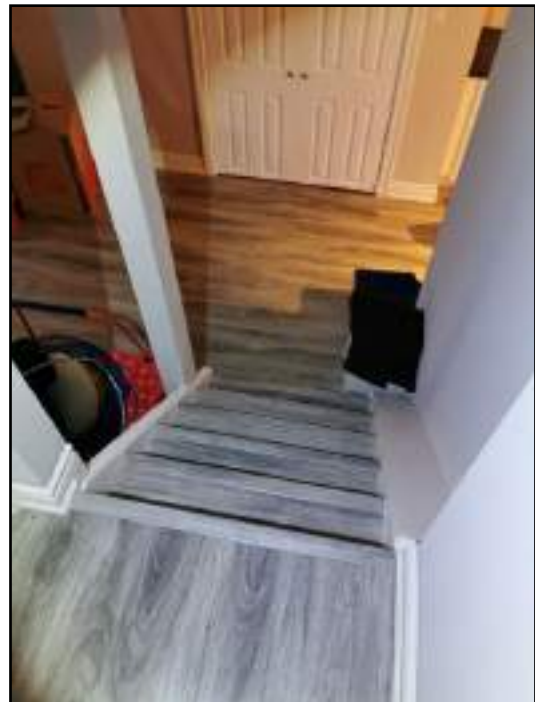
58. Condition: • [Missing](#)

Missing

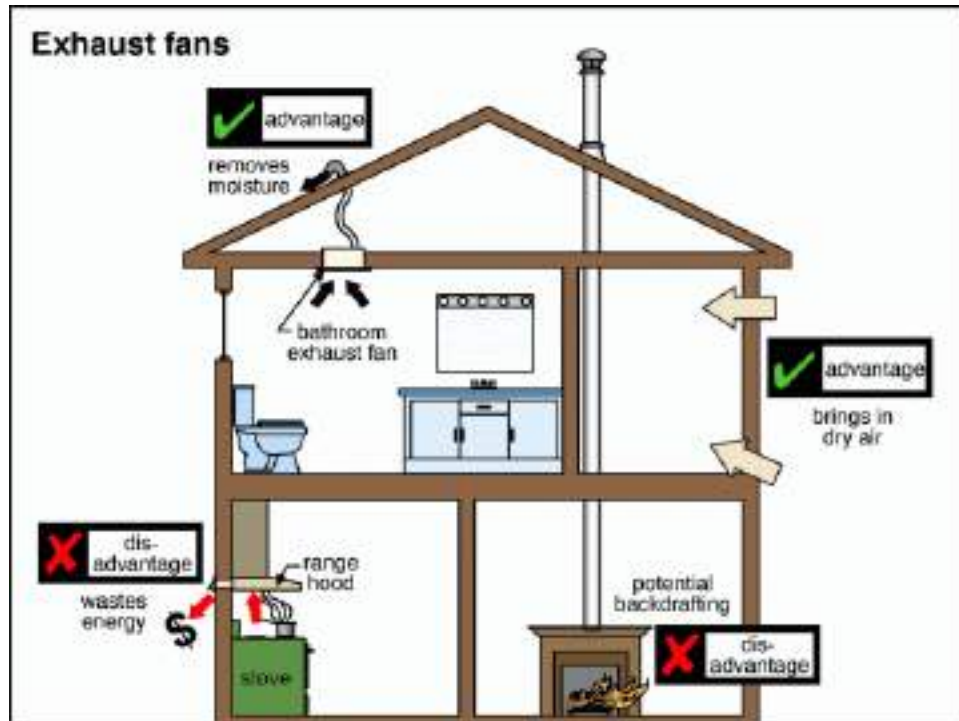
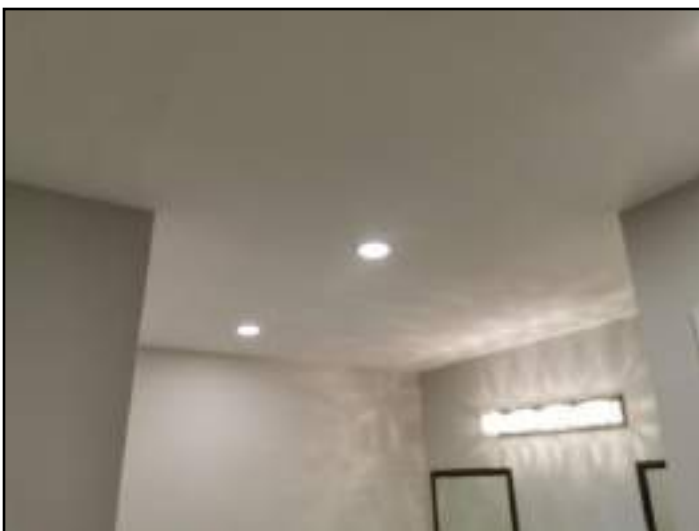
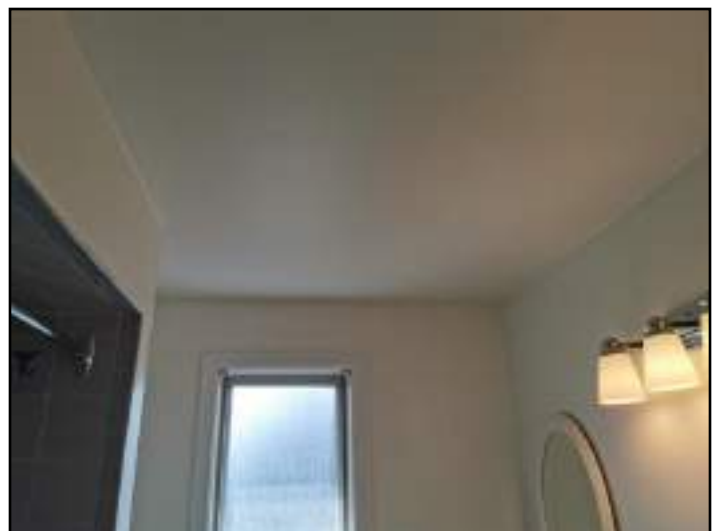
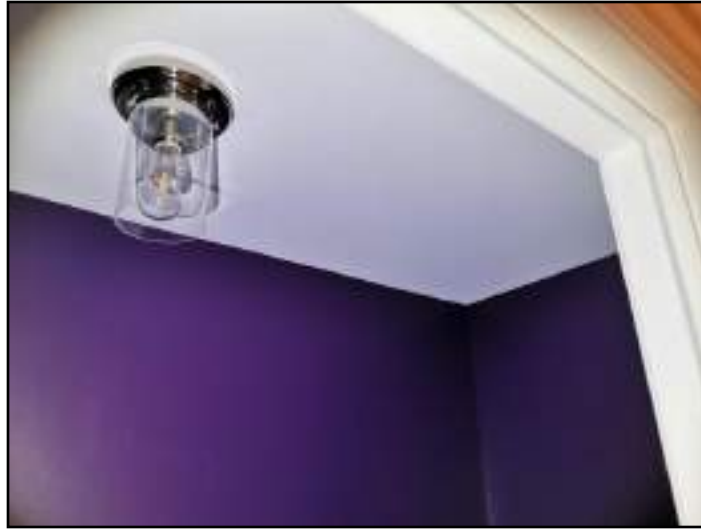
59. Condition: • [Missing](#)

Missing

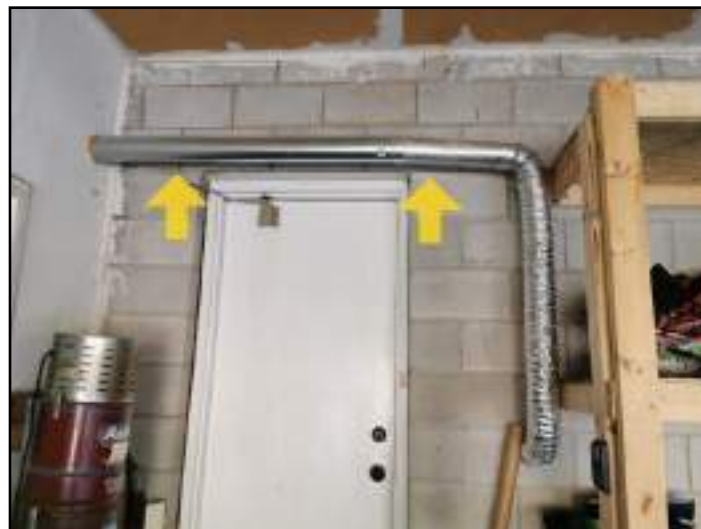
60. Condition: • [Not insulated in unconditioned space](#)

Not insulated in unconditioned space

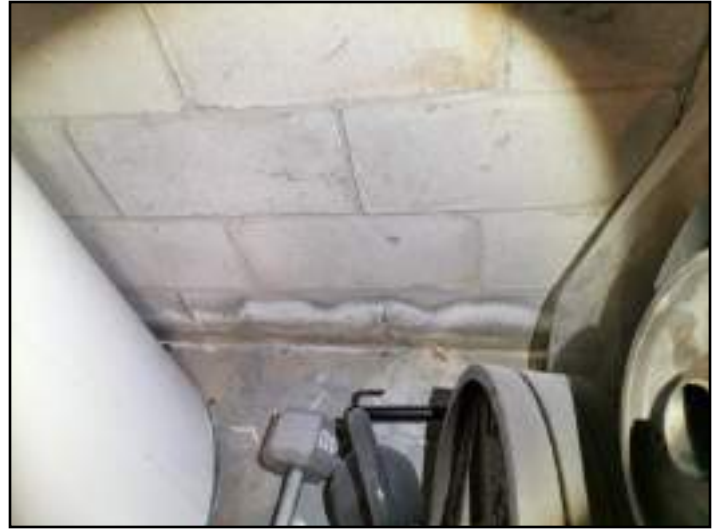
62. Condition: • [Mold](#)

Mold

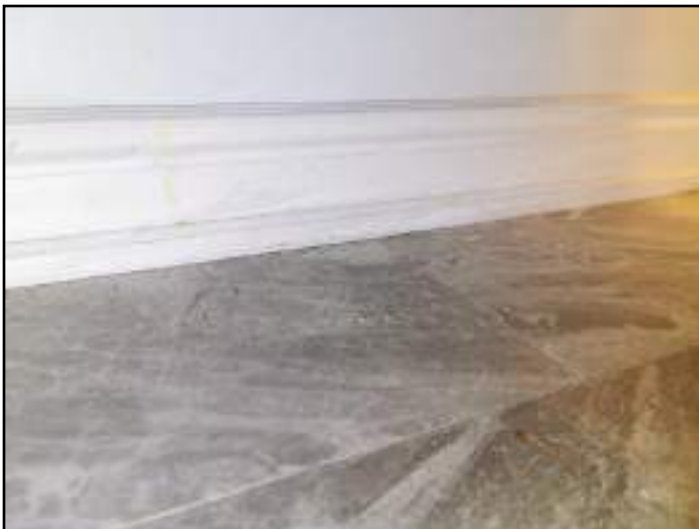
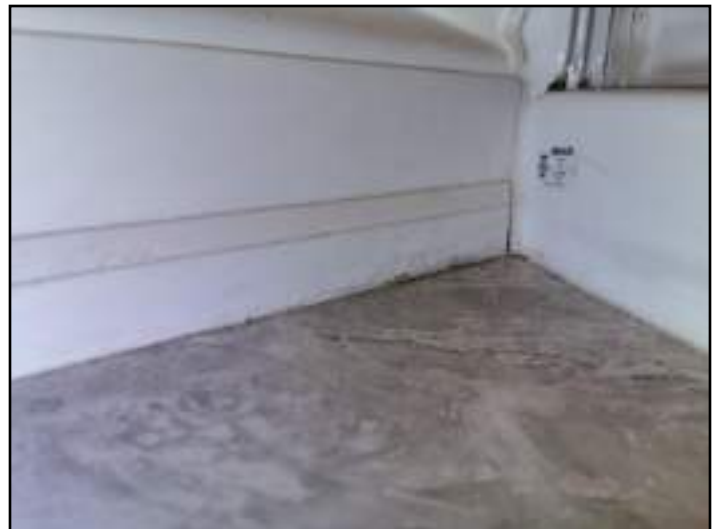
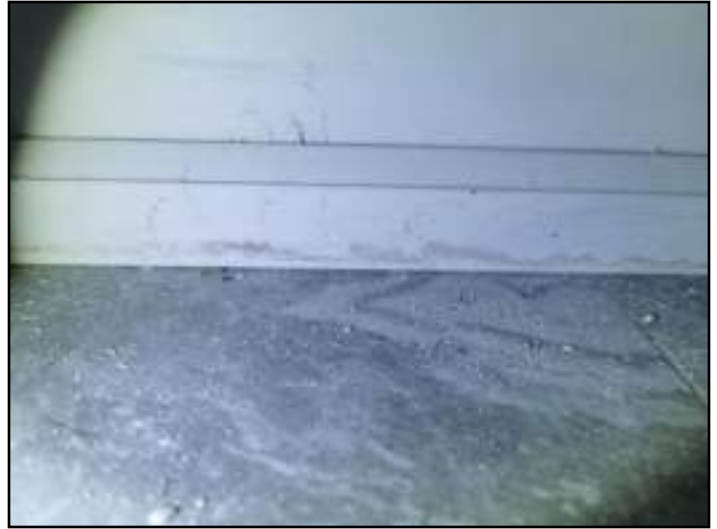
63. Condition: • [Stains](#)

Stains on baseboards. Note that this is very close to crack that was noted in Structural section.

Stains
