Your Inspection Report

123 Yonge Street
Toronto, ON

PREPARED BY:
Boris Vorobyov

RE: Report No. 1015, v.2
123 Yonge Street
Toronto, ON

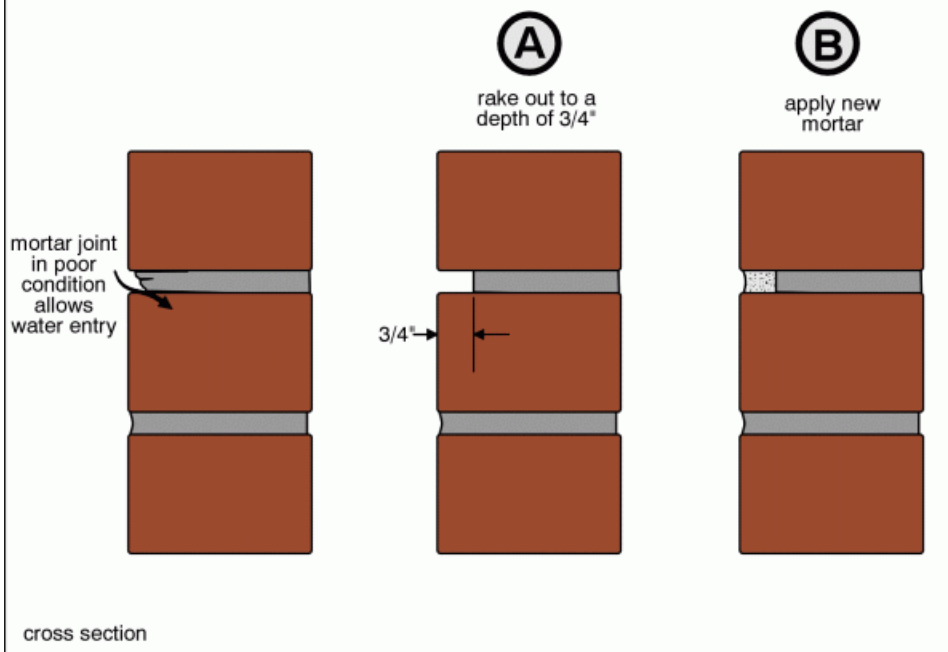
Repointing

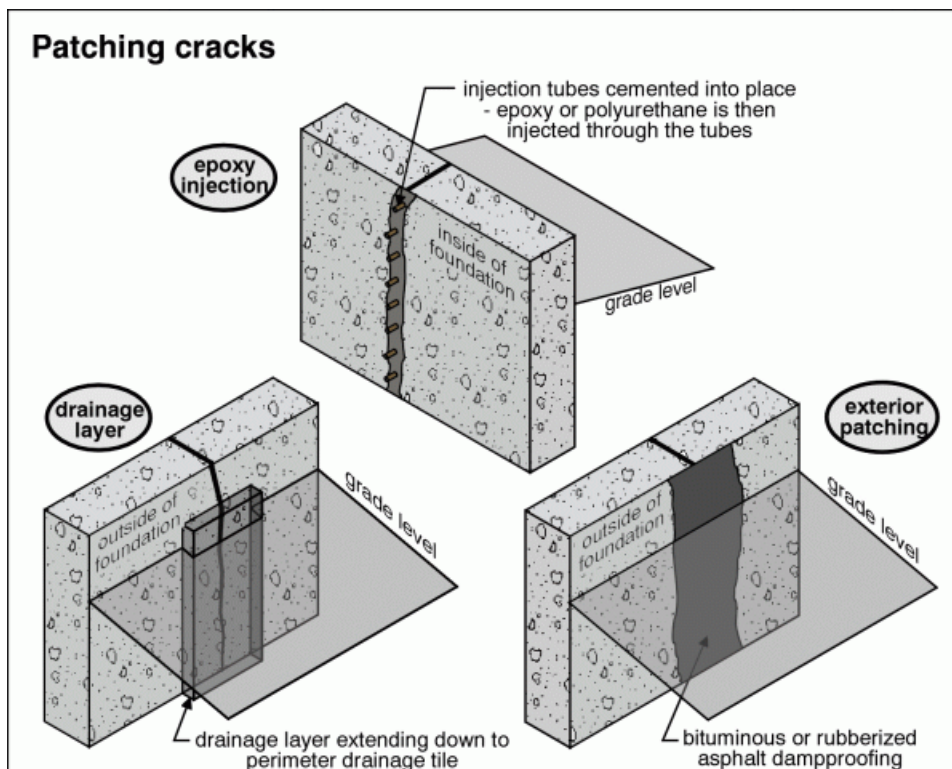
Crack repair - epoxy and polyurethane injection

polyurethane is flexible and is not a structural repair, however, it can prevent leakage

epoxy is as strong as concrete and forms a structural seal

however, it hardens slowly, and if there is space at the back of the crack, it may leak out

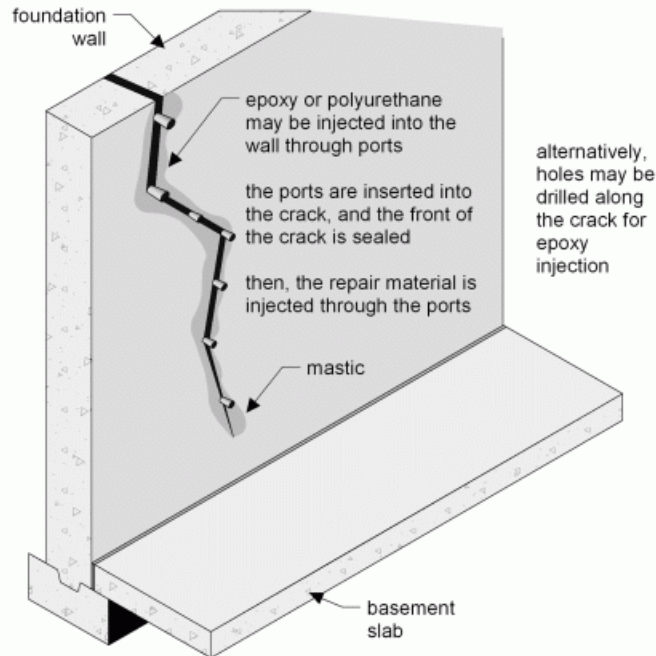
alternatively, holes may be drilled along the crack for epoxy injection

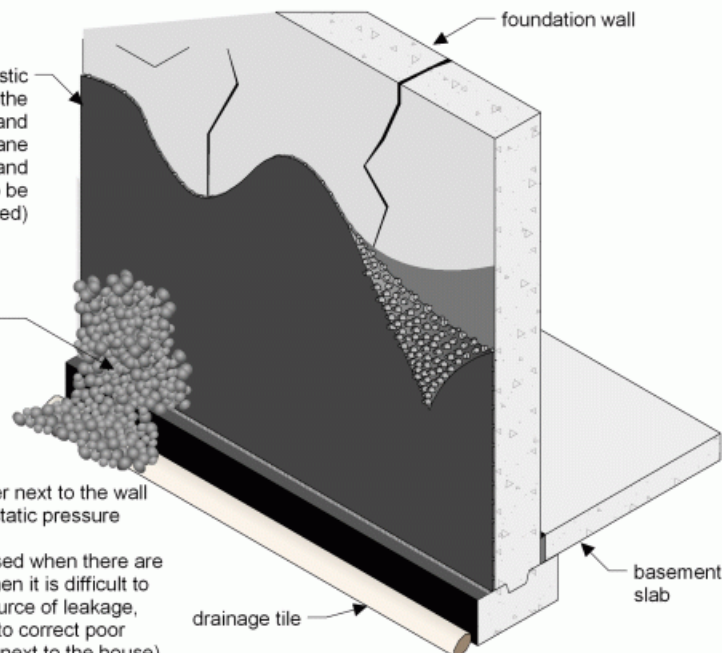
adding a drainage layer next to the wall helps to relieve hydrostatic pressure

this method may be used when there are many small cracks, when it is difficult to identify the specific source of leakage, and when it is difficult to correct poor grading (such as a hill next to the house).

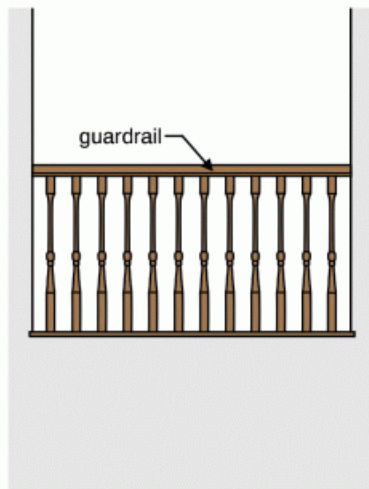
Handrail support

guardrails and handrails anchored to walls are the strongest

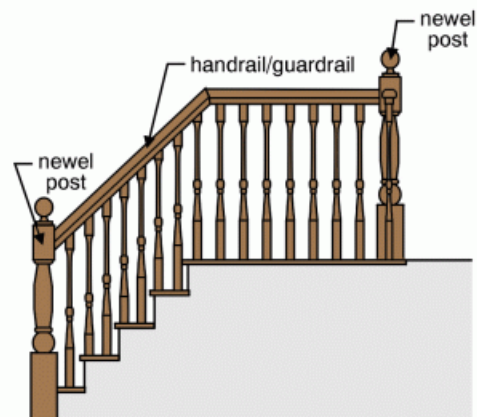
if the handrail (or guardrail) is supported at its ends by newel posts and the posts are not well secured, the whole assembly can be loose
