YOUR Inspection Report

INSPECTION DATE:

Wednesday, August 7, 2019

Boris Vorobyov

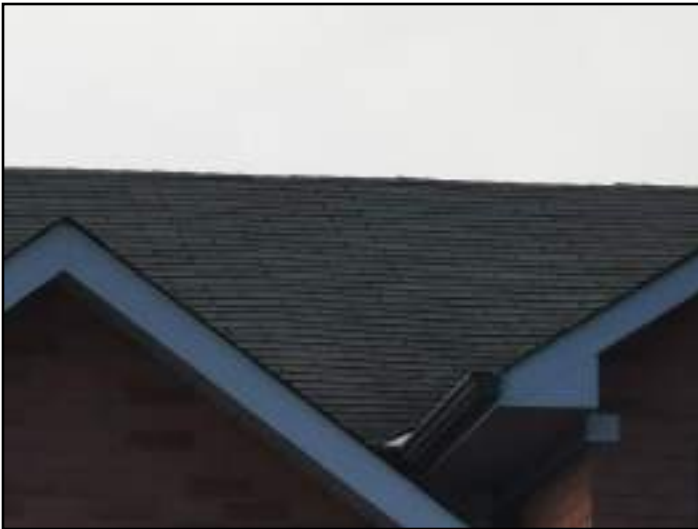
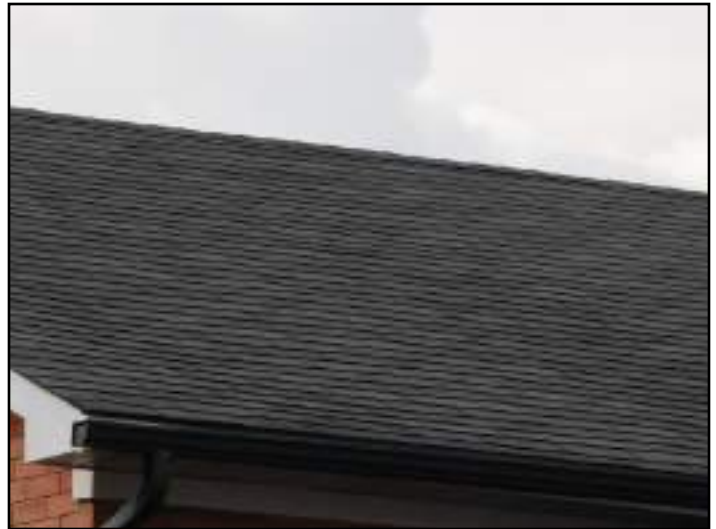
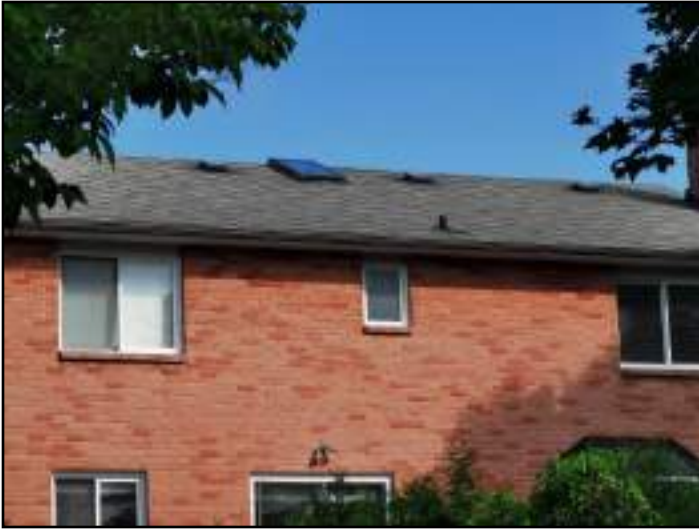
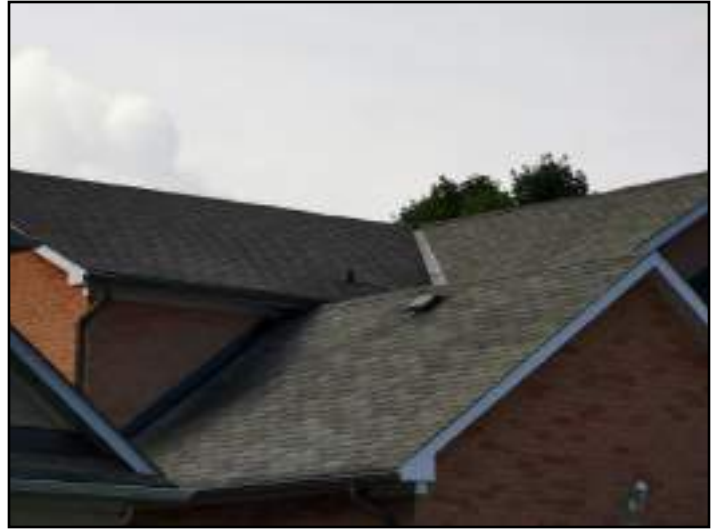
1. **Condition:** • [Cupping, curling, clawing](#)

Shingles have started to curl, cup and claw. Indicating that they are at the end of their life expectancy they will likely need to be replaced in next 3 years.

Implication(s): Chance of water damage to contents, finishes and/or structure

Cupping, curling, clawing

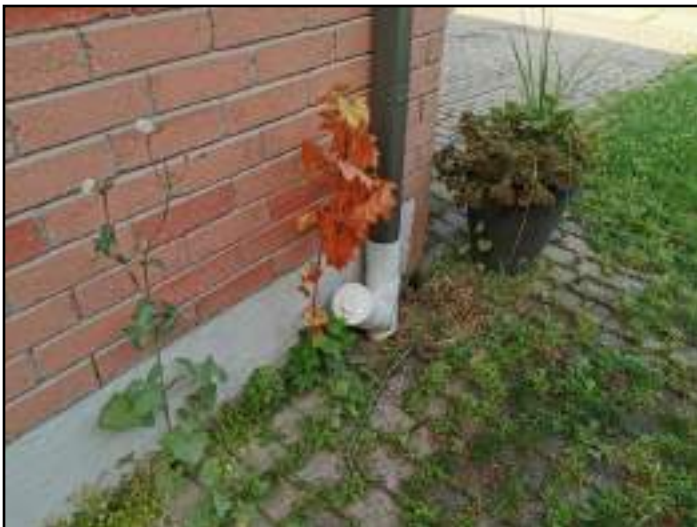
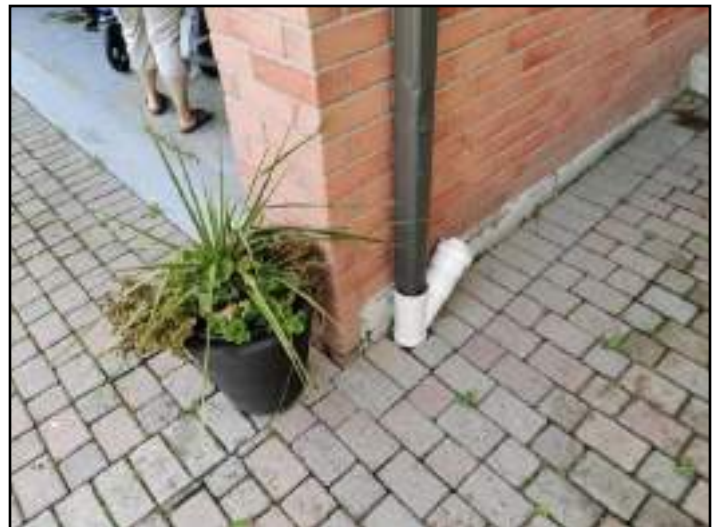
5. **Condition:** • [Discharge below grade](#)

Implication(s): Chance of water damage to contents, finishes and/or structure

Discharge below grade

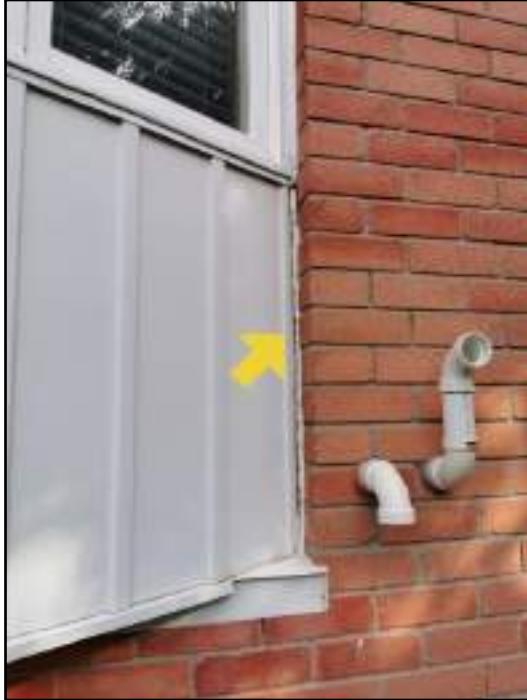
6. Condition: • Caulking missing or ineffective

Replace caulking where it is cracked and brittle and provide where it is missing.

Implication(s): Chance of water damage to contents, finishes and/or structure

Caulking missing or ineffective

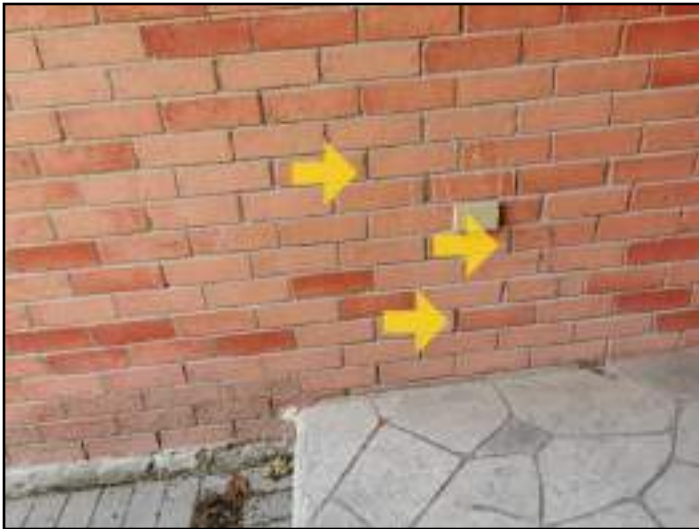
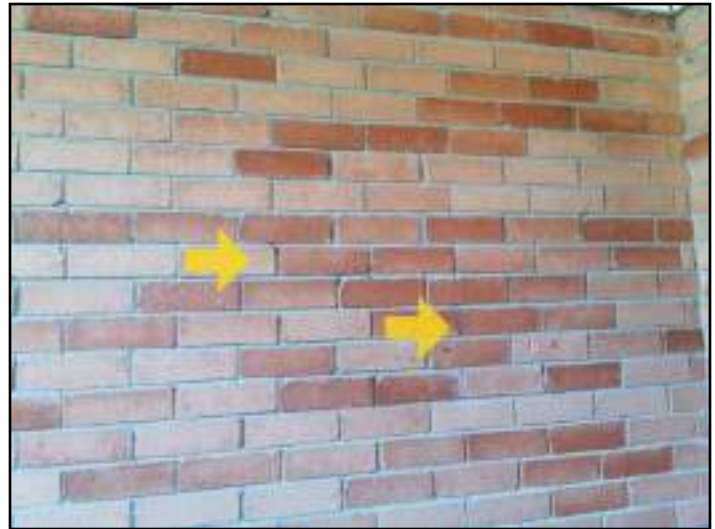
Front Porch

7. Condition: • [Cracked](#)

Step cracking on bricks in various areas around home. Typically cracks are caused due to minor settlement of home. Since the bricks are not structural but are brick veneer it is not as necessary but still recommended to repair by tuck pointing.

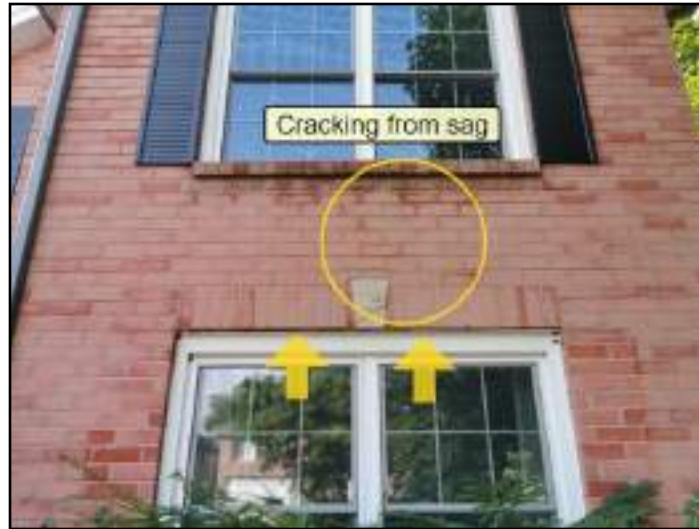
9. Condition: • [Lintel sagging](#)

It is not possible to tell when this damage occurred whether it was before the window was was changed or could be from time of construction. Repair cracking by tuck pointing and continue to monitor.

Lintel sagging

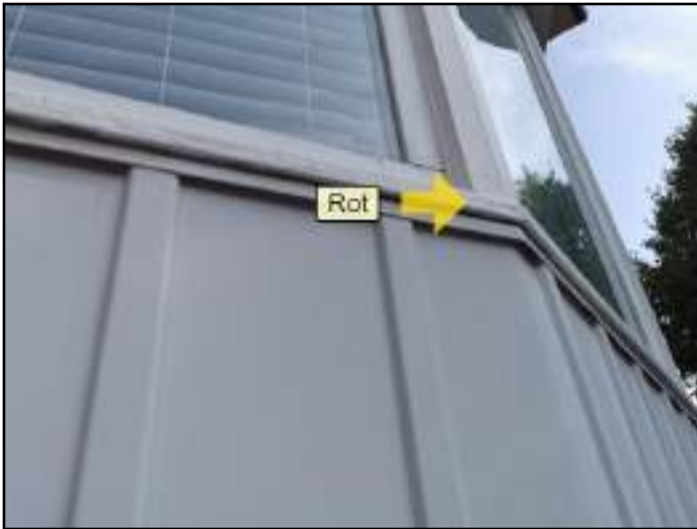
10. Condition: • Rot

Several windows that were original where in poor condition.

Caulking missing

Rot on frames

Cracked Glass

It is highly likely that many windows will not be able to be repair and will need to be replaced.

Rot

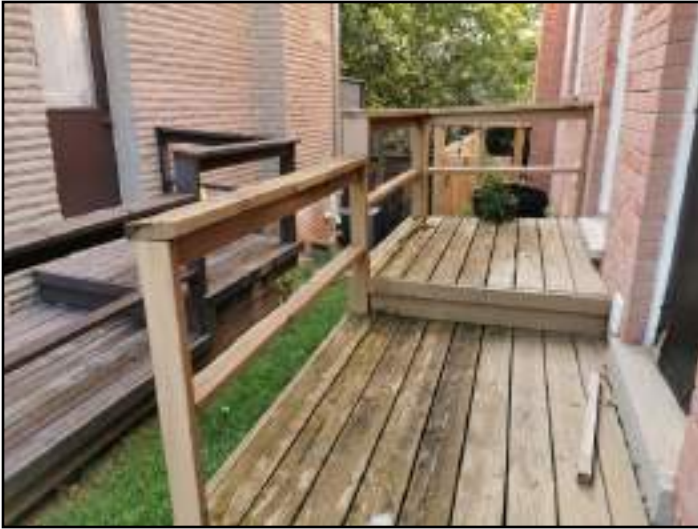
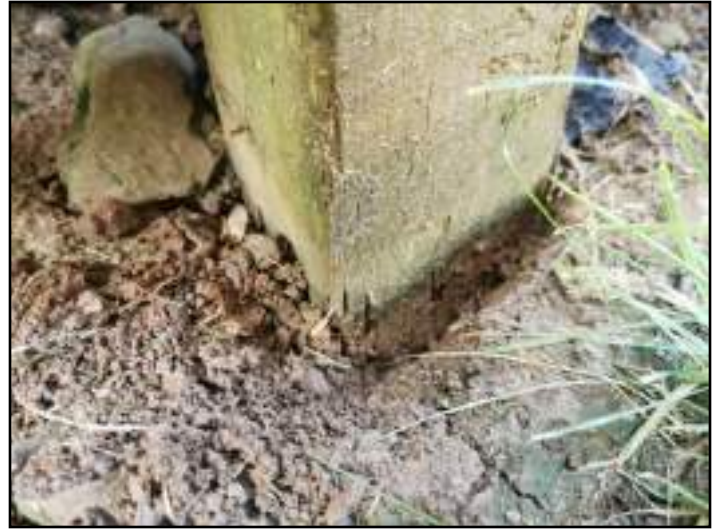
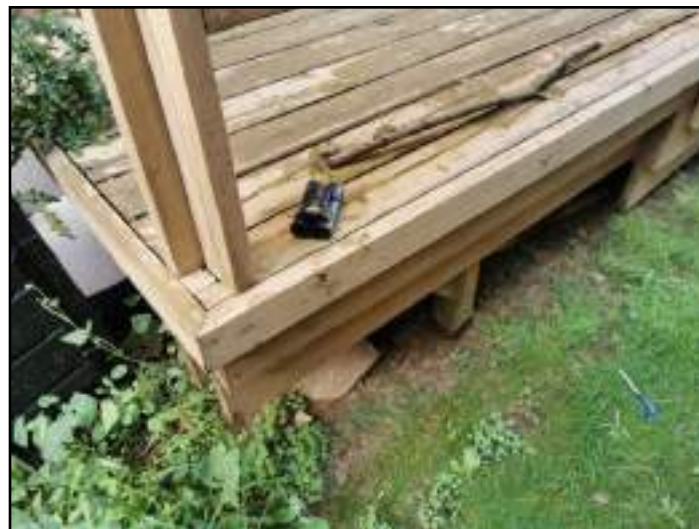
PORCHES, DECKS, STAIRS, PATIOS AND BALCONIES \ General**13. Condition:** • [Wood/soil contact](#)

Wooden deck structure mounted in ground as opposed to concrete footing. This post is starting to rot and will have to be replaced.

Implication(s): Rot | Insect damage

Wood/soil contact

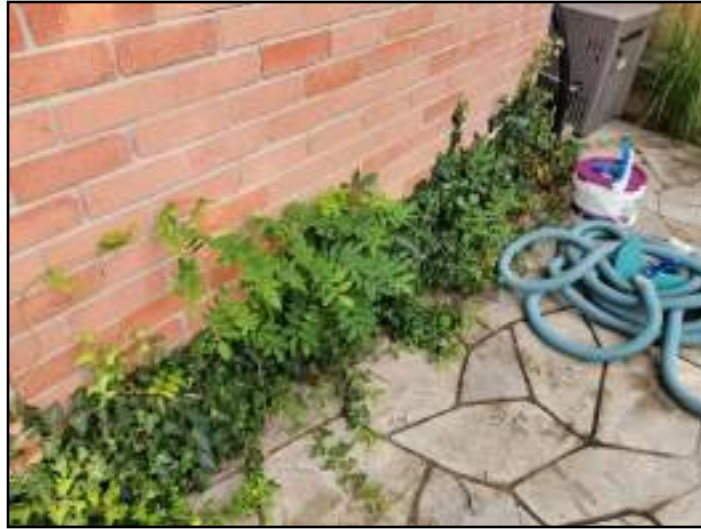
16. Condition: • Vines on building

Implication(s): Chance of damage to finishes | Chance of pests entering building

Vines on building

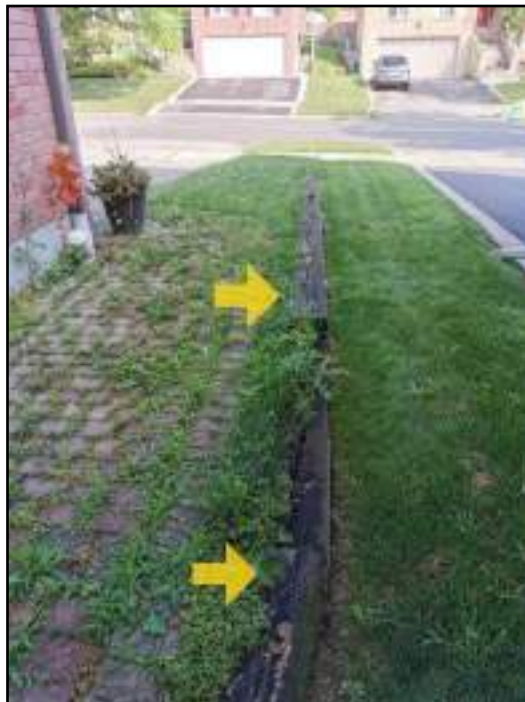
17. Condition: • [Rot](#)

Implication(s): Weakened structure | Material deterioration

Rot

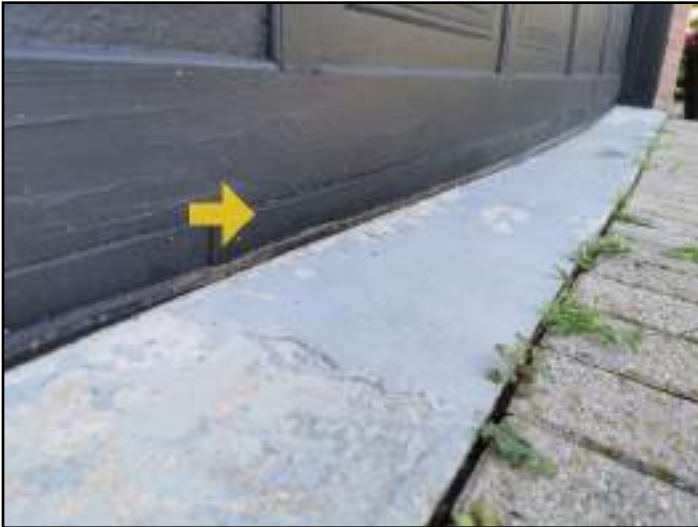
GARAGE \ Floor**18. Condition:** • [Improper slope](#)

Noted garage slab is settled towards middle and there has been an extension added to garage door to have it seal against floor. No corrective action needed.

Improper slope

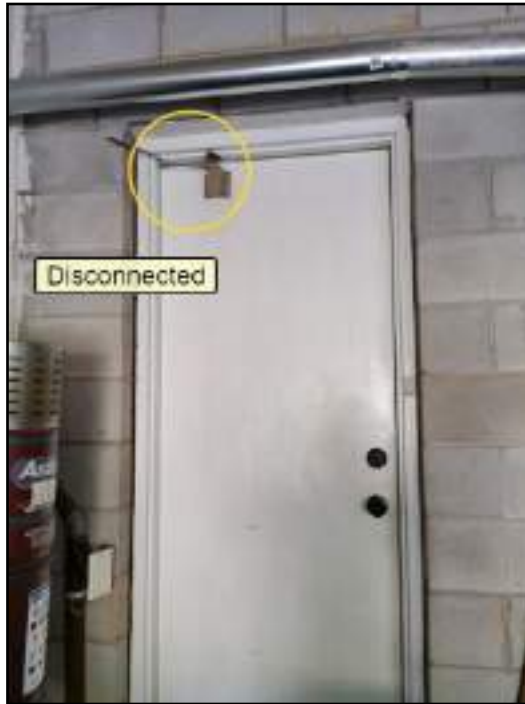
GARAGE \ Door into garage / Man-door**19. Condition:** • [No self-closer](#)

Implication(s): Hazardous combustion products entering home | Increased fire hazard

No self-closer

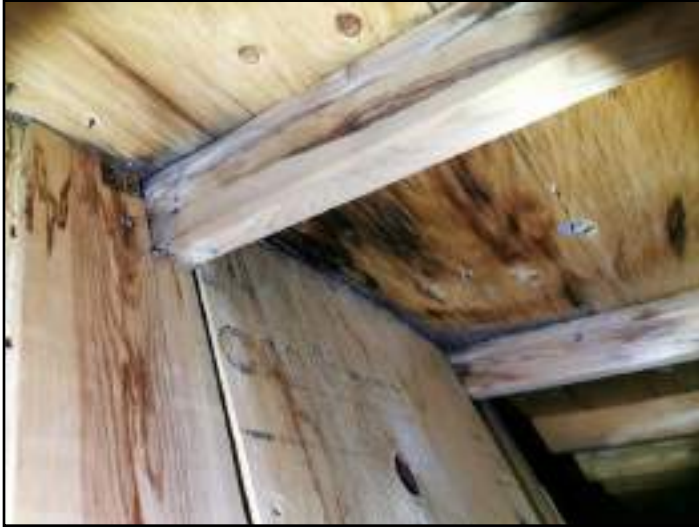
21. Condition: • [Water stains](#)

Small area where there was some water staining around skylight. Area was dry at time of inspection. Likely it is a minor problem, recommended to replace or re-seal skylight when re-shingling and monitor until then.

Damage could also be from previous shingles prior to them being replaced.

Water stains

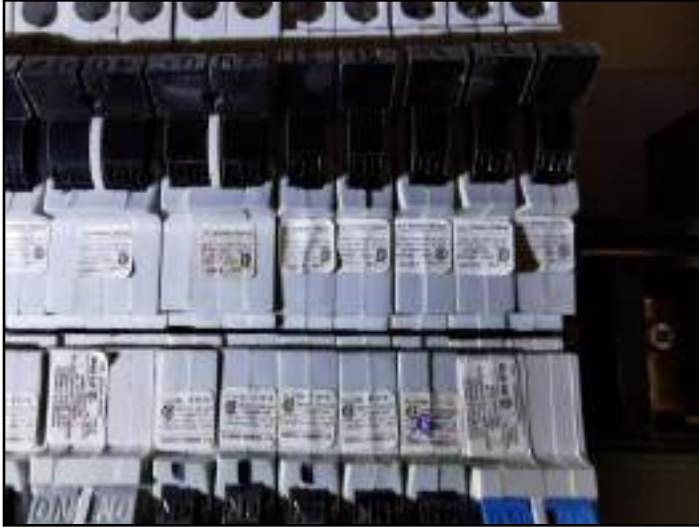
FPE (Federal Pioneer Electric) - Stablok...

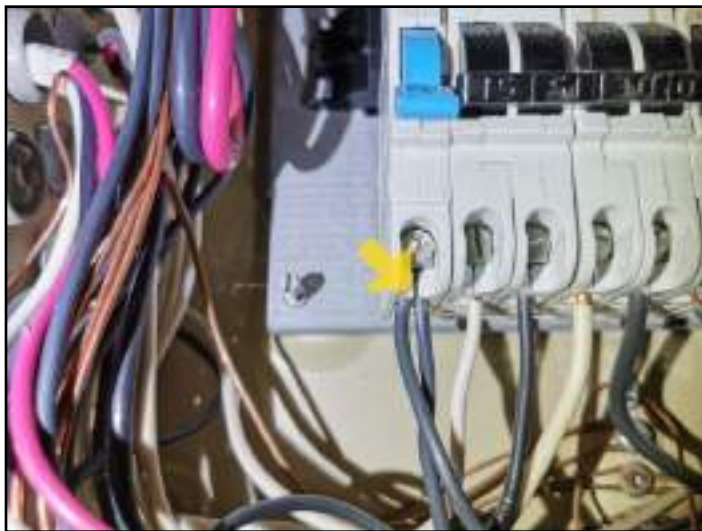
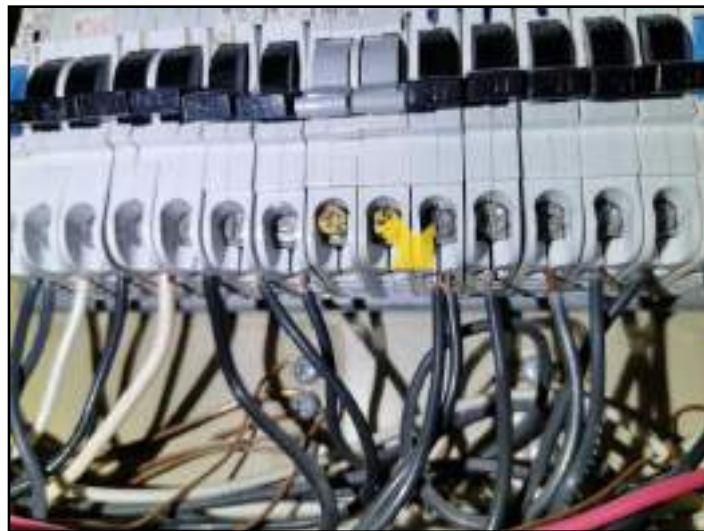
23. Condition: • [Double taps](#)

*Double taps*

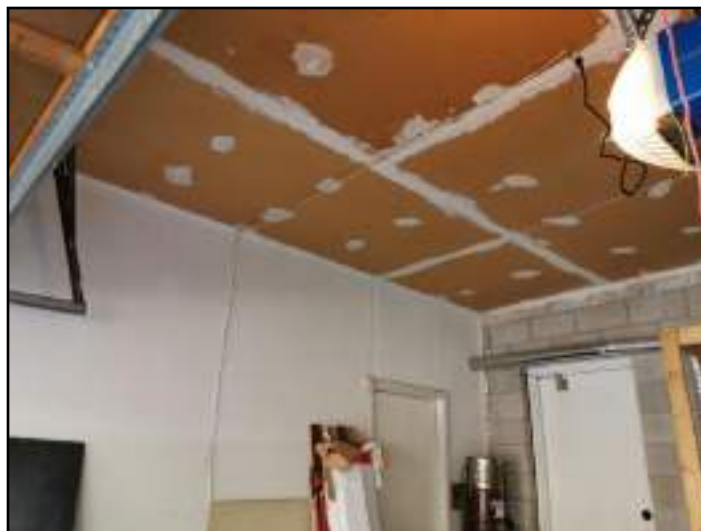
Extension cord for garage door opener

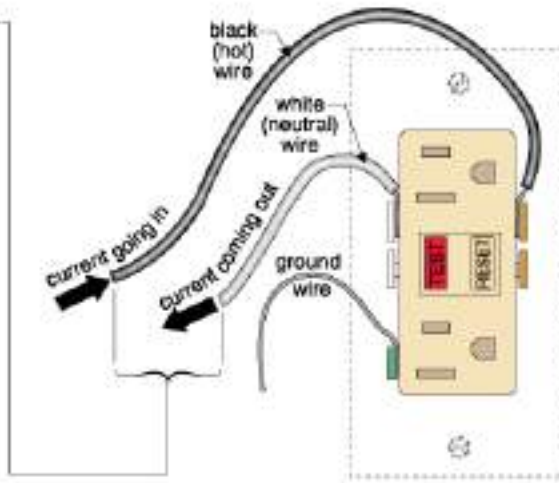
GFCI/GFI needed (Ground Fault Circuit...

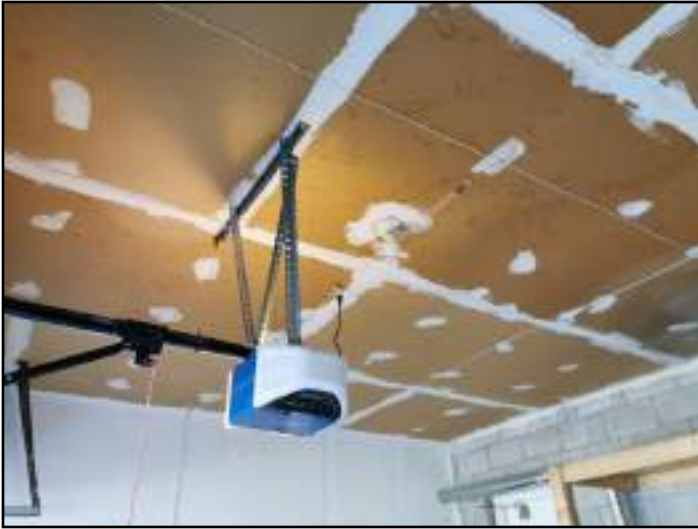
Garage

DISTRIBUTION SYSTEM \ Lights**27. Condition:** • [Inoperative](#)

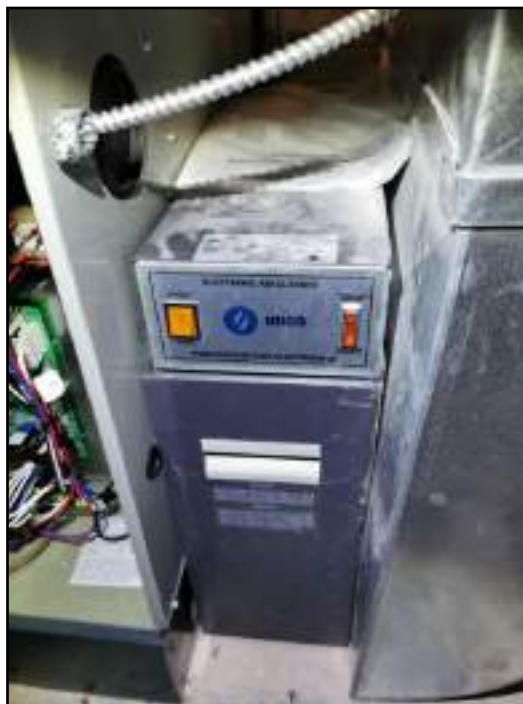
30. Condition: • [Inoperative](#)

Inoperative

Task: Repair or replace

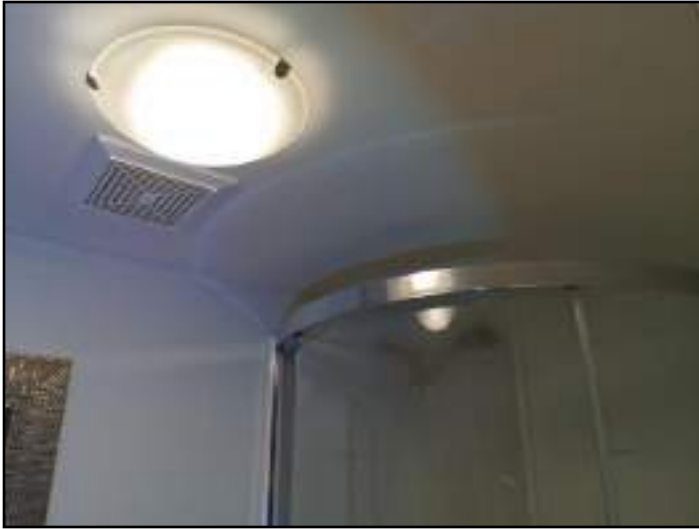
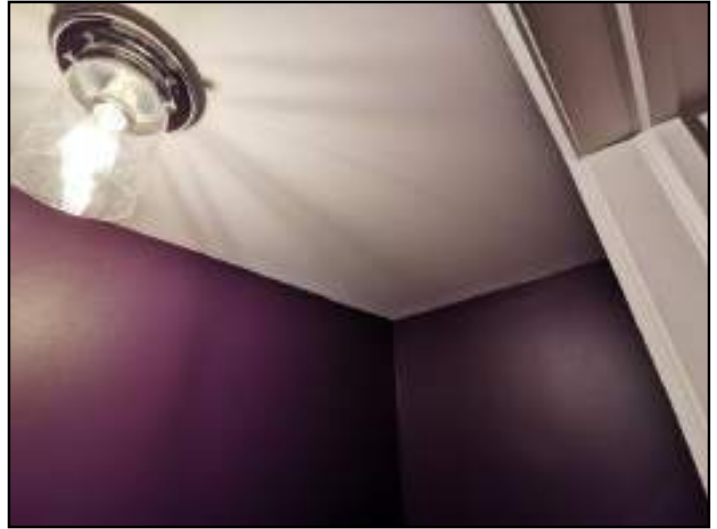
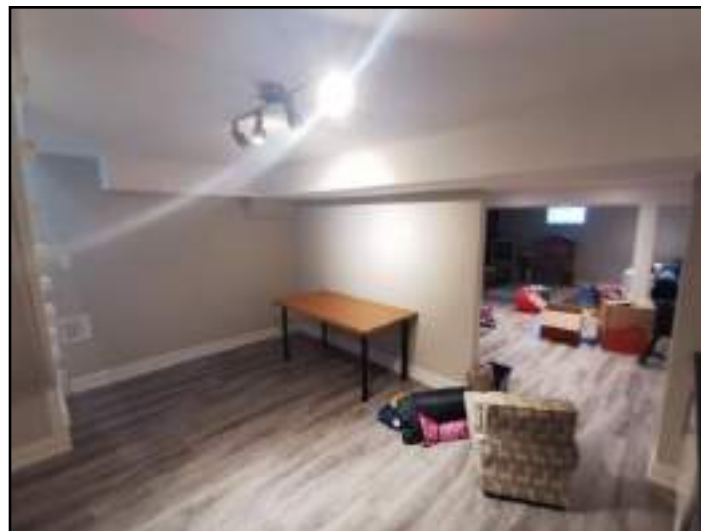
31. Condition: • No heat source

Each room with exterior wall must have a heat source. Both basement bathrooms and basement kitchen area there was no heat source found. Recommended to add supply from forced air system or have a dedicated heater in each room.

*No heat source*

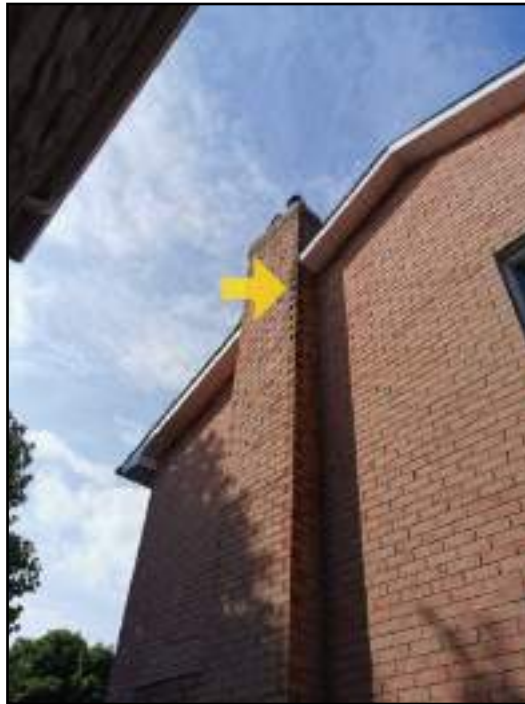
32. Condition: • [Loose, missing or deteriorated masonry](#)

Loose, missing or deteriorated masonry

Task: Repair

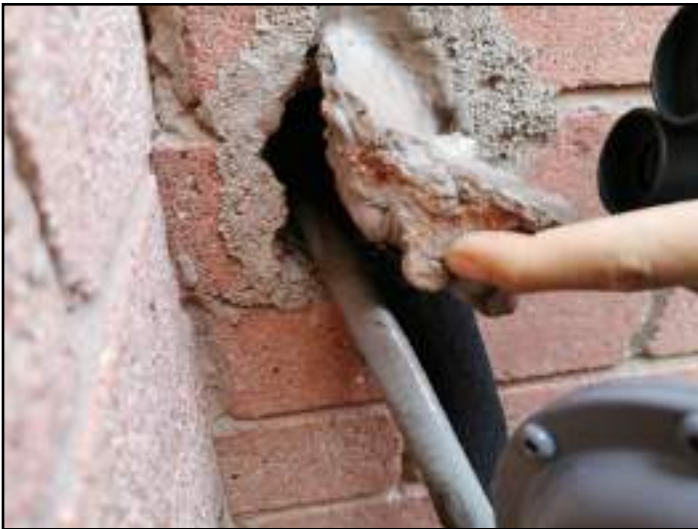
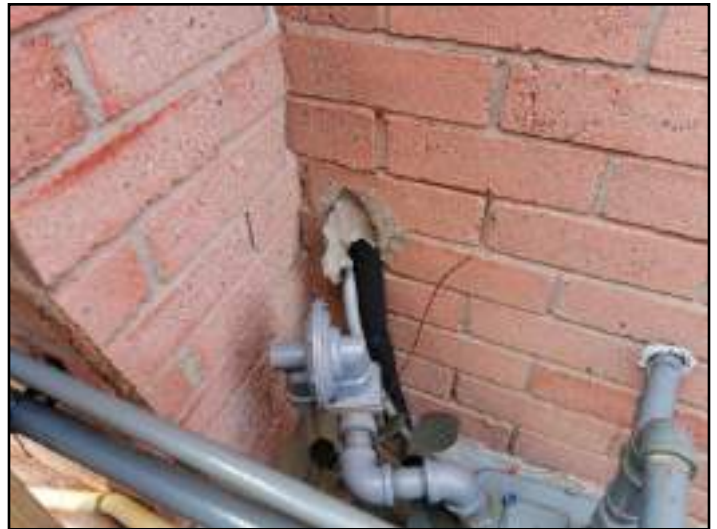
38. Condition: • [Poor seal at building](#)

Poor seal at building

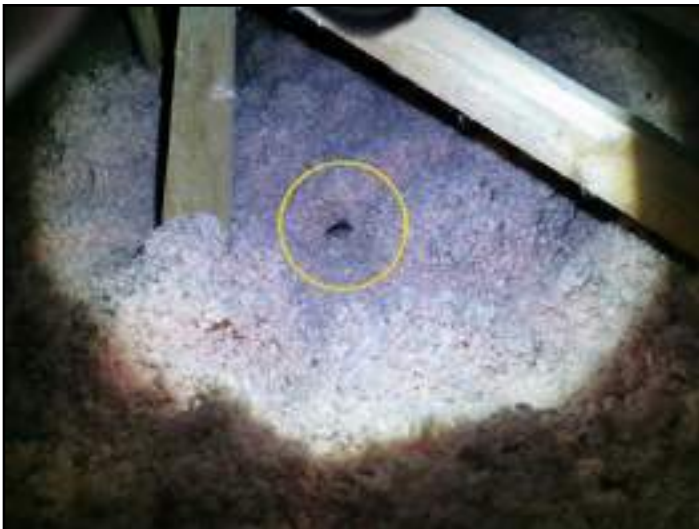
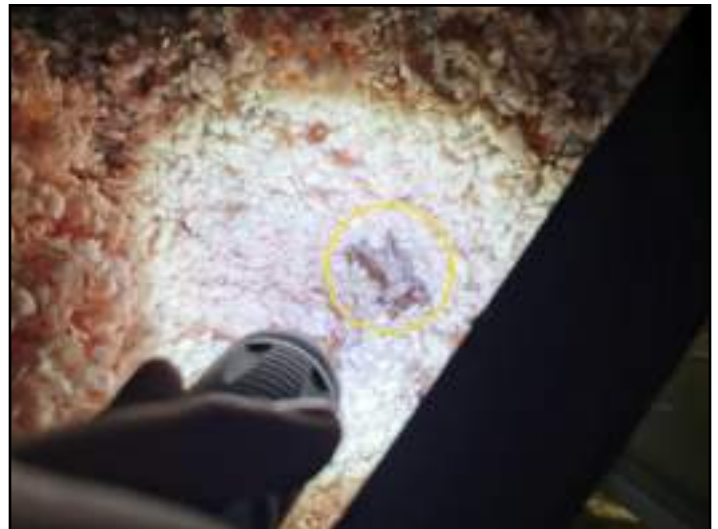
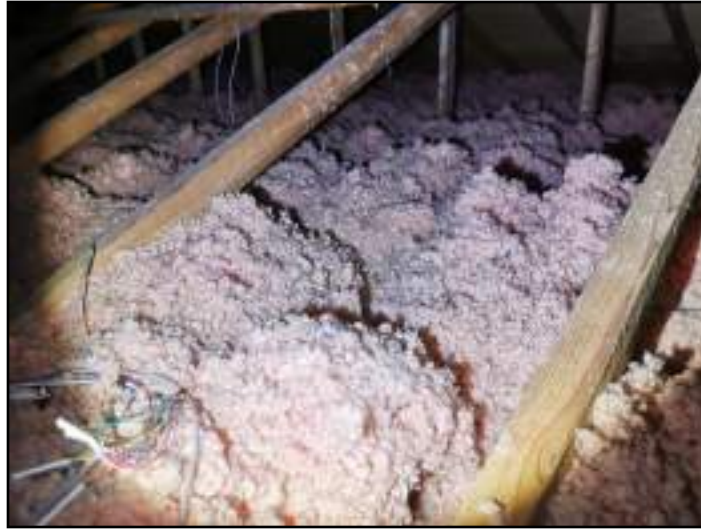
39. Condition: • [Gaps or voids](#)

There was evidence of mice tunnels and gaps throughout insulation in attic. Further evaluation by exterminator recommended if necessary.

Gaps or voids

Task: Further evaluation

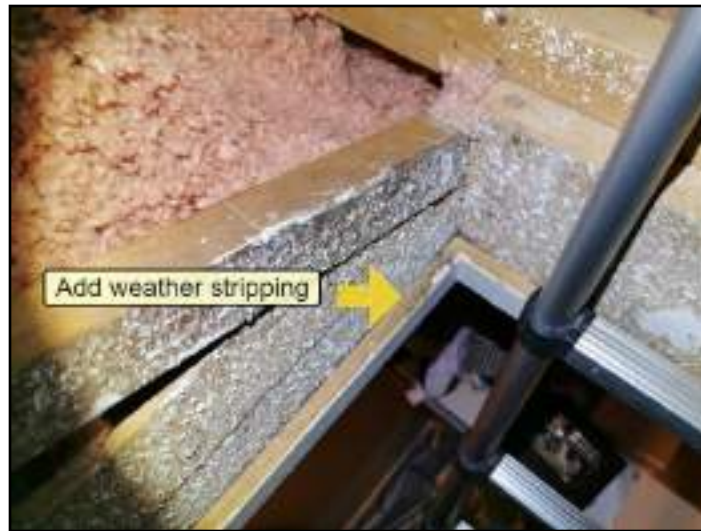
40. Condition: • [Not weatherstripped](#)

Implication(s): Chance of condensation damage to finishes and/or structure | Increased heating and cooling costs

Not weatherstripped

Task: Improve

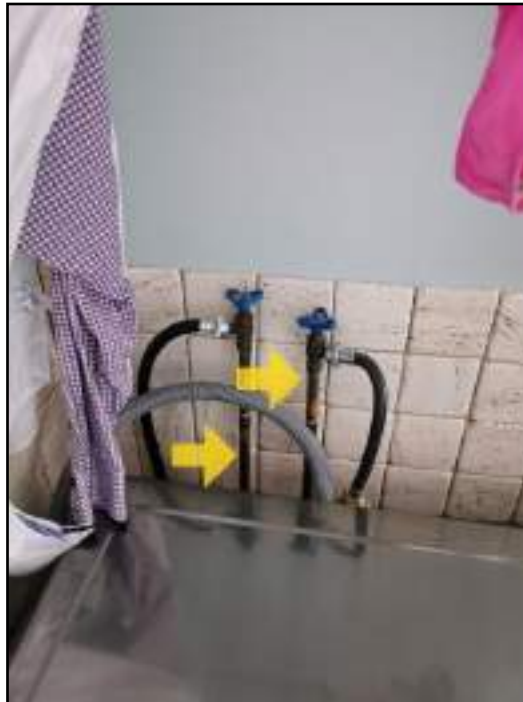
43. **Condition:** • [Poor support](#)

Implication(s): Chance of water damage to contents, finishes and/or structure | Leakage

Poor support

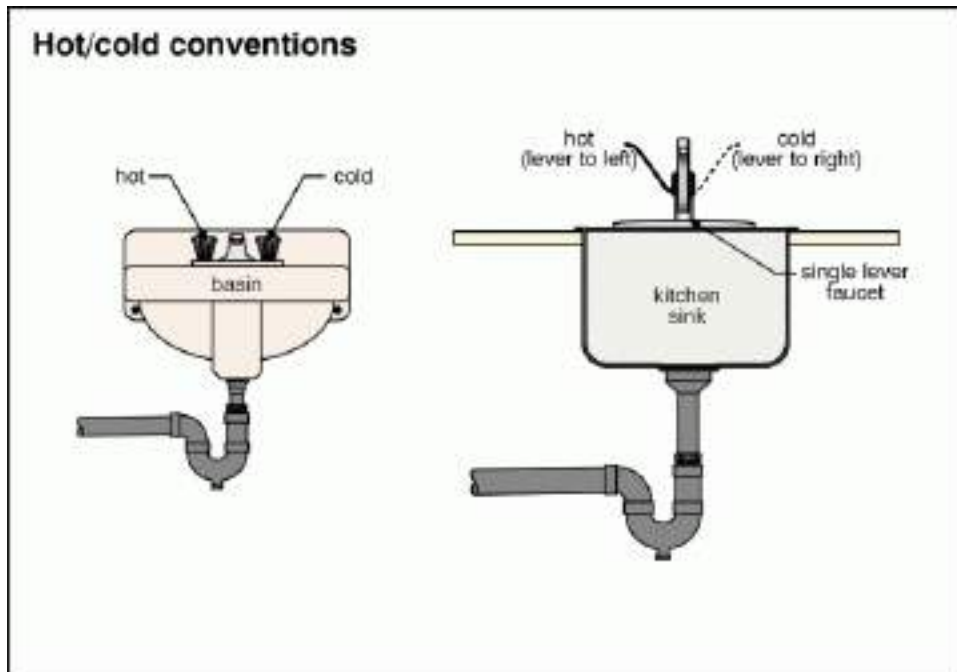
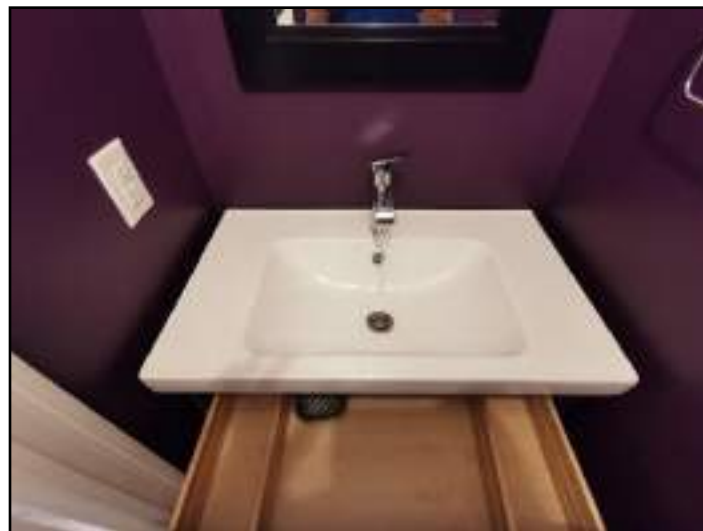
FIXTURES AND FAUCETS \ Faucet**46. Condition:** • [Hot and cold reversed](#)**Implication(s):** Scalding**Location:** Basement Powder Room**Task:** Repair**Time:** Immediate

Hot and cold reversed

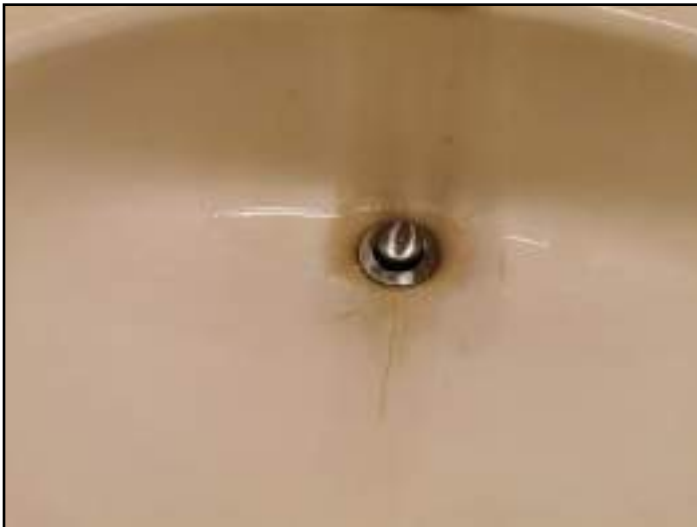
48. Condition: • [Surface defects](#)

Surface defects

Task: Replace

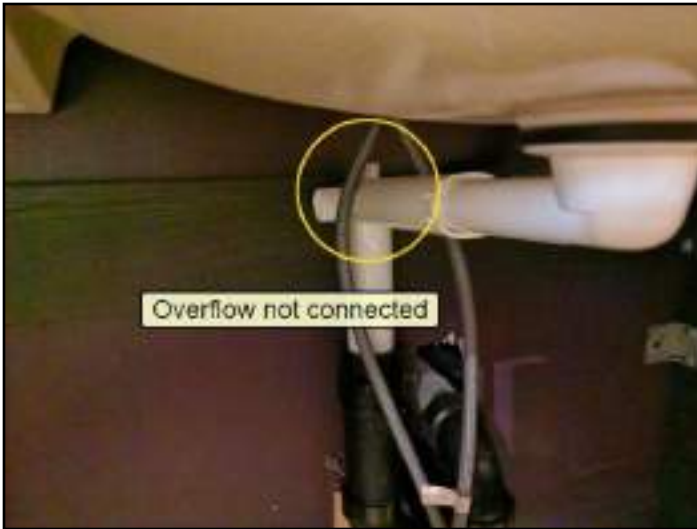
50. Condition: • [Overflows missing, leak, rust or inappropriate](#)

Implication(s): Chance of water damage to contents, finishes and/or structure

Overflows missing, leak, rust or...

Task: Repair

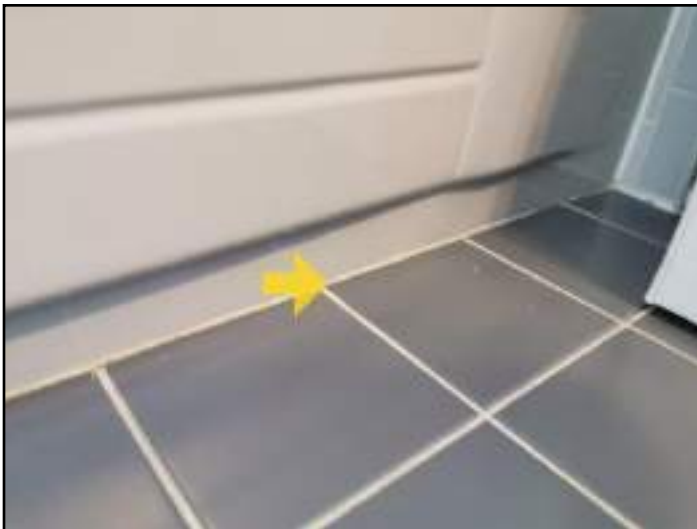
51. Condition: • [Caulking loose, missing or deteriorated](#)

Implication(s): Chance of water damage to contents, finishes and/or structure

Caulking loose, missing or deteriorated

Task: Provide

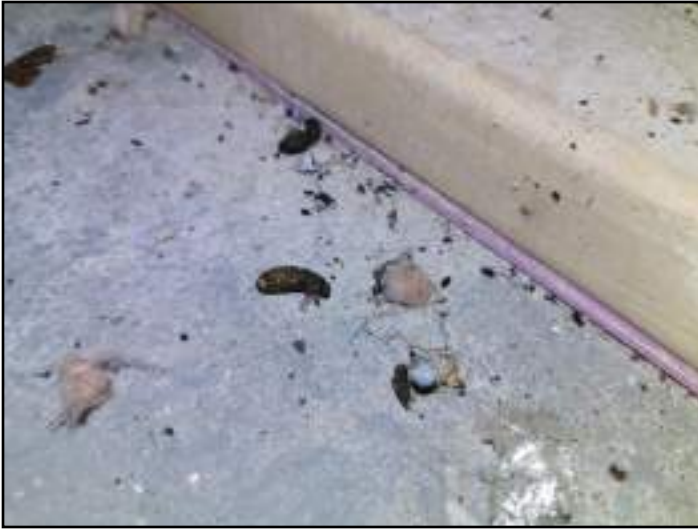
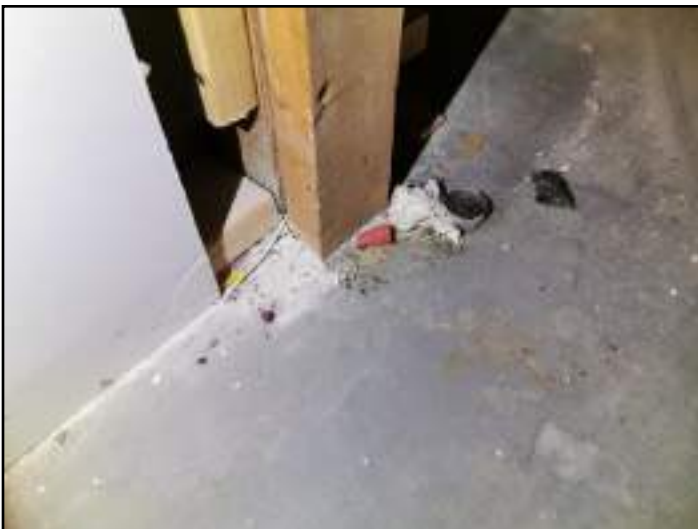
54. • Noted presence of mice due to droppings around the home. Further evaluation and inspection by rodent inspector recommended.

Noted presence of mice due to droppings...

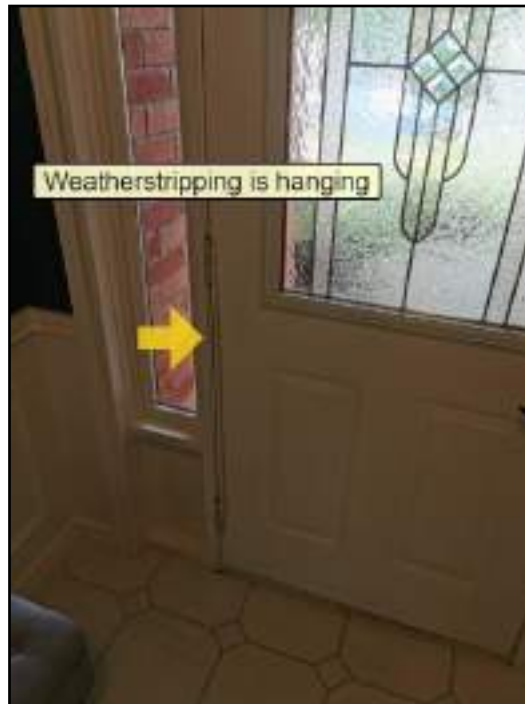
55. Condition: • [Weatherstripping missing or ineffective](#)

Weatherstripping missing or ineffective

Task: Replace

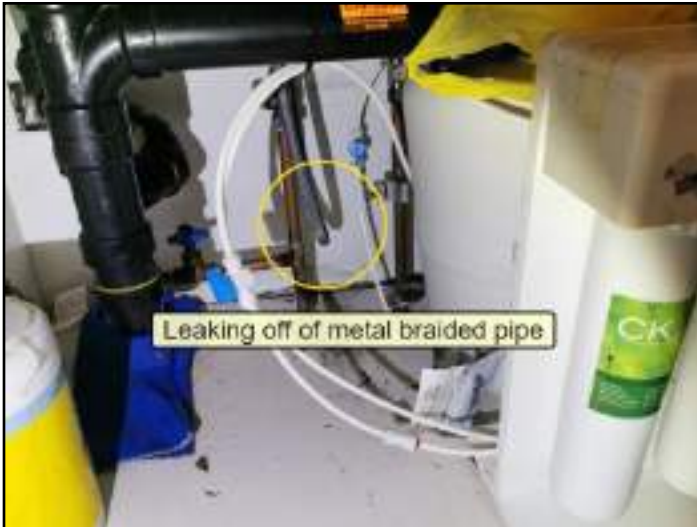
57. Condition: • [Water damage](#)

Implication(s): Material deterioration

Water damage

Task: Repair or replace

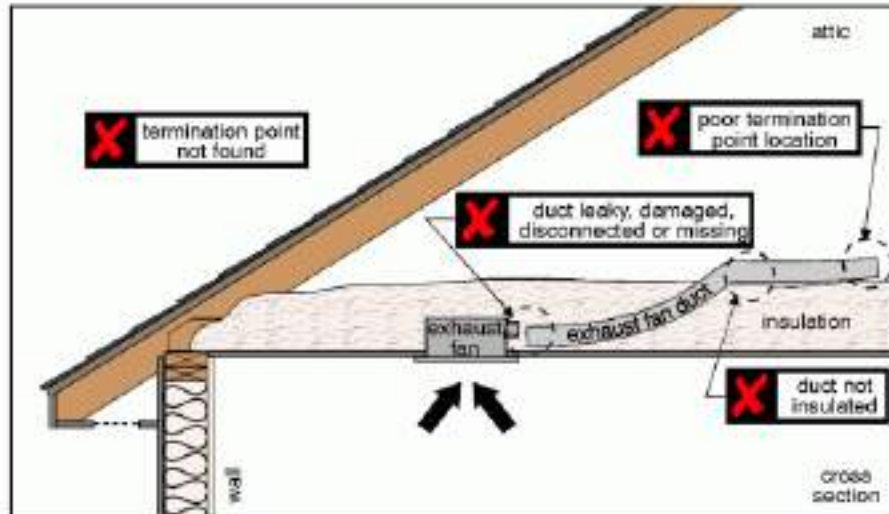
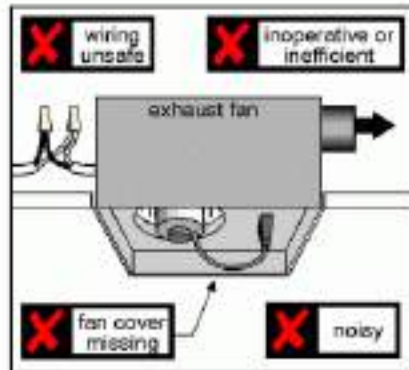
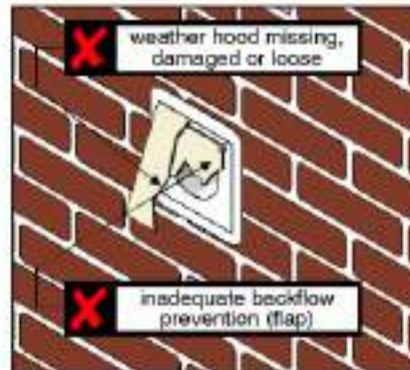
Not insulated in unconditioned space

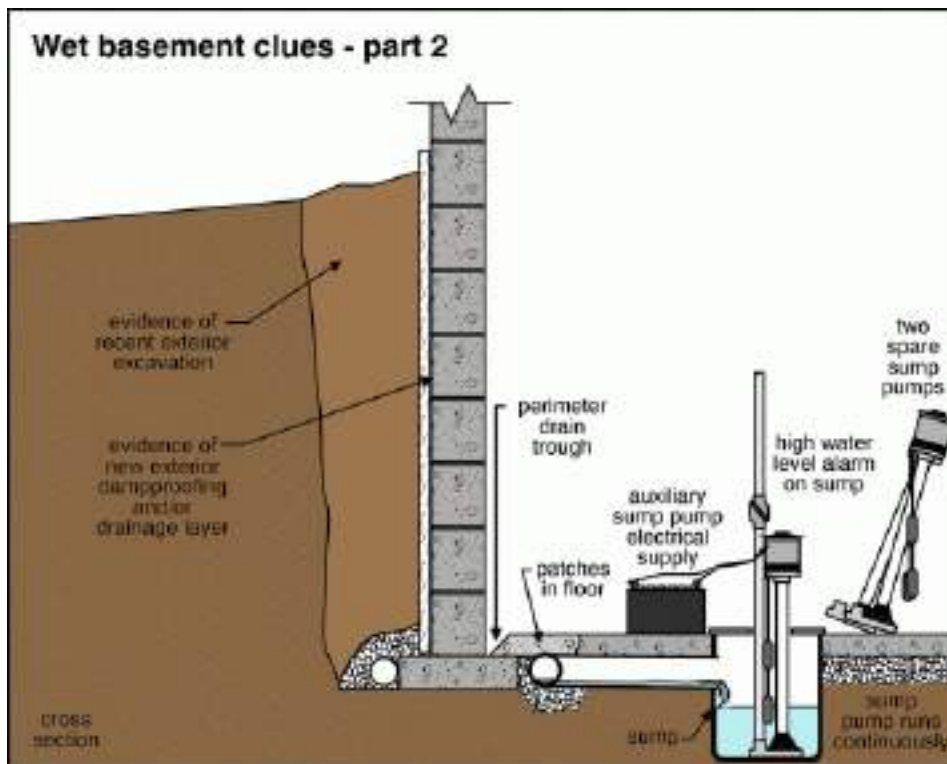
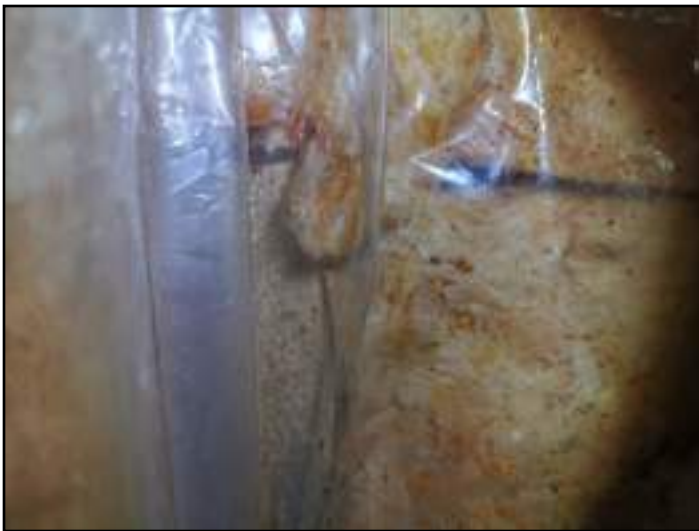
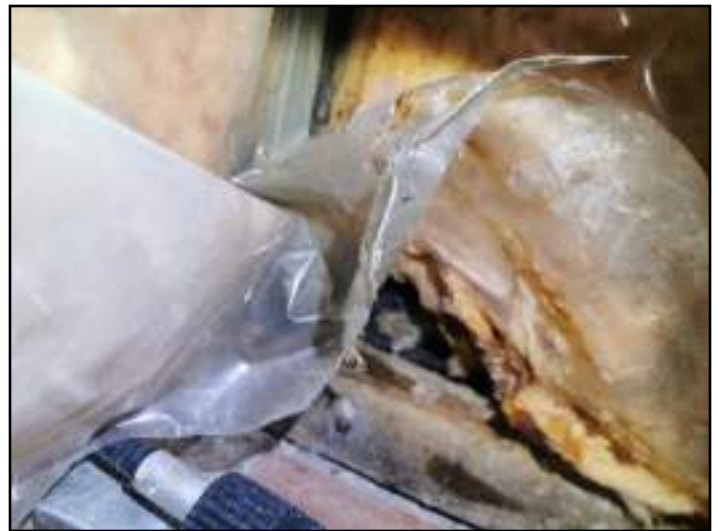
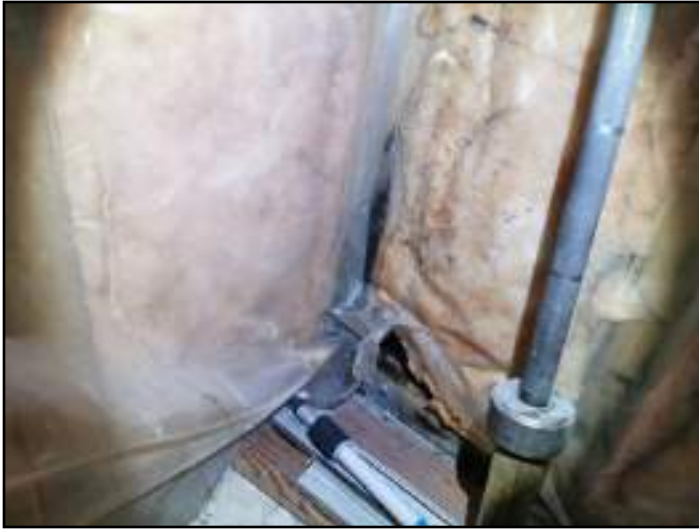
62. Condition: • [Mold](#)

Implication(s): Chance of water damage to contents, finishes and/or structure | Contaminants may enter building air

Mold

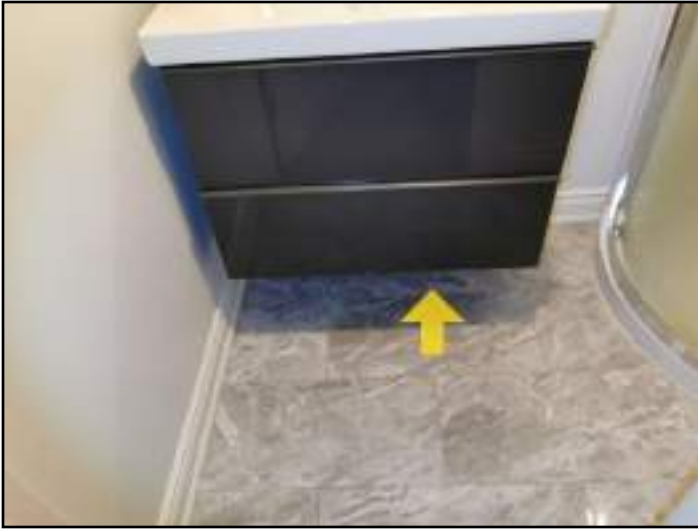
63. Condition: • [Stains](#)

Stains on baseboards. Note that this is very close to crack that was noted in Structural section.

Implication(s): Chance of water damage to contents, finishes and/or structure

Stains

Task: Repair

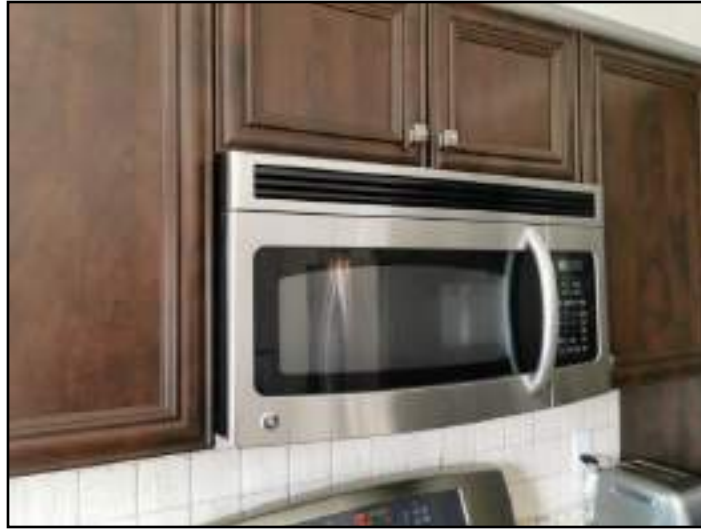
65. Condition: • Not vented properly
Range hood should be vented to exterior.

Not vented properly

Task: Repair

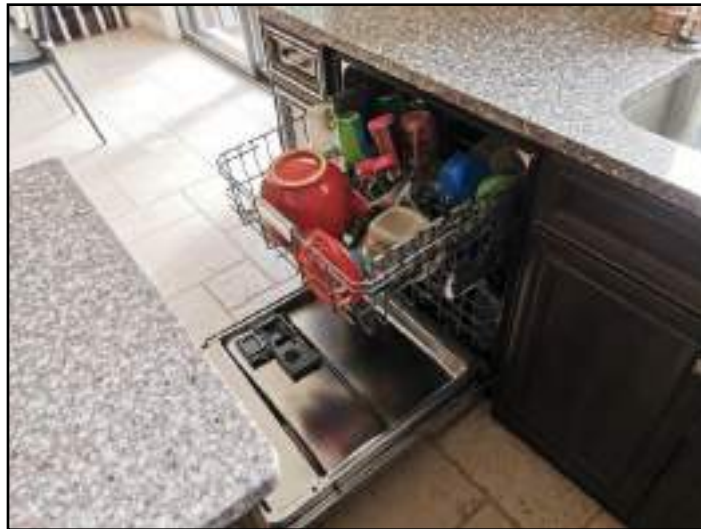
66. Condition: • Poorly secured

Poorly secured

Task: Improve

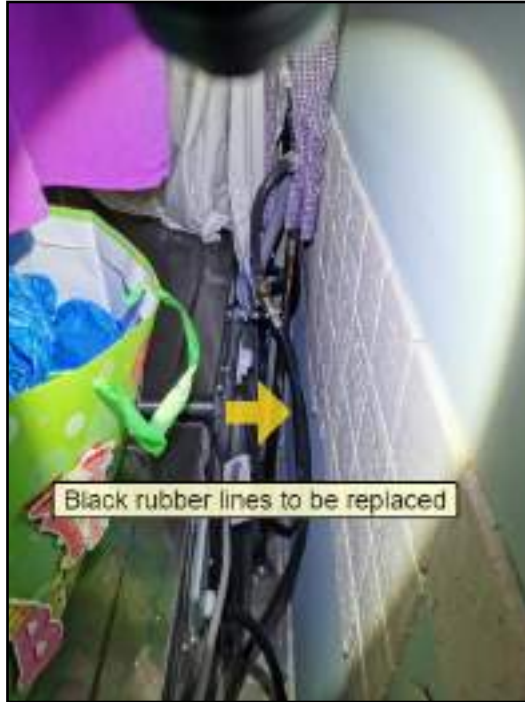
67. Condition: • Rubber lines recommended to be changed to metal braided.

Rubber lines recommended to be changed to...

Task: Replace
